**FINAL
GEOMORPHIC ASSESSMENT REPORT
BIG WOOD RIVER
BLAINE COUNTY, IDAHO**

Trout Unlimited

research & consulting inc.

February 1, 2016

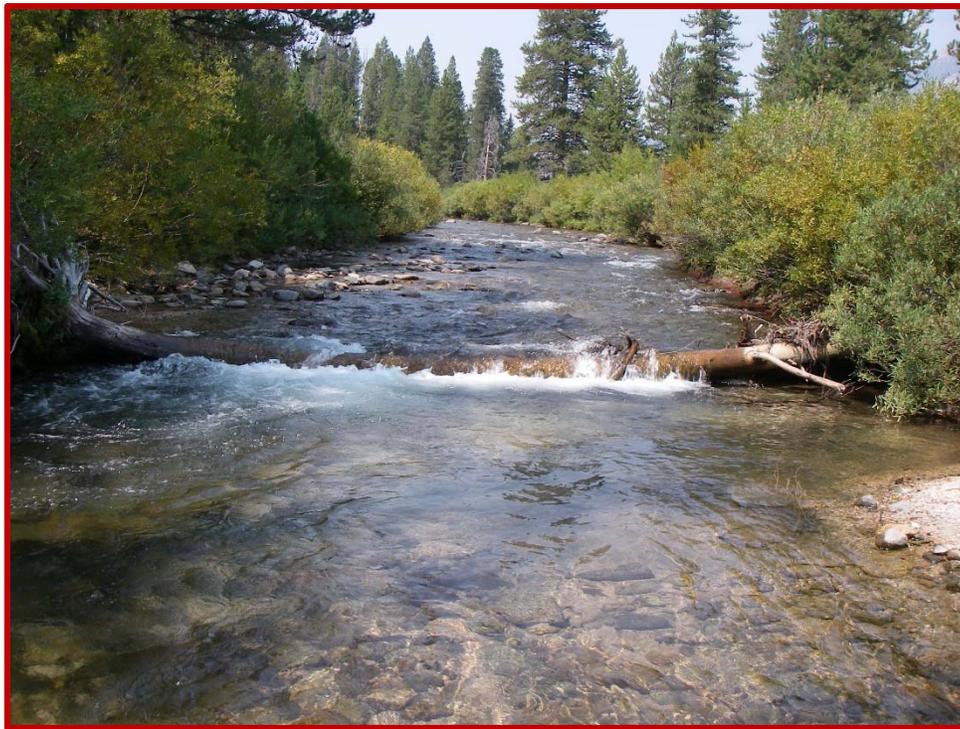
Figure 8. Photograph of spill over log and typical robust riparian vegetation resulting in low BEHI ratings and moderately stable channel conditions in Upstream Reference Reach.

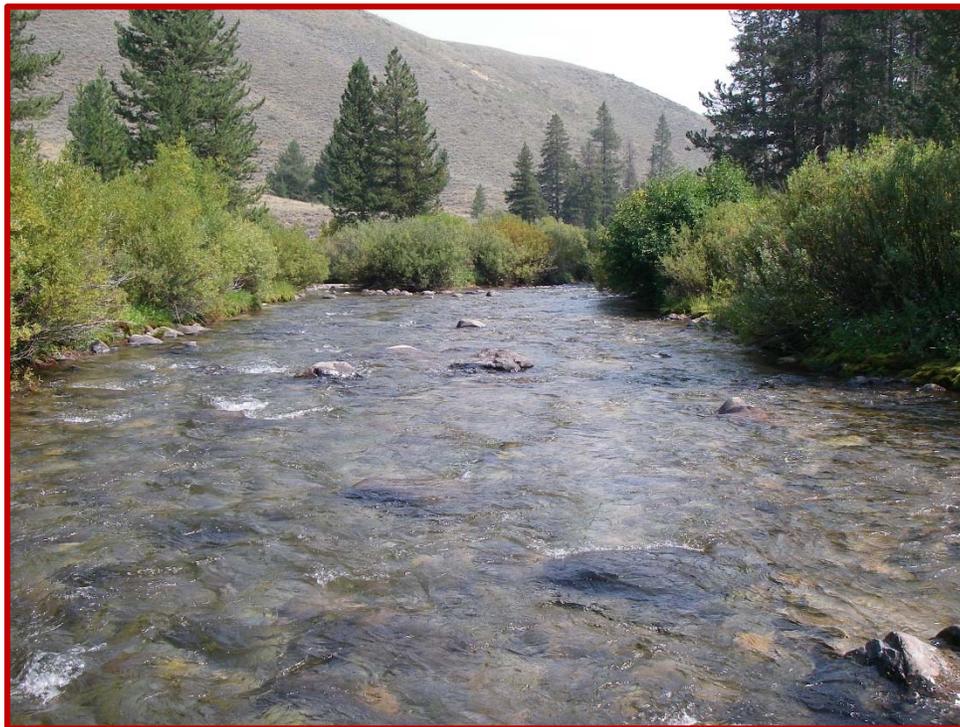
Figure 9. Typical moderate width/depth ratio and moderately stable channel conditions in Upstream Reference Reach.

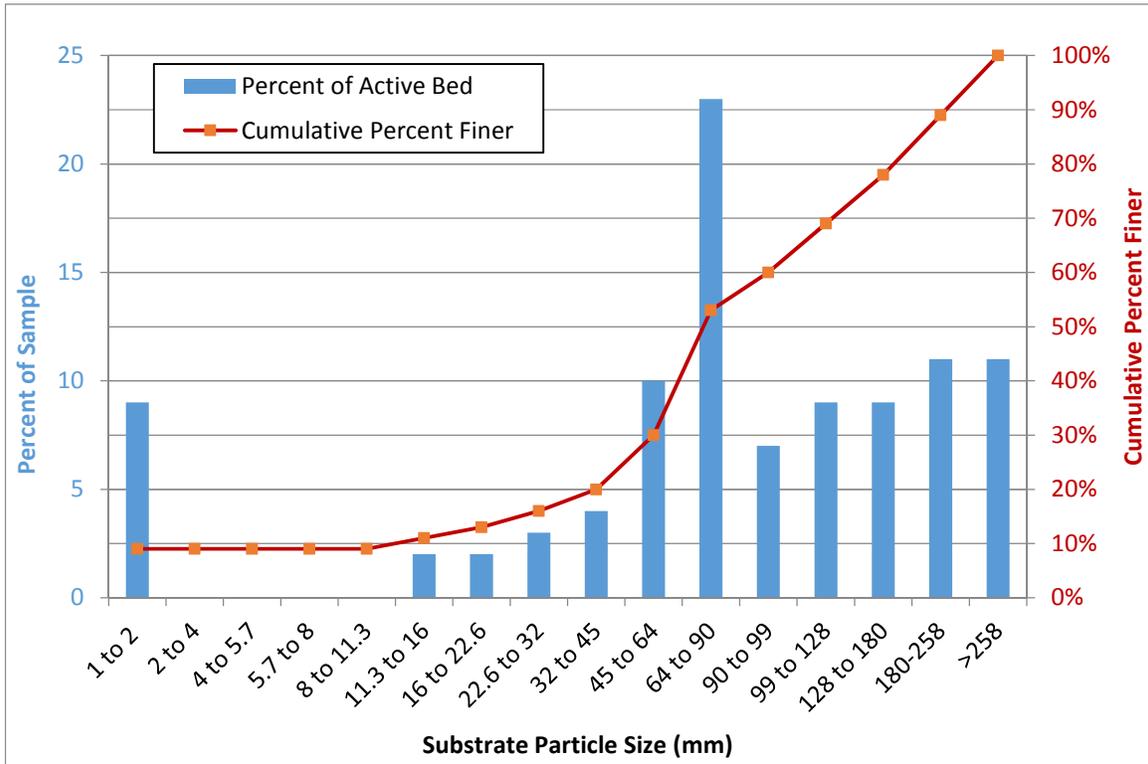
The dimensionless bankfull shear stress in the Upstream Reference Reach is 0.022 and the dimensional shear stress is 1.038 lbs/ft². Bankfull hydraulic conditions result in the mobilization of a 156 mm particle according to a modified Shields curve depicting the incipient motion of sediment particles based on shear stress (Rosgen 2010). Survey data indicate that the reach is capable of transporting the largest particles in the available bedload, and is capable of mobilizing the approximate 75th percentile particle (D75) of the surface grains based upon material size class distribution (Figure 13). These analyses indicate that the reach is competent to mobilize the available bedload and that the existing surface grain size class distribution promotes vertical channel stability.

Figure 13. Surface particle size class distribution in the Upstream Reference reach.

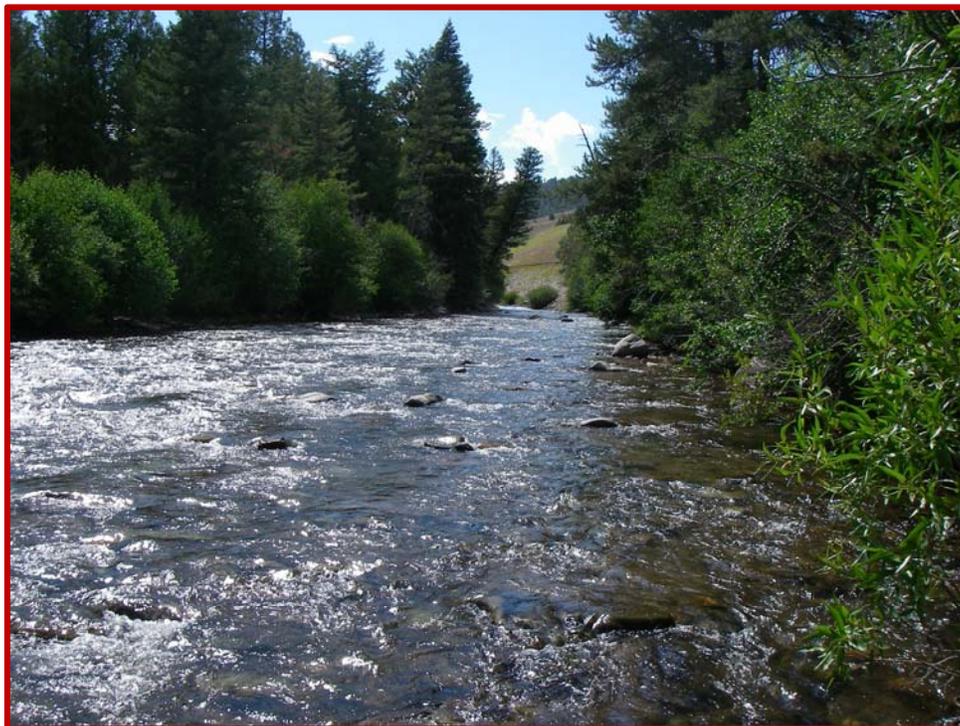
Figure 16. Photograph of typical channel confinement and robust riparian vegetation in Wood River Campground Reach.

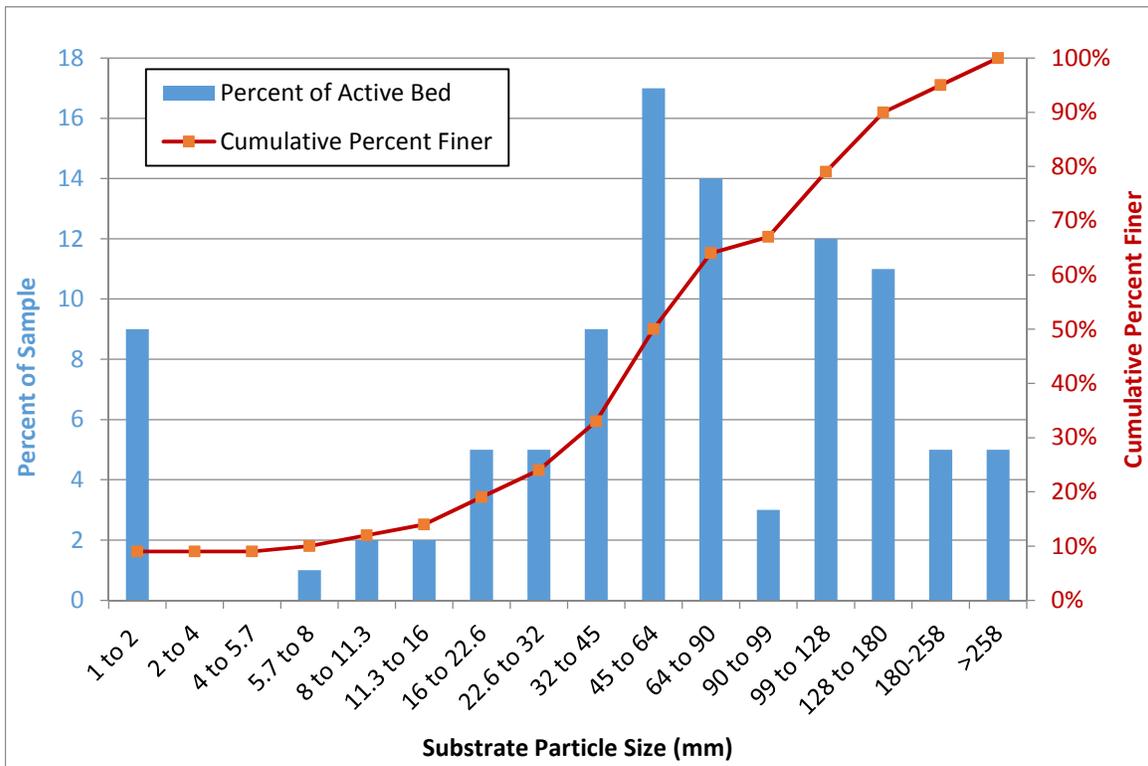
largest particles in the available bedload, and is competent to mobilize up to the D90 of the surface grains based upon material size class distribution (Figure 19). These analyses indicate that the reach is competent to transport the available bedload, but that excess shear stress could achieve mobilization of larger surface grains and result in channel degradation.

Figure 19. Surface particle size class distribution in the Wood River Campground Reach.

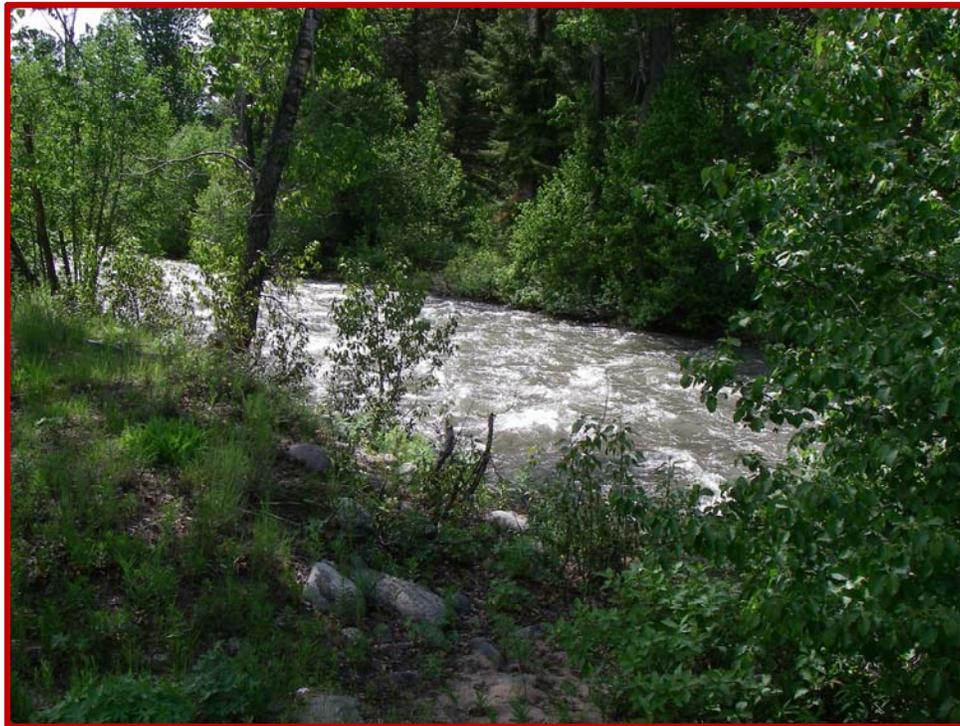
Figure 20. Photograph of slightly entrenched channel conditions during near bankfull discharge at the USGS Stream Gauge near Ketchum.

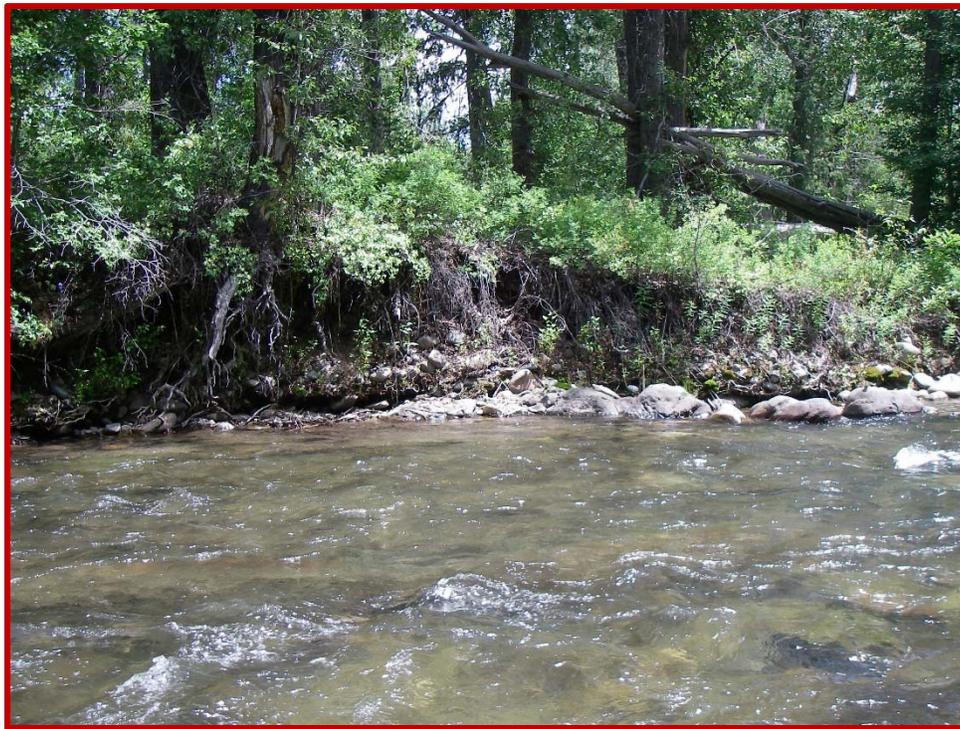
Figure 25. Photograph of typical low bank height, bank erosion conditions, and coarse substrate in Fox Creek reference reach.

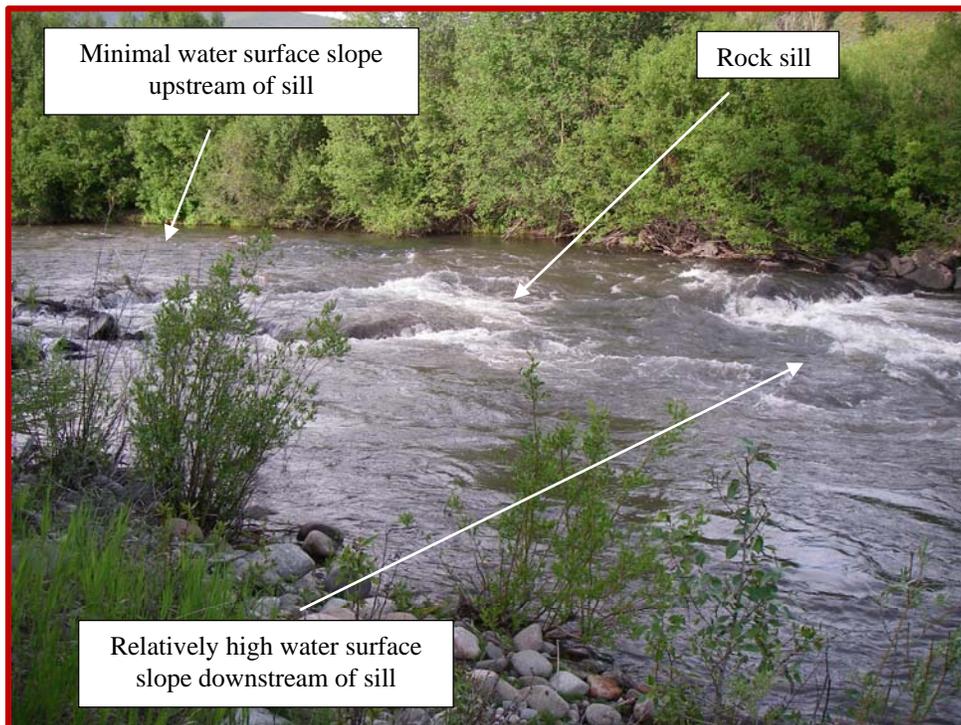
Figure 31. Photograph depicting an installed rock sill at near bankfull conditions in the Training Channel Reach.

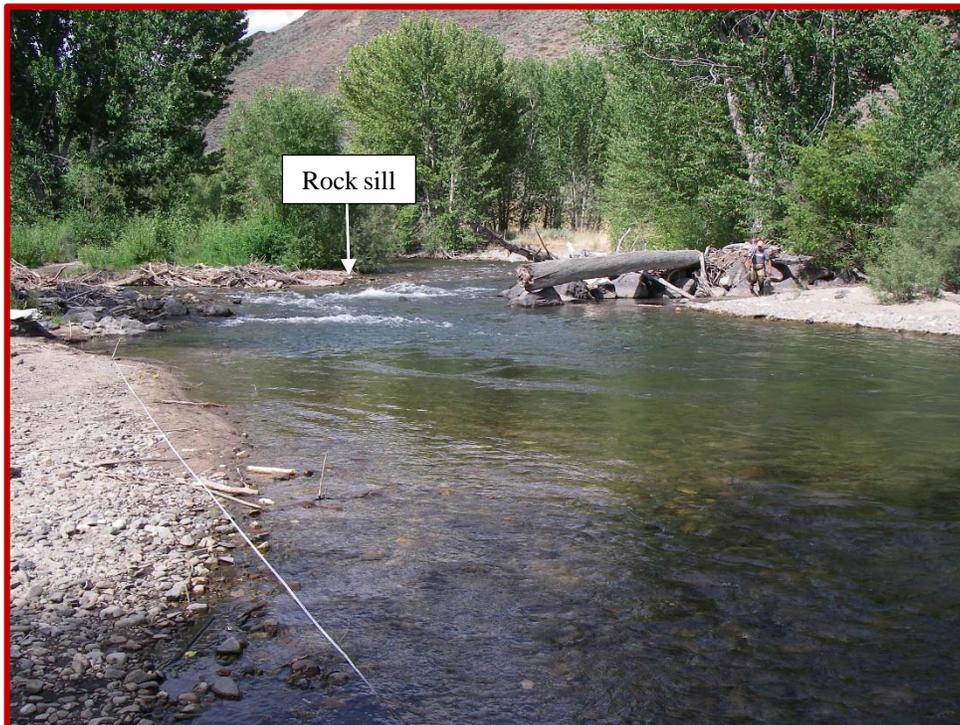
Figure 40. Photograph looking upstream at constructed rock sill, depositional side bars, and confluence of split channel configuration in Hulen Meadows Reach.

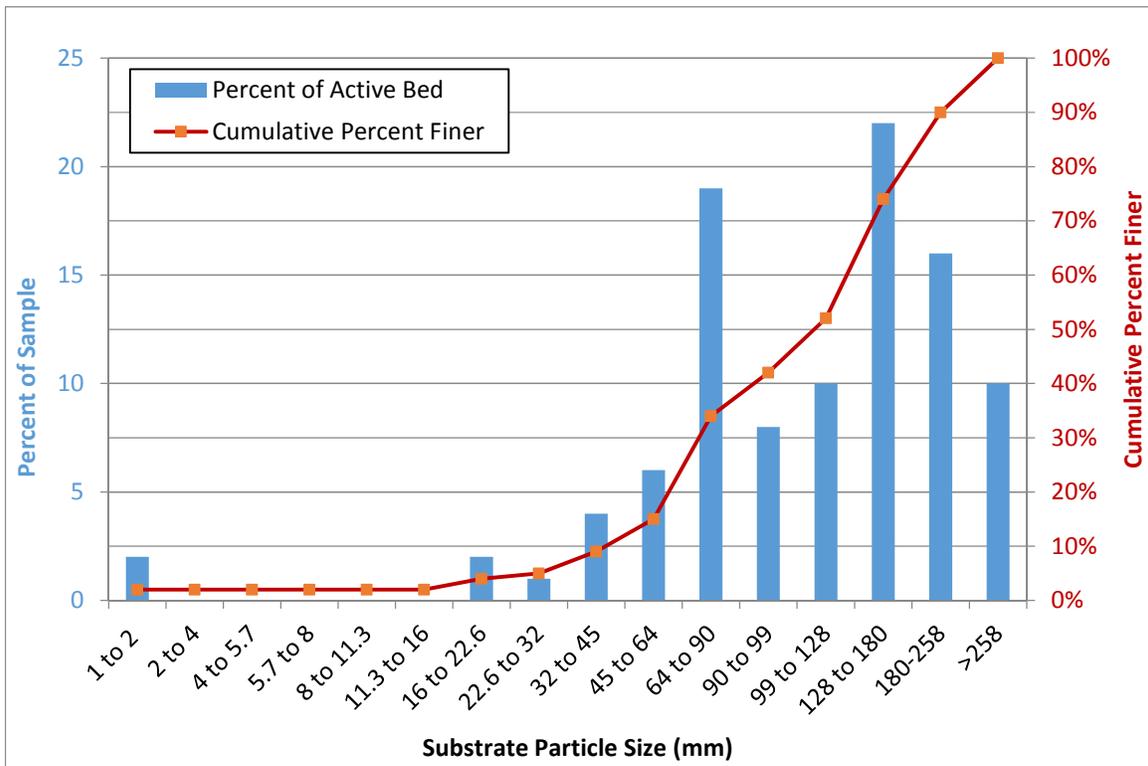
available bedload, and is capable of mobilizing up to the D75 of the surface grains based upon material size class distribution (Figure 43). These analyses indicate that the reach is competent to mobilize the available bedload and that the existing surface grain size class distribution promotes vertical channel stability.

Figure 43. Surface particle size class distribution in the Hulen Meadows Reach.

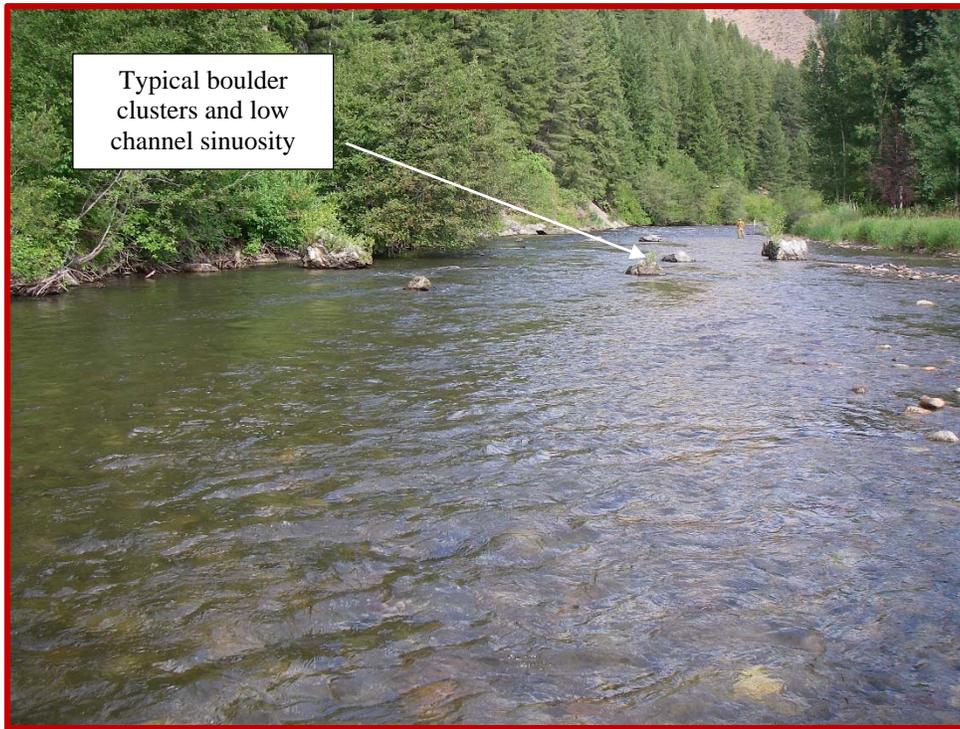
Figure 49. Photograph depicting typical channel conditions in the Ski Hill Reach.

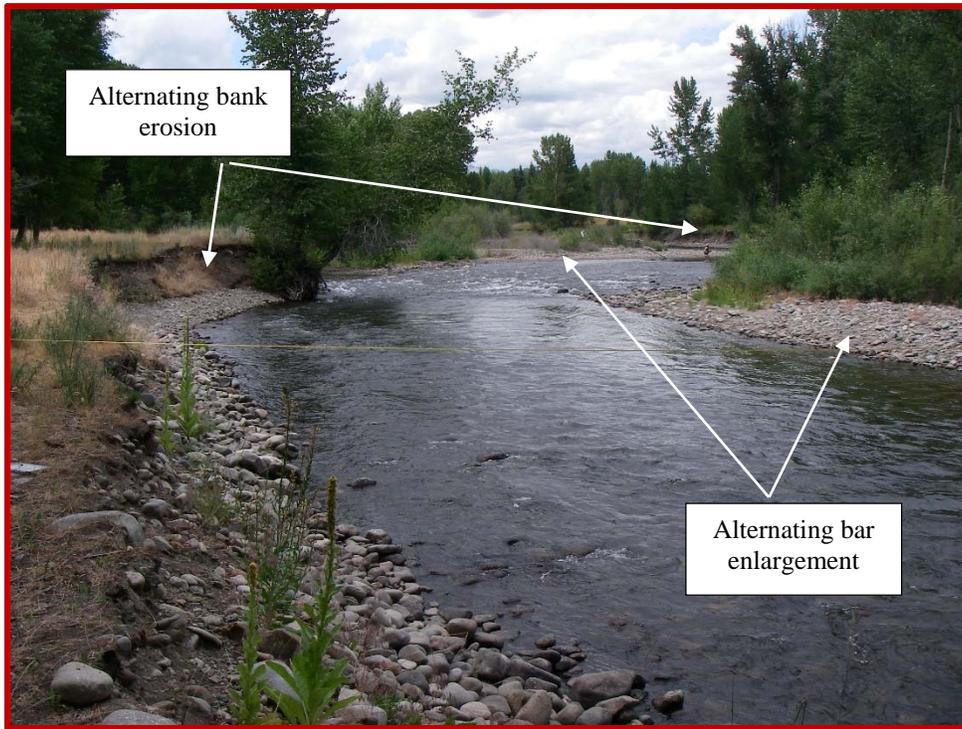
Figure 58. Photograph looking upstream at typical conditions in the Highway 75 Reach.

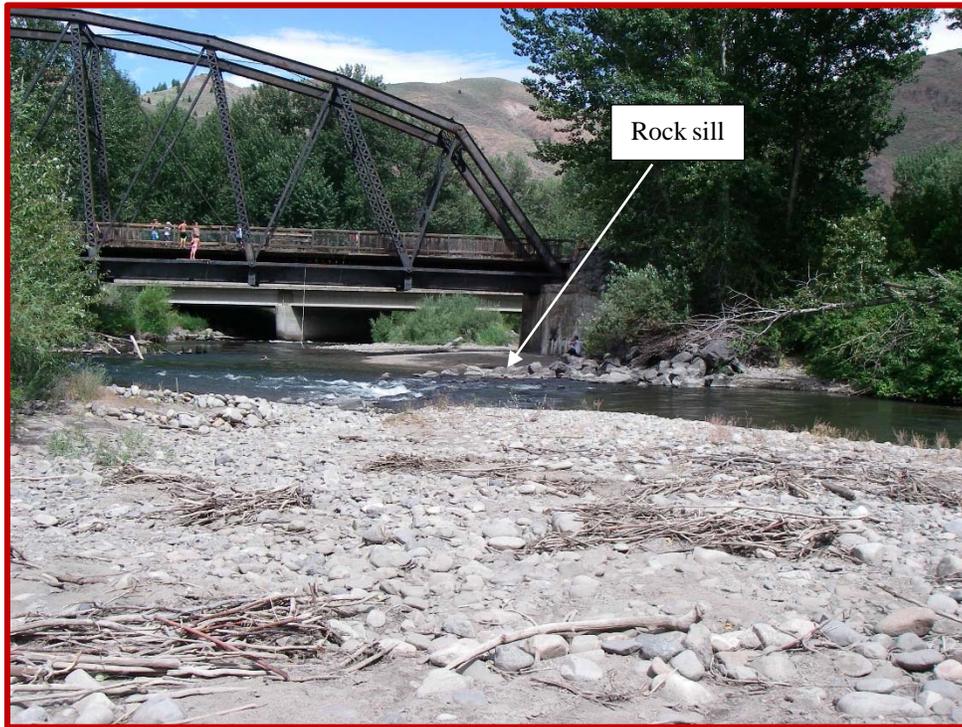
Figure 59. Photograph looking downstream at point bar enlargement, installed rock sill, and bridges in the Highway 75 Reach.

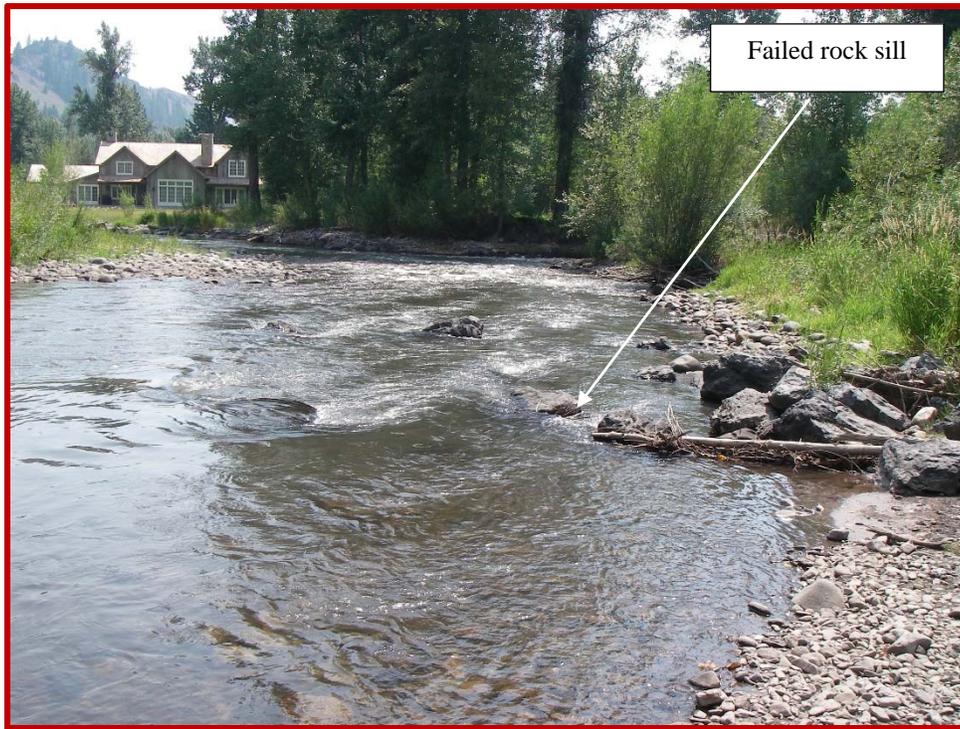
Figure 64. Photograph depicting failed rock sill and development encroachment in the Highway 75 Reach.

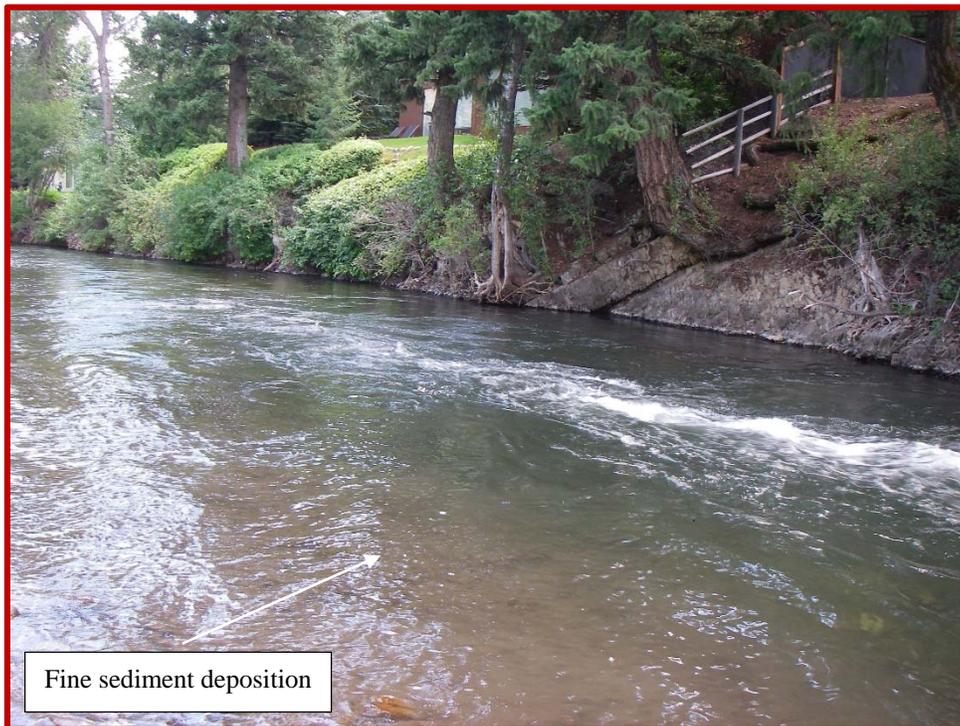
Figure 70. Photograph depicting development encroachment and fine sediment deposition in the Downstream of East Fork Reach.

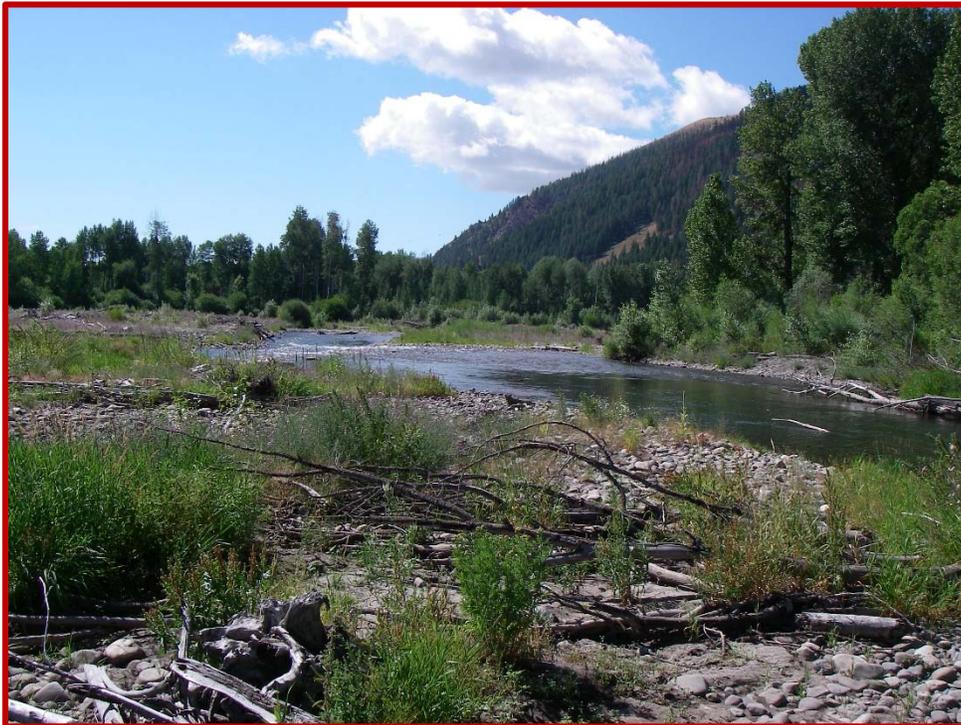
Figure 78. Photograph depicting high width/depth ratio slightly entrenched channel in the Downstream of Deer Creek Reach.

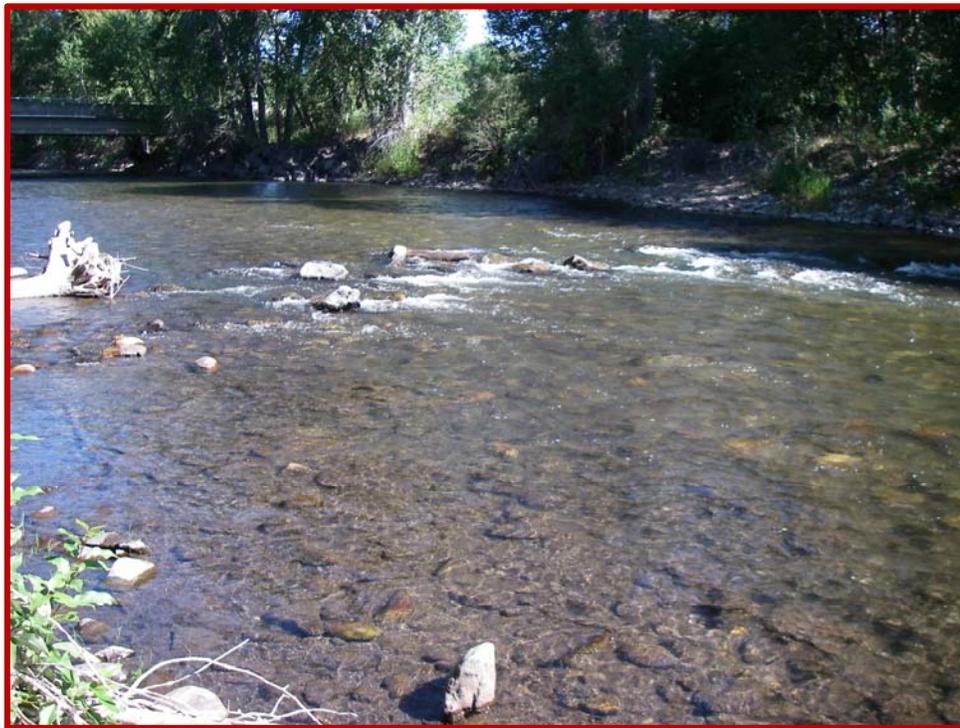
Figure 82. Photograph depicting typical channel confinement and failing rock sill structure in the Bullion Bridge Reach.

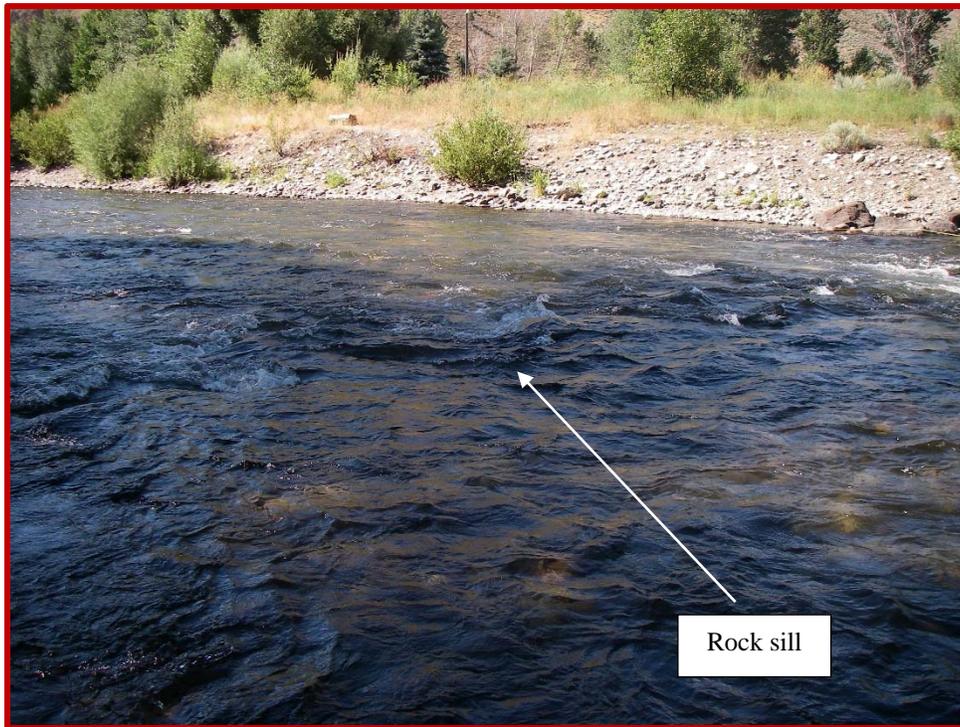
Figure 83. Photograph depicting typical channel entrenchment and constructed rock sill in the Bullion Bridge Reach.

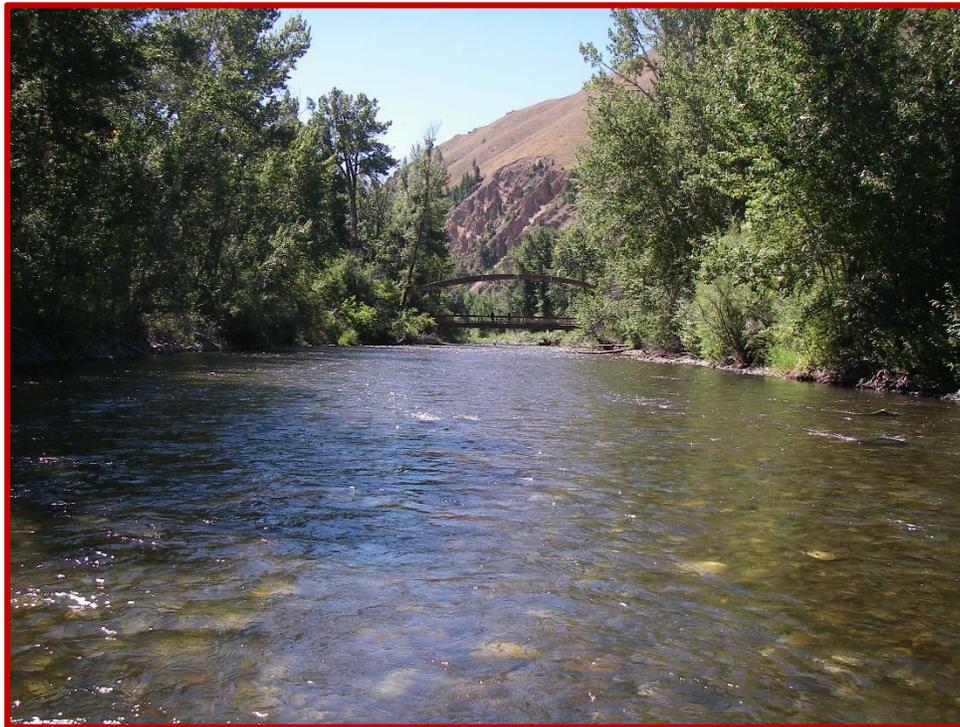
Figure 84. Photograph depicting typical high width/depth ratio channel in the Bullion Bridge Reach.

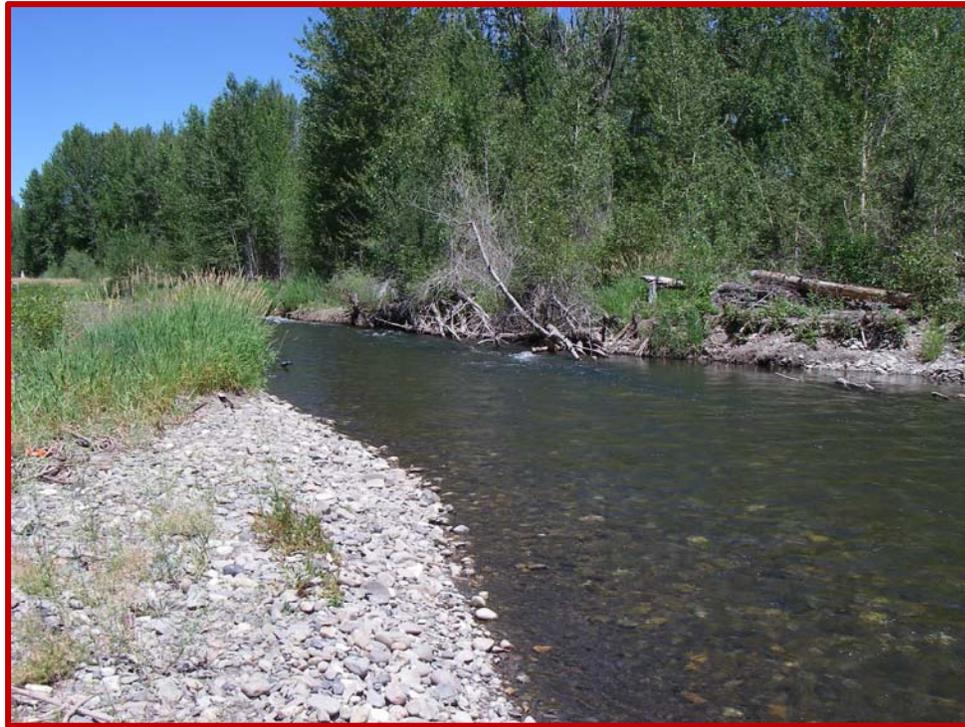
Figure 91. Photograph depicting bar enlargement and eroding cut bank in the Colorado Gulch Reach.

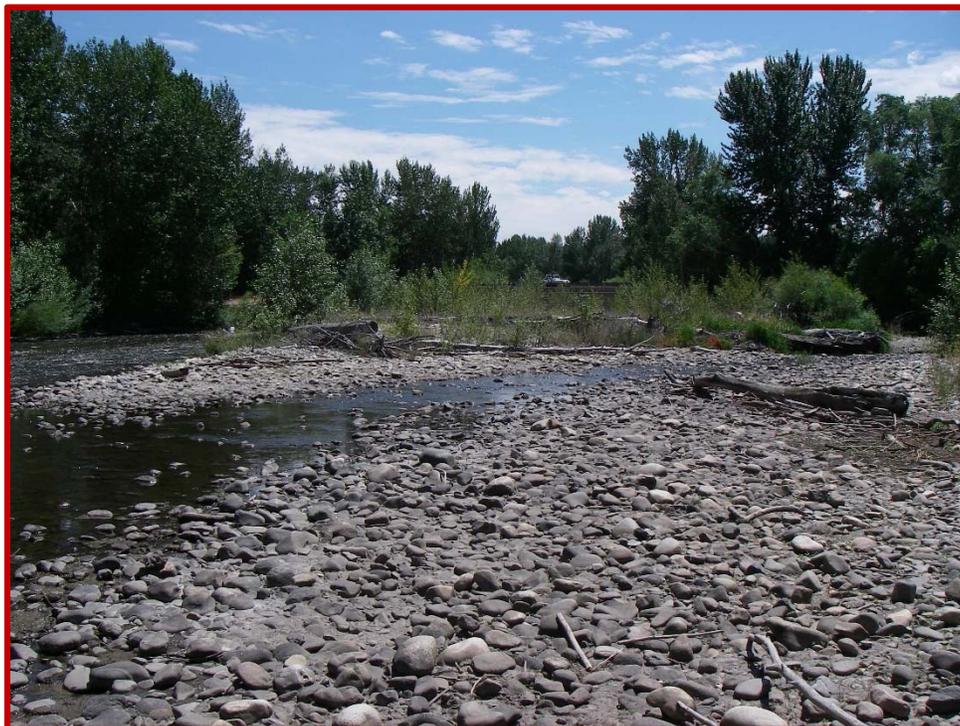
Figure 99. Photograph depicting sedimentation in the Broadford Street Bridge Reach.

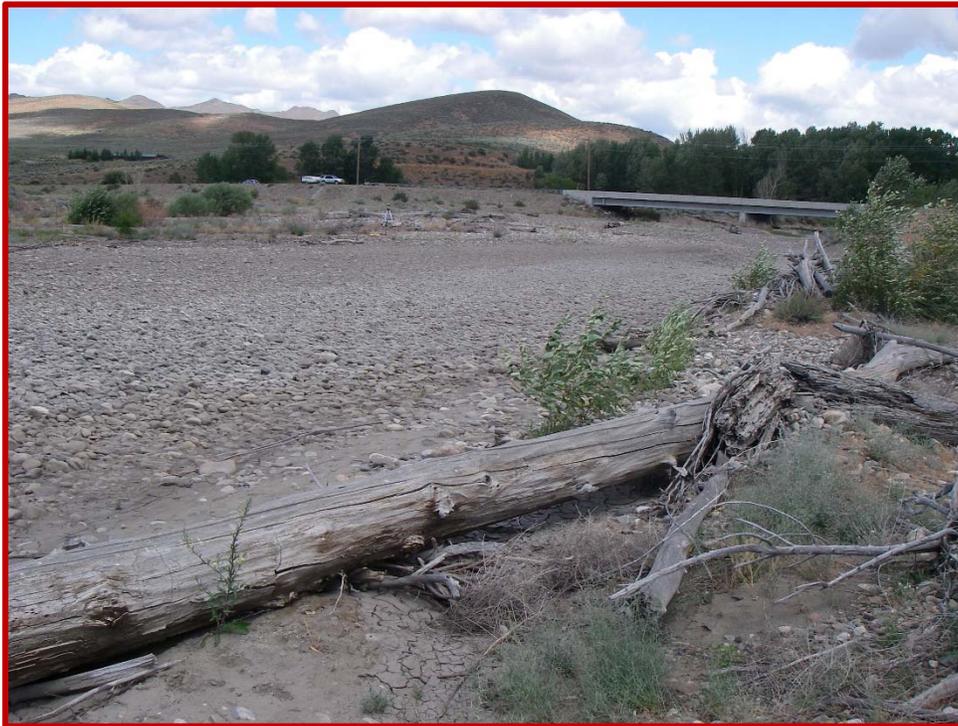
Figure 103. Photograph depicting typical high width/depth ratio channel and dewatered conditions in the Glendale Reach.

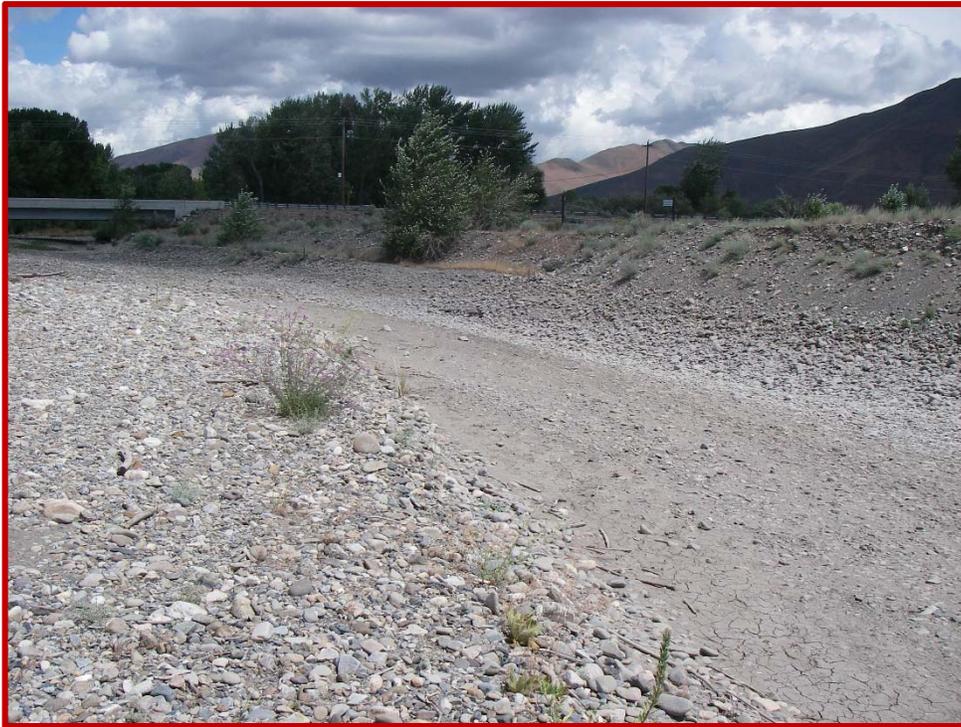
Figure 104. Photograph depicting typical denuded riparian vegetation in the Glendale reach.

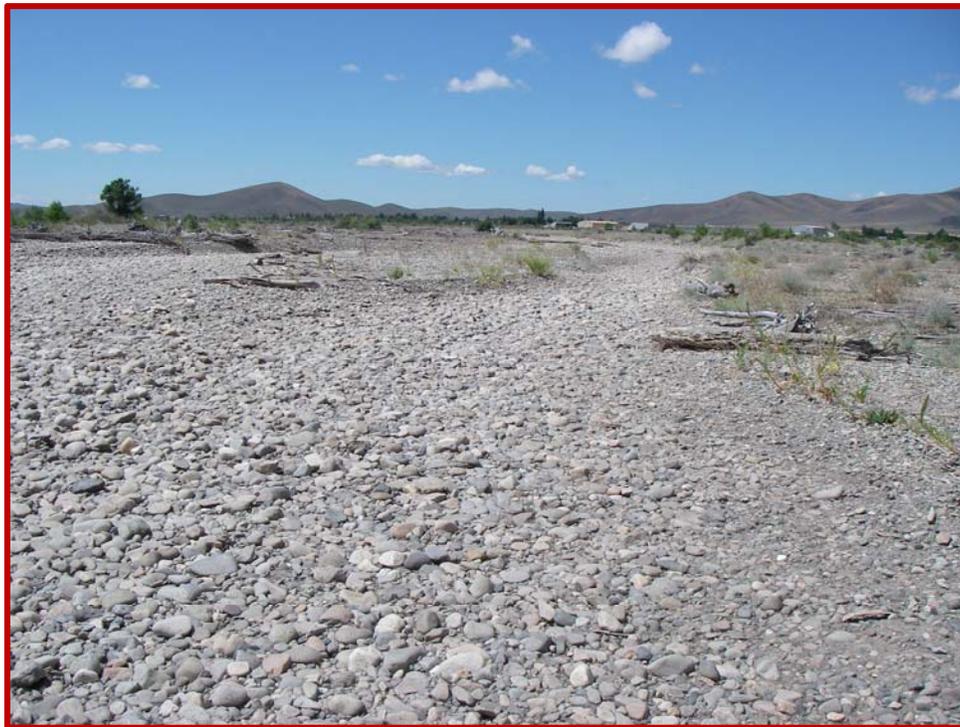
Figure 106. Photograph depicting mid-channel bars and dominant braided channel form in the Glendale Reach.

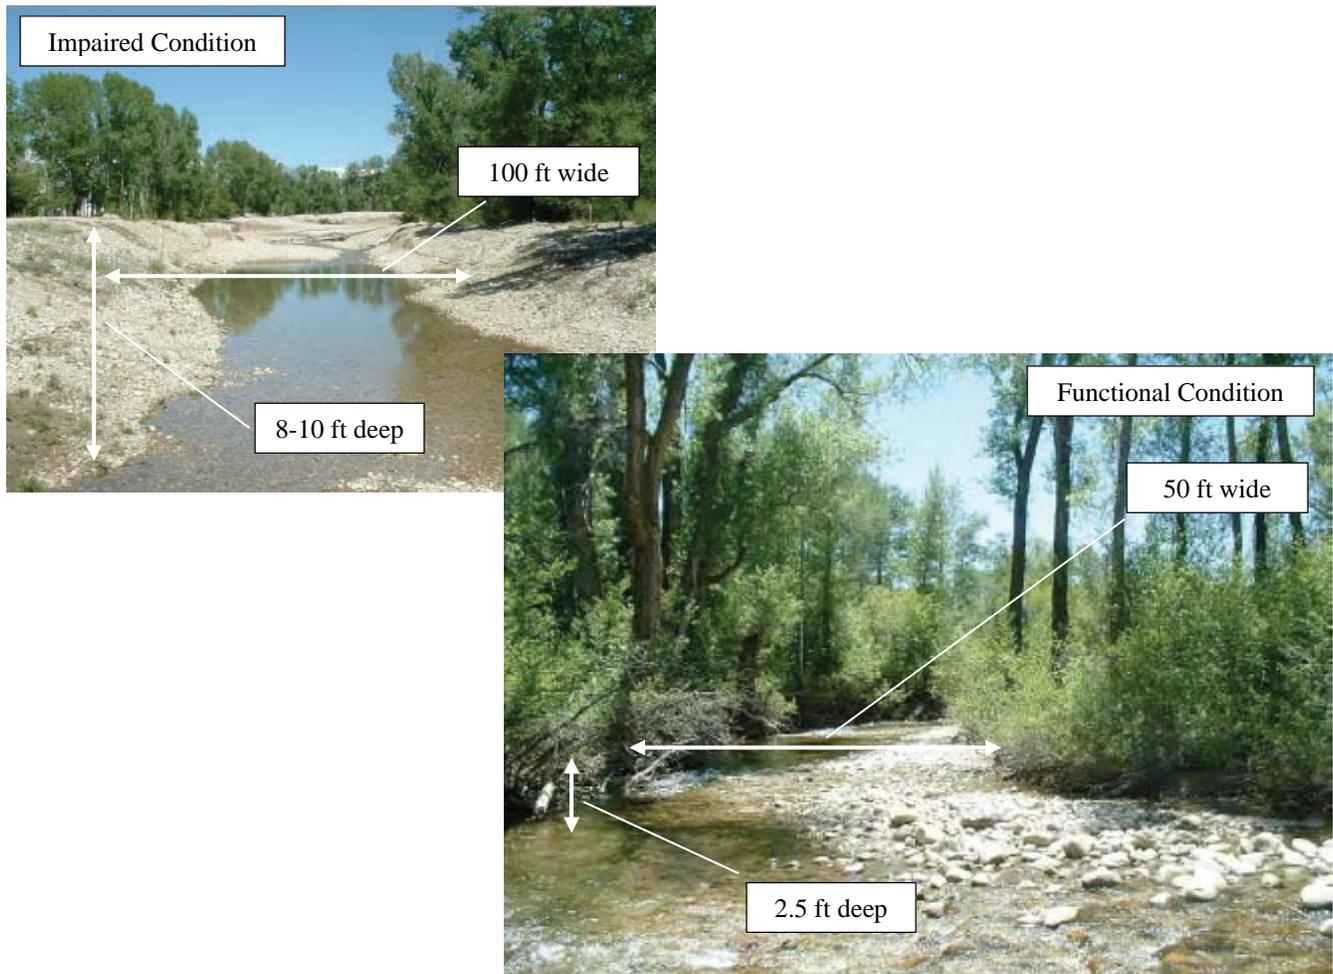
Figure 114. The over-widened and degraded river channel (top) was narrowed and shaped to mimic stable functional conditions (bottom). The functional channel with proper width, depth, profile, and alignment (bottom) provides river functions and fish habitat superior to those of the impaired channel condition (top).

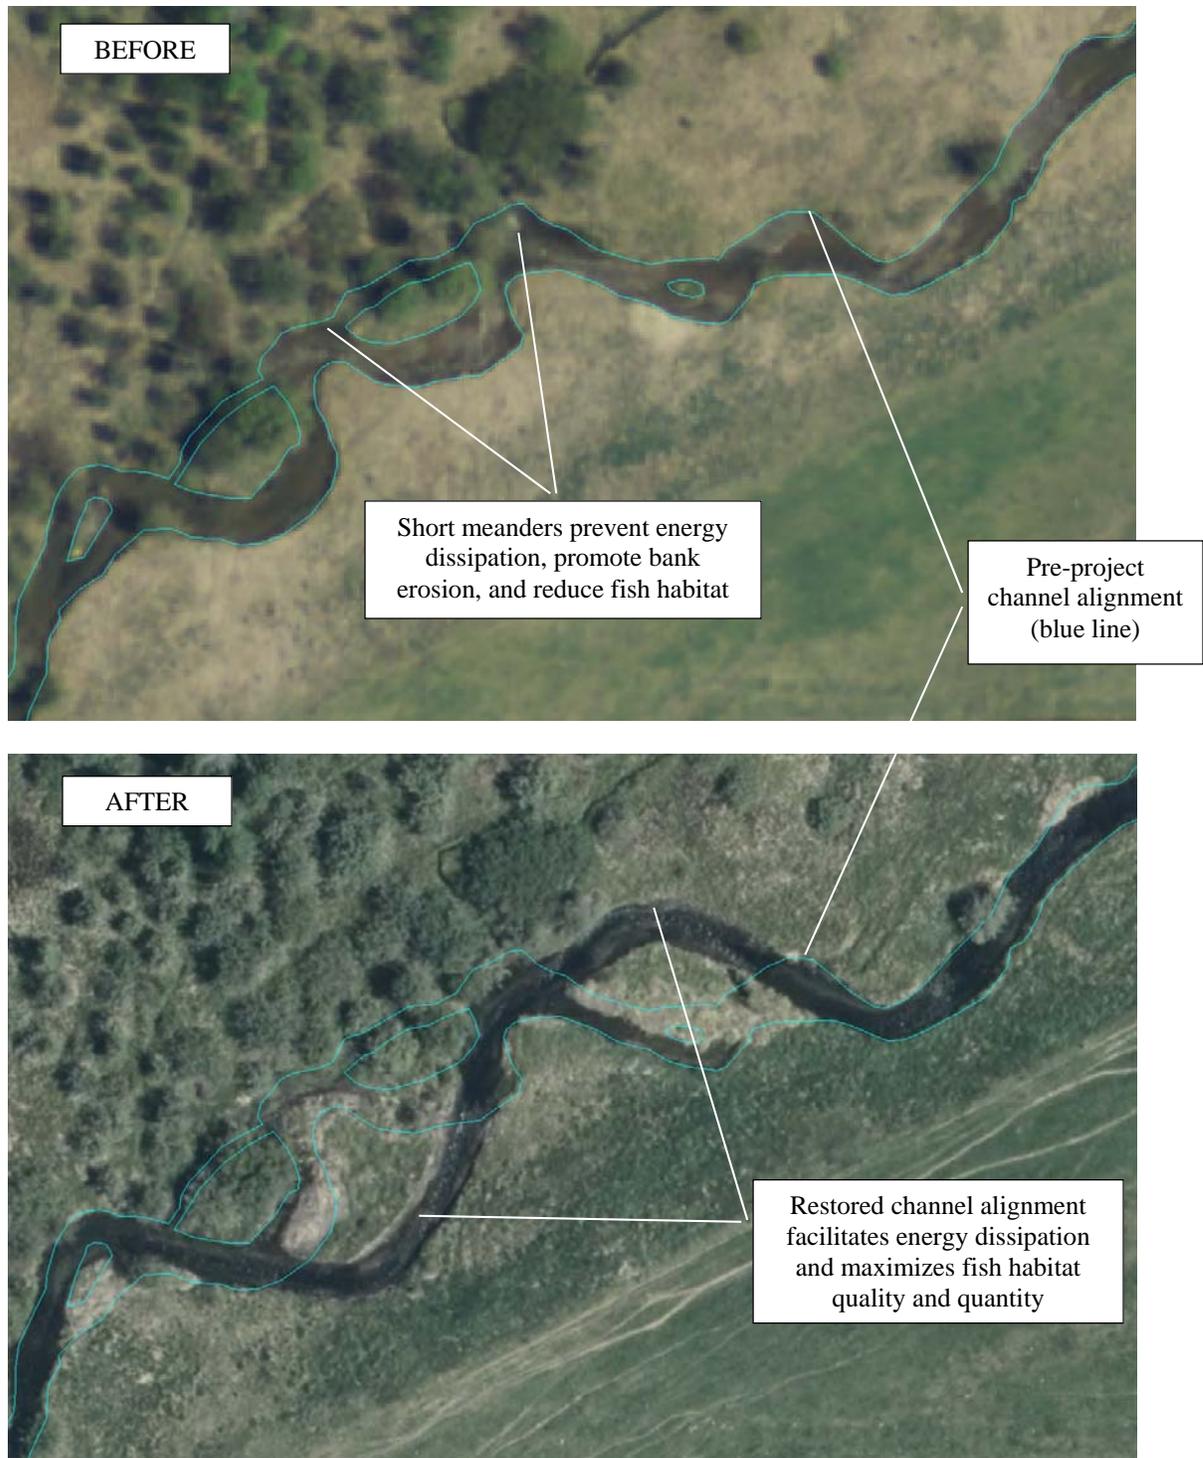
Figure 115. An unstable channel alignment (top) was corrected through construction of suitable meander pattern (bottom). The constructed meander pattern maintains aquatic habitat complexity associated with riffles and lateral scour pool bed features to maximize fish habitat.
