**FINAL
GEOMORPHIC ASSESSMENT REPORT
BIG WOOD RIVER
BLAINE COUNTY, IDAHO**

Trout Unlimited

research & consulting inc.

February 1, 2016

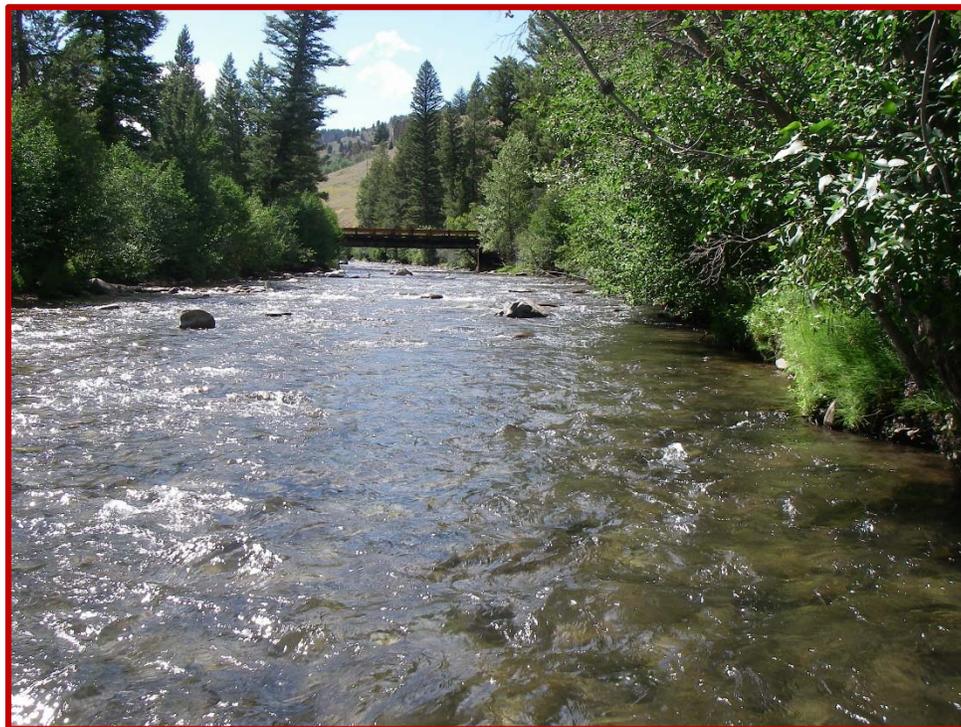
Figure 14. Photograph looking upstream at typical moderate to high width/depth ratio, low entrenchment ratio, and heavily vegetated riparian zone in the Wood River Campground Reach.

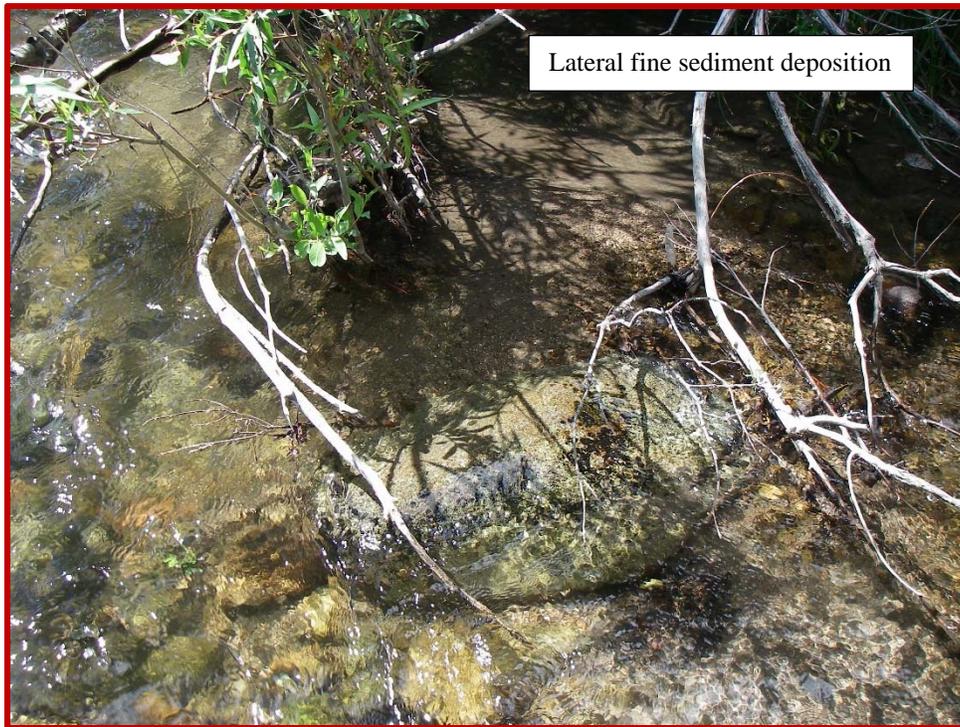
Figure 15. Photograph of coarse substrate with fine sediment accumulations in the Wood River Campground Reach.

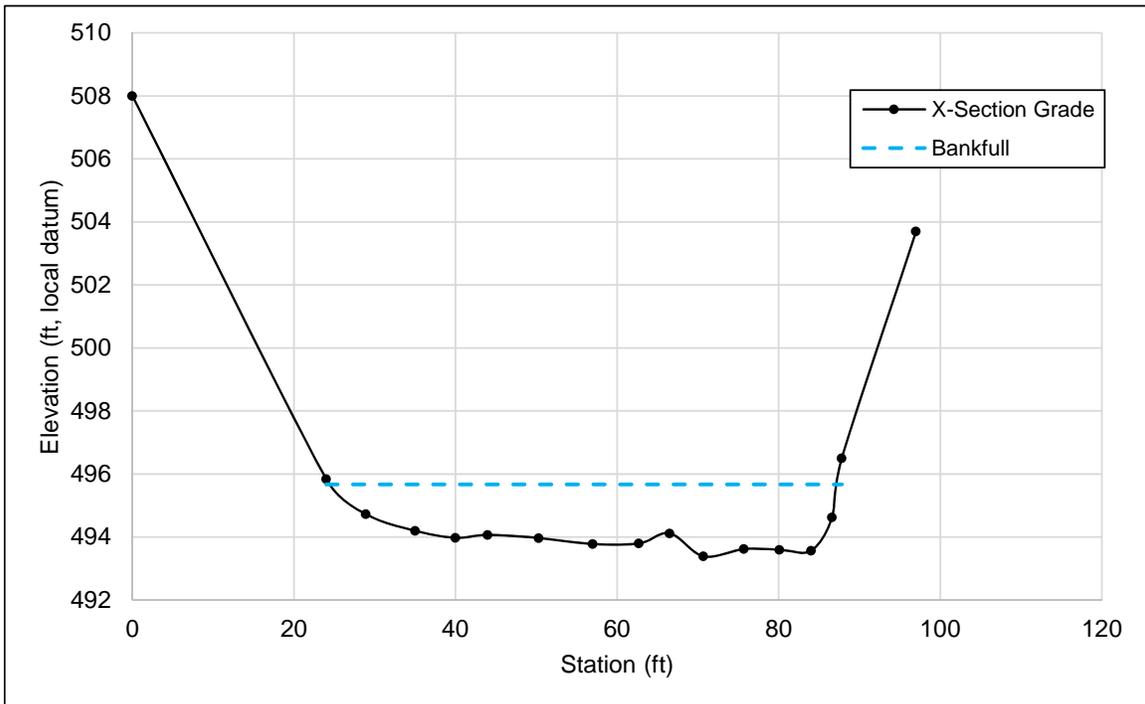
The Wood River Campground Reach channel profile was analyzed through derivation of a longitudinal profile of the surveyed river reach (Figure 17) in which channel thalweg is depicted in red, water surface is depicted in blue, bankfull indicators are depicted in green, bankfull slope is depicted in dashed black line, and top of bank elevations are depicted in blue. The reach-wide bankfull channel slope is approximately 0.87%, and a typical riffle cross section depicting an entrenched channel with moderate to high width/depth ratio is presented in Figure 18.

Figure 18. Typical riffle cross section in Wood River Campground Reach.

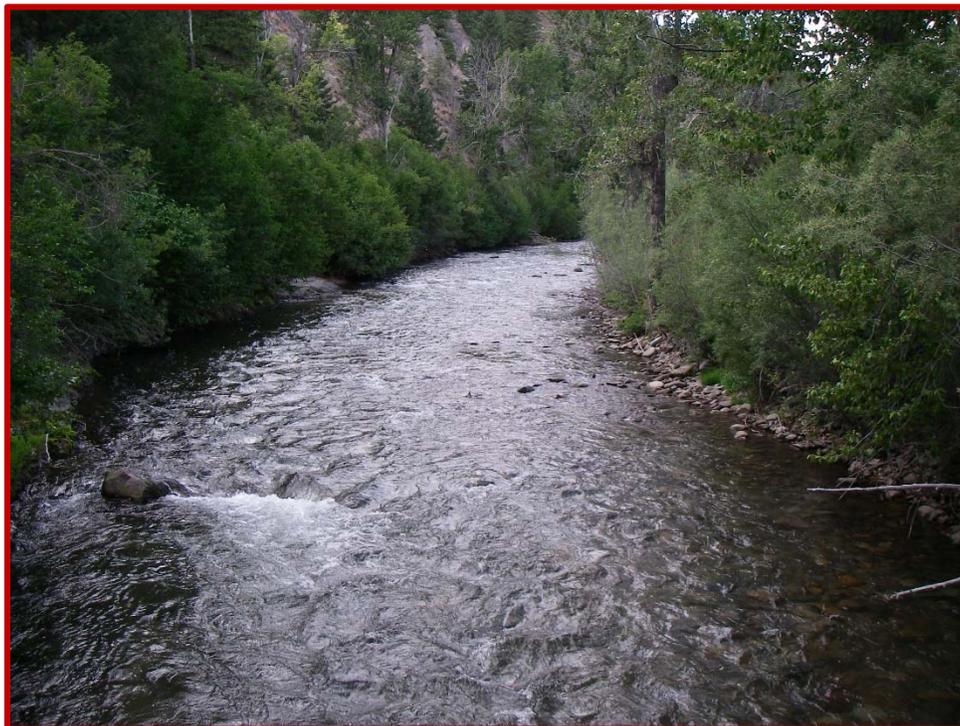
Figure 24. Photograph looking upstream from bridge at typical moderate channel incision in the Fox Creek Reference Reach.

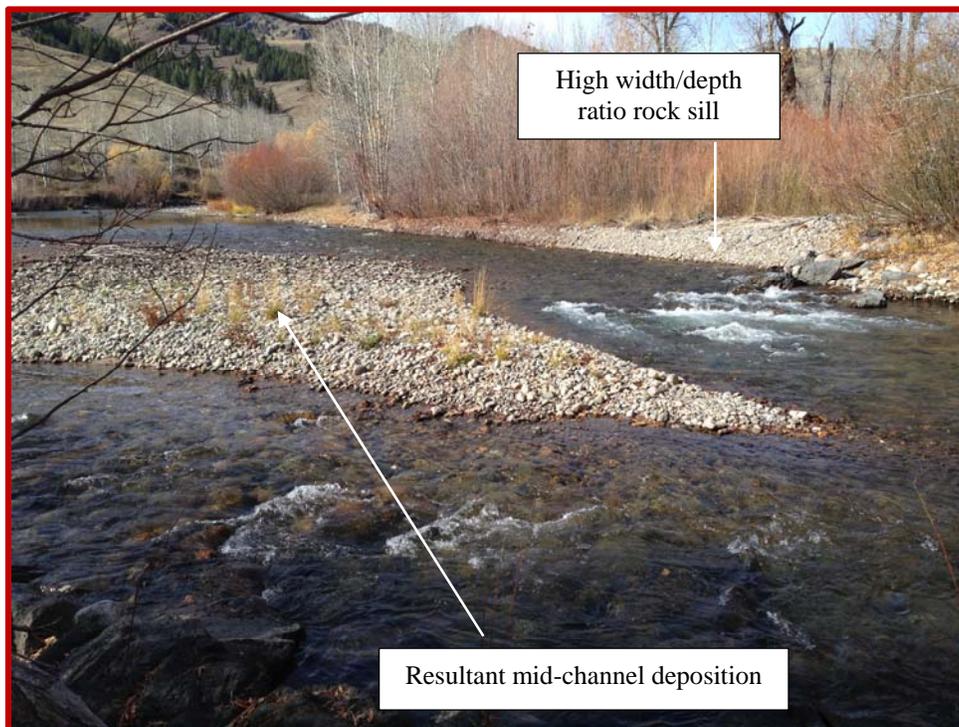
Figure 29. Photograph depicting an installed rock sill and resultant sedimentation in the Training Channel Reach.

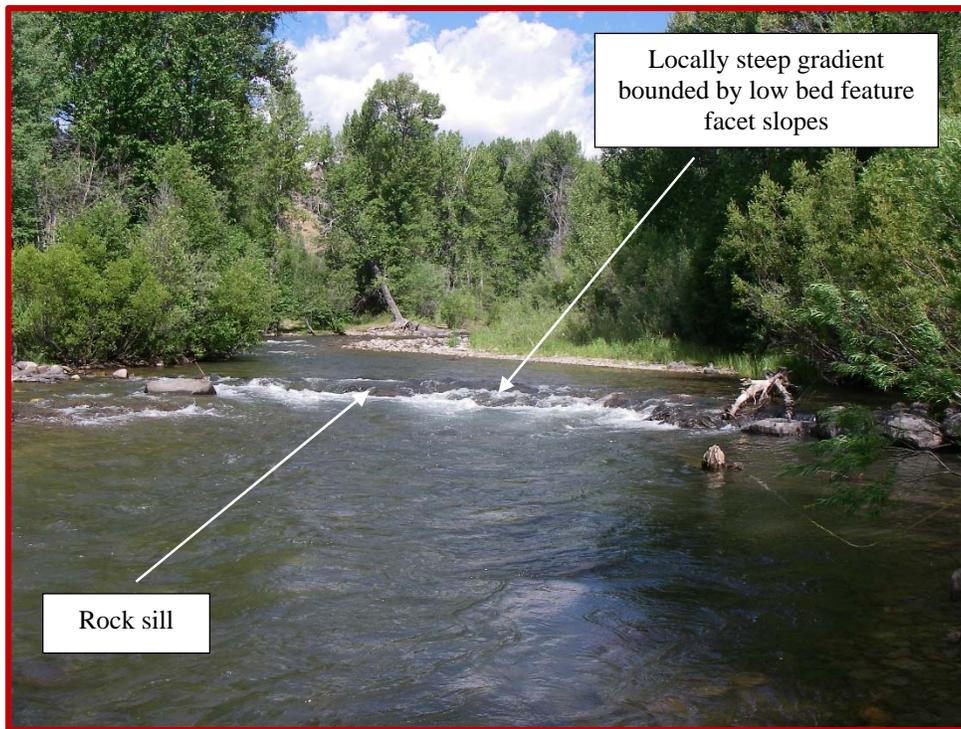
Figure 30. Photograph depicting an installed rock sill and localized confinement of available gradient in the Training Channel Reach.

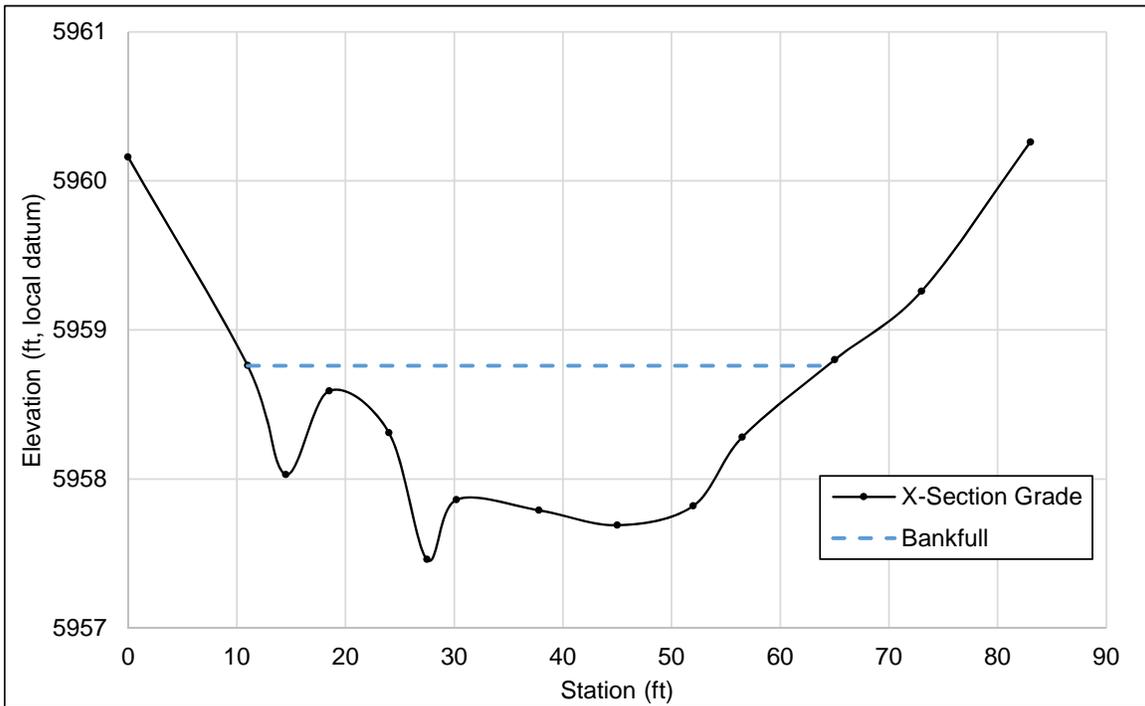
Figure 33. Typical constructed sill cross section in the Training Channel Reach.

The dimensionless bankfull shear stress in the Training Channel Reach is 0.015 and the dimensional shear stress is 0.908 lbs/ft². Bankfull hydraulic conditions result the mobilization of a 142 mm particle according to a modified Shields curve depicting the incipient motion of sediment particles based on shear stress (Rosgen 2010). Survey data indicate that the reach is competent to transport the largest particles in the available bedload, and is capable of mobilizing up to the D90 of the surface grains based upon material size class distribution (Figure 35). These analyses indicate that the reach is competent to mobilize the available bedload, but that excess shear stress could achieve mobilization of the largest surface grains and result in channel degradation. However, the installed rock sills appear to have maintained grade control and precluded channel degradation.

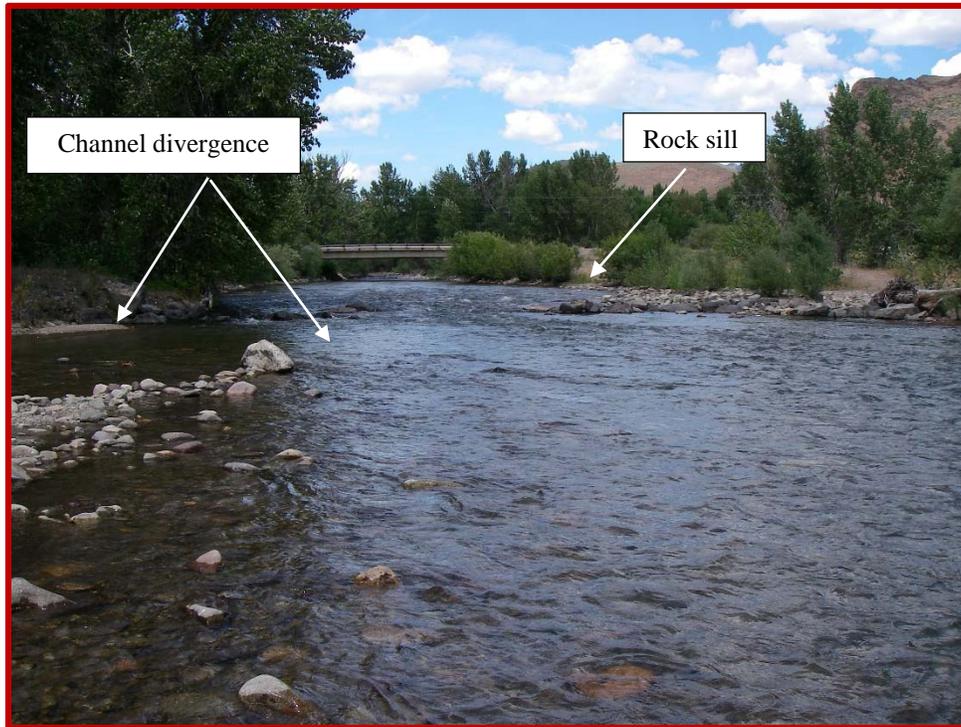
Figure 36. Photograph looking upstream from the top of the site at a rock sill directly upstream of the channel split in the Hulen Meadows Reach.

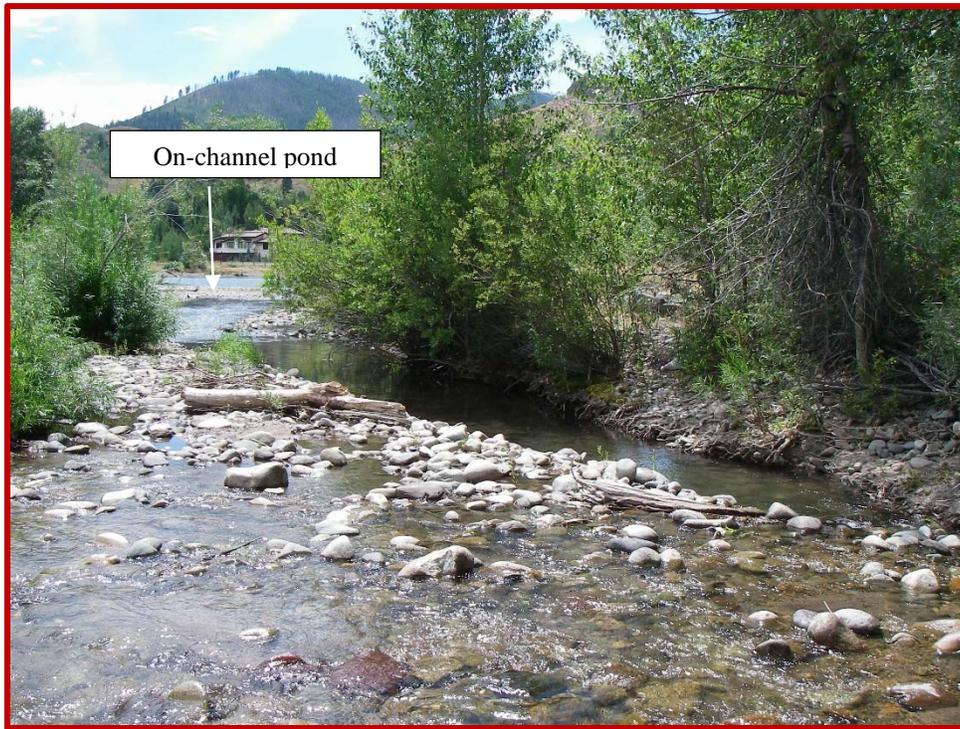
Figure 37. Photograph looking downstream along a side channel at a sediment collection pond in the Hulen Meadows Reach.

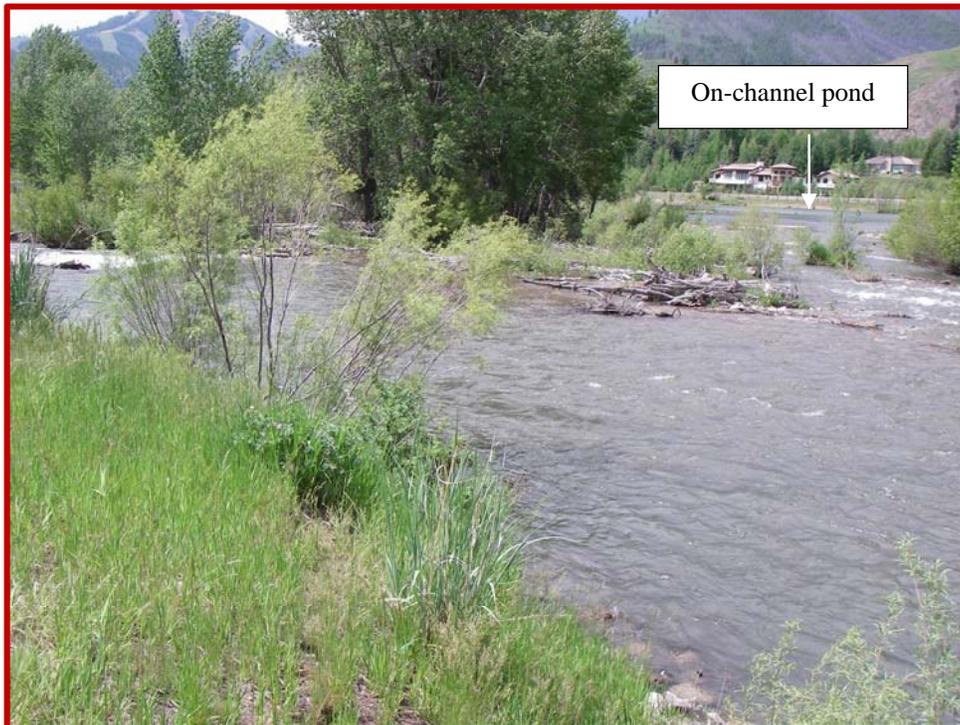
Figure 38. Photograph looking downstream at the channel split during spring runoff with the pond in the background on the right side of the photo, Hulen Meadows Reach.

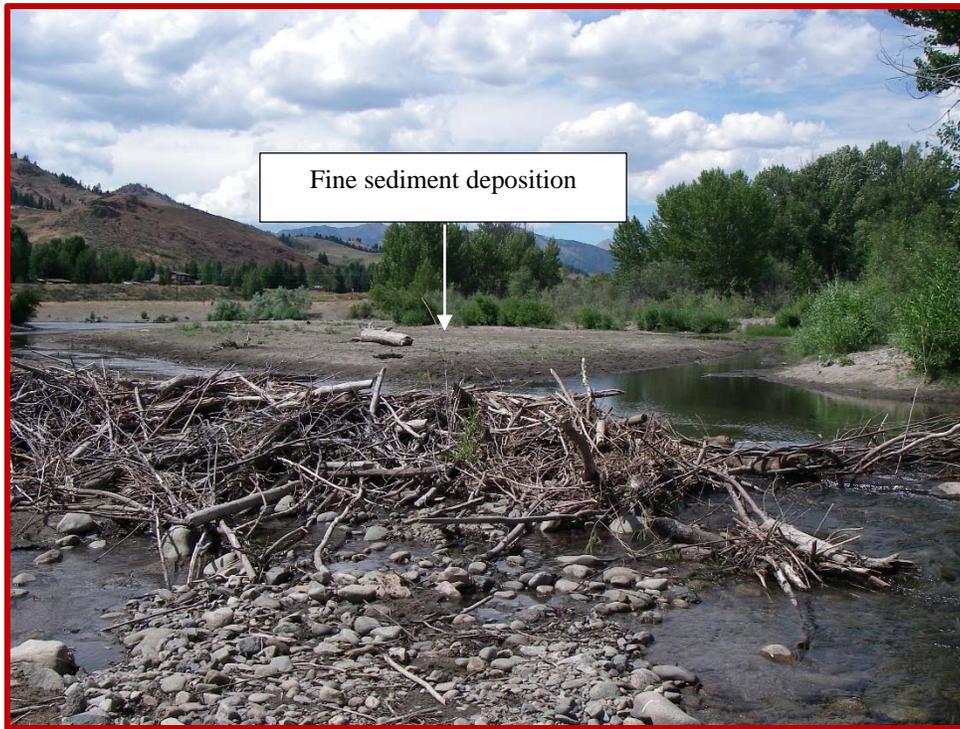
Figure 39. Photograph looking upstream at the on-channel pond outlet with breached beaver dam and significant fine sediment accumulation in the Hulen Meadows Reach.

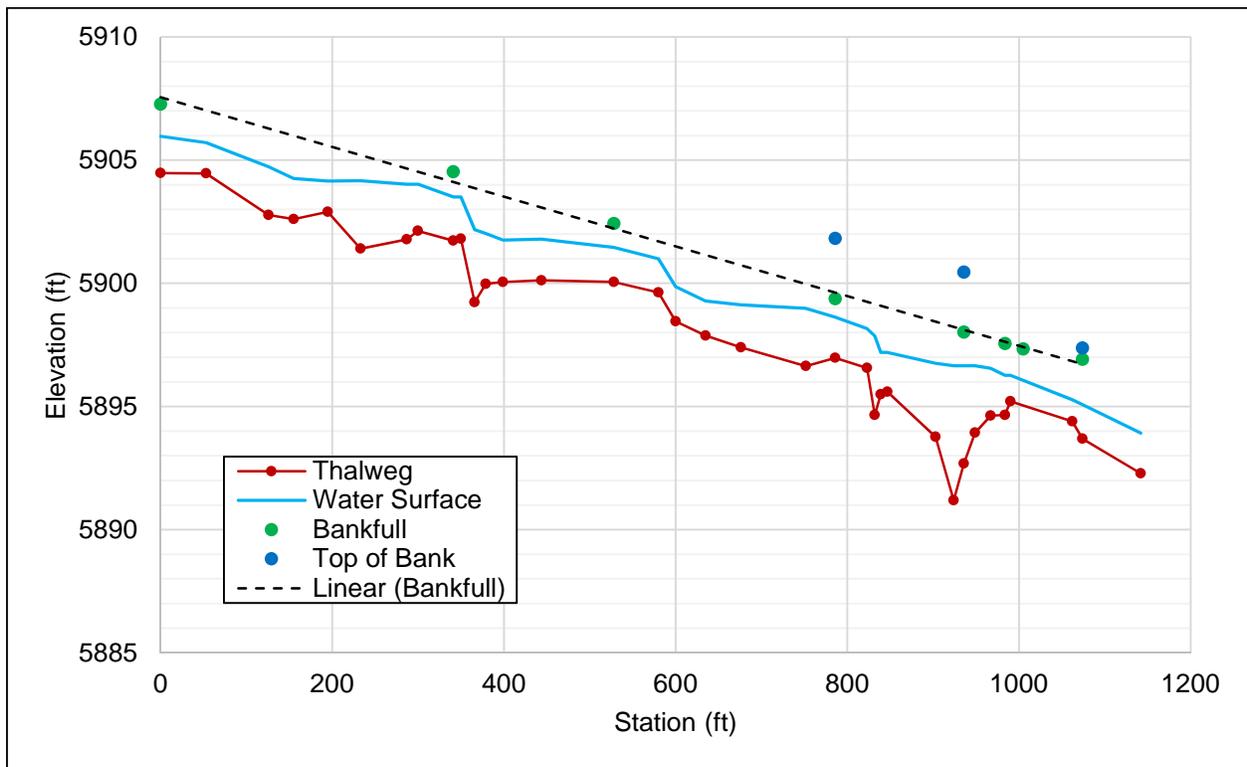
The Hulen Meadows Reach channel profile was analyzed through derivation of a longitudinal profile of the surveyed river reach (Figure 41) in which channel thalweg is depicted in red, water surface is depicted in blue, bankfull indicators are depicted in green, bankfull slope is depicted in dashed black line, and top of bank elevations are depicted in blue. The reach-wide bankfull channel slope is approximately 1%, and a typical riffle cross section depicting moderate width/depth ratio and hydraulically connected floodplain is presented in Figure 42.

Figure 41. Longitudinal profile of the Hulen Meadows Reach.

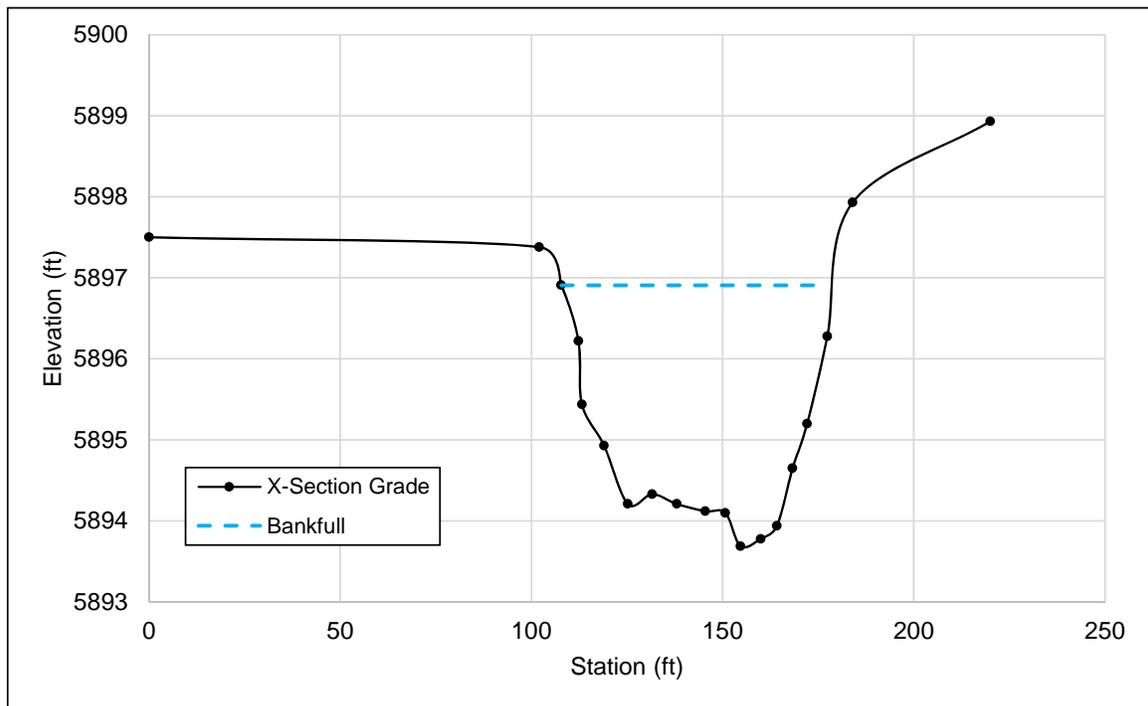
Figure 42. Typical riffle cross section in the Hulen Meadows Reach

The dimensionless bankfull shear stress in the Hulen Meadows Reach is 0.032 and the dimensional shear stress is 1.273 lbs/ft². Bankfull hydraulic conditions result the mobilization of a 182 mm particle according to a modified Shields curve depicting the incipient motion of sediment particles based on shear stress (Rosgen 2010). Survey data indicate that the reach is competent to transport the largest particles in the

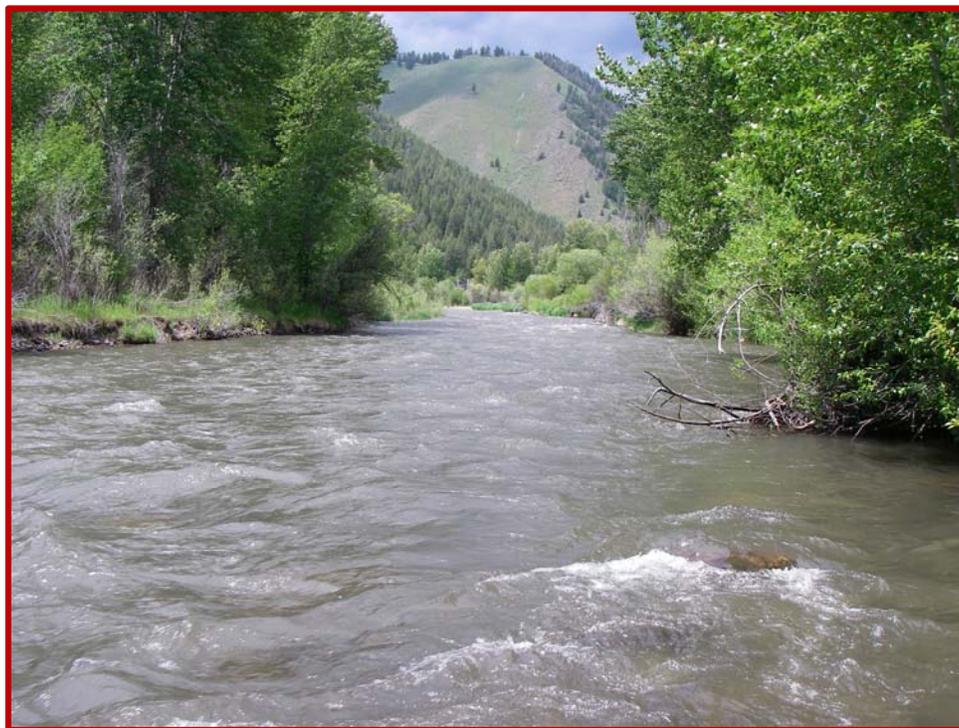
Figure 44. Photograph depicting near bankfull discharge and moderate entrenchment in Ski Hill Reach.

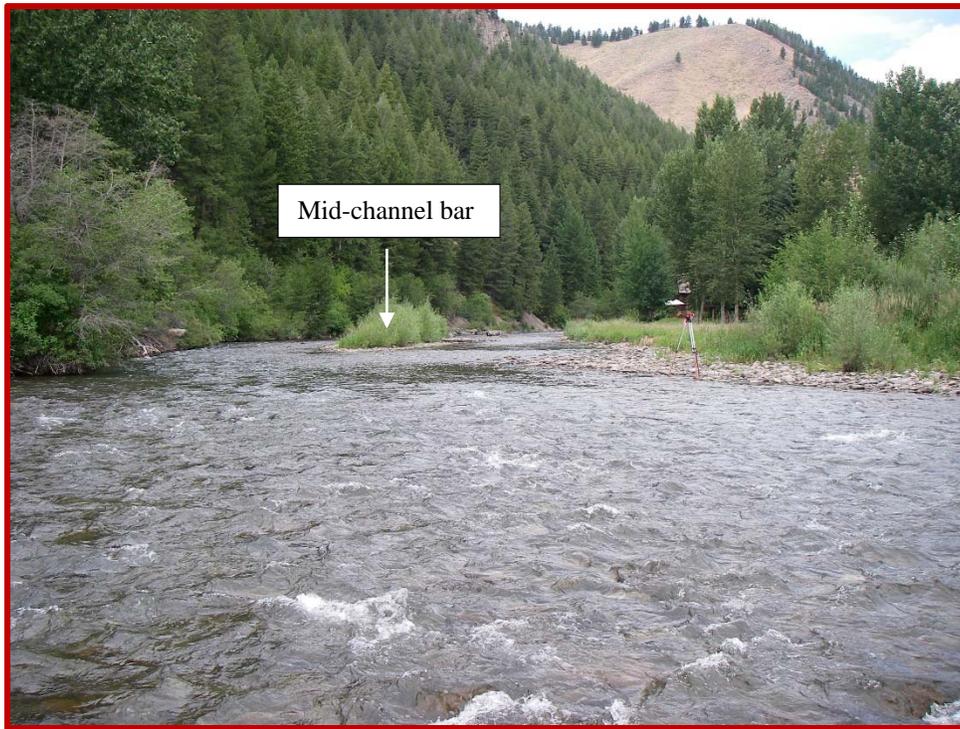
Figure 45. Photograph looking upstream at depositional features in the Ski Hill Reach.

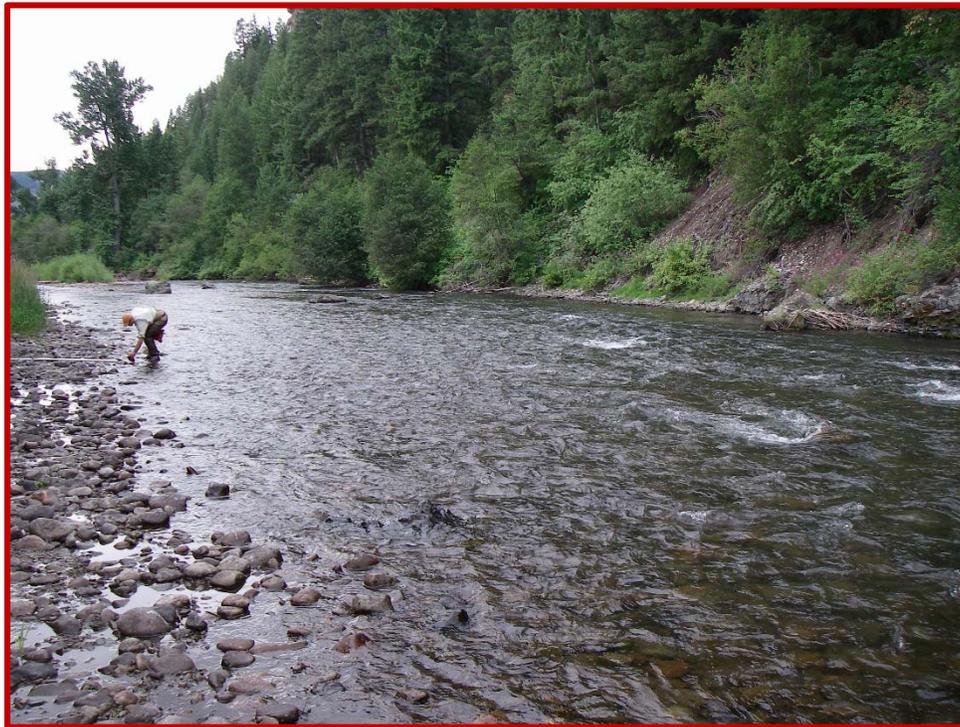
Figure 46. Photograph depicting steep eroding hillside on river right in the Ski Hill Reach.

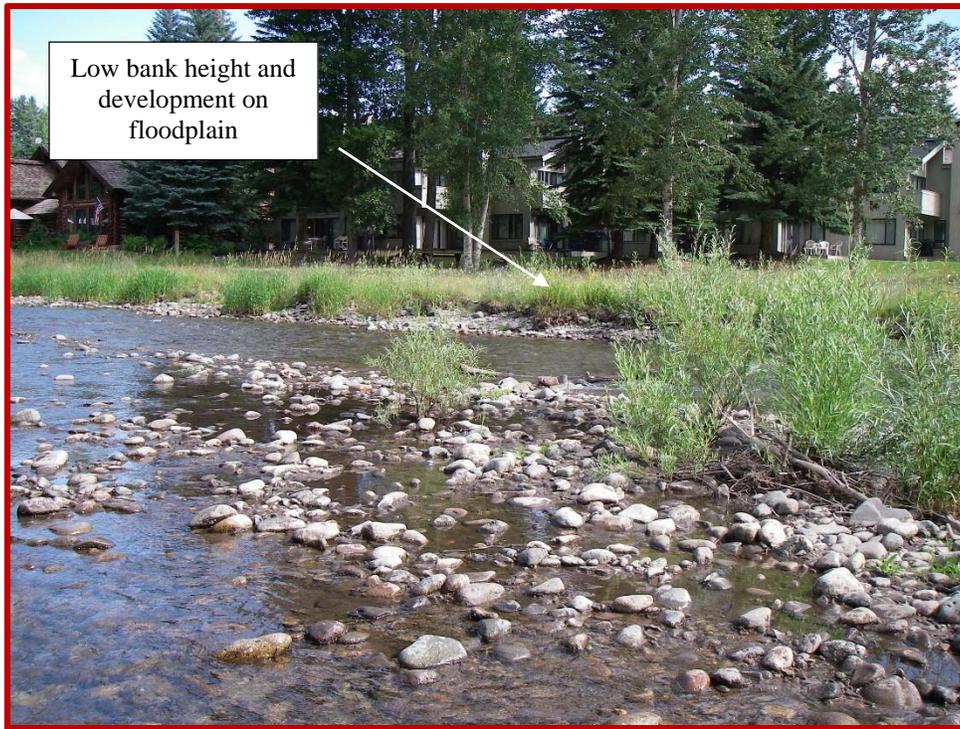
Figure 47. Photograph depicting mid-channel bar and residential development encroachment in the Ski Hill Reach.

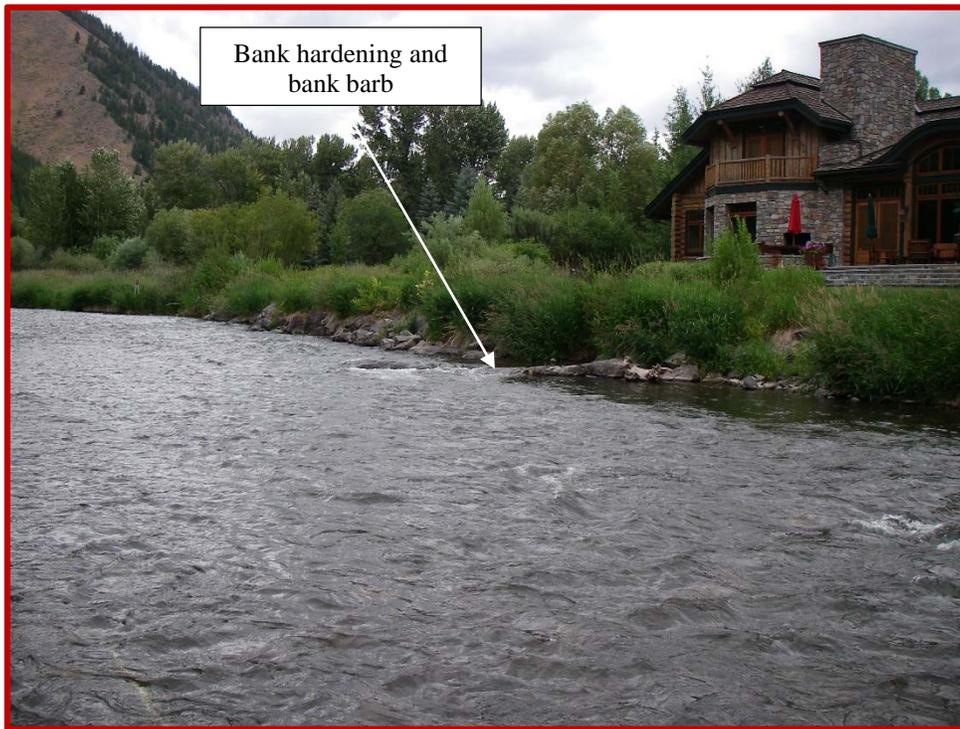
Figure 48. Photograph depicting bank stabilization and development encroachment in Ski Hill Reach.

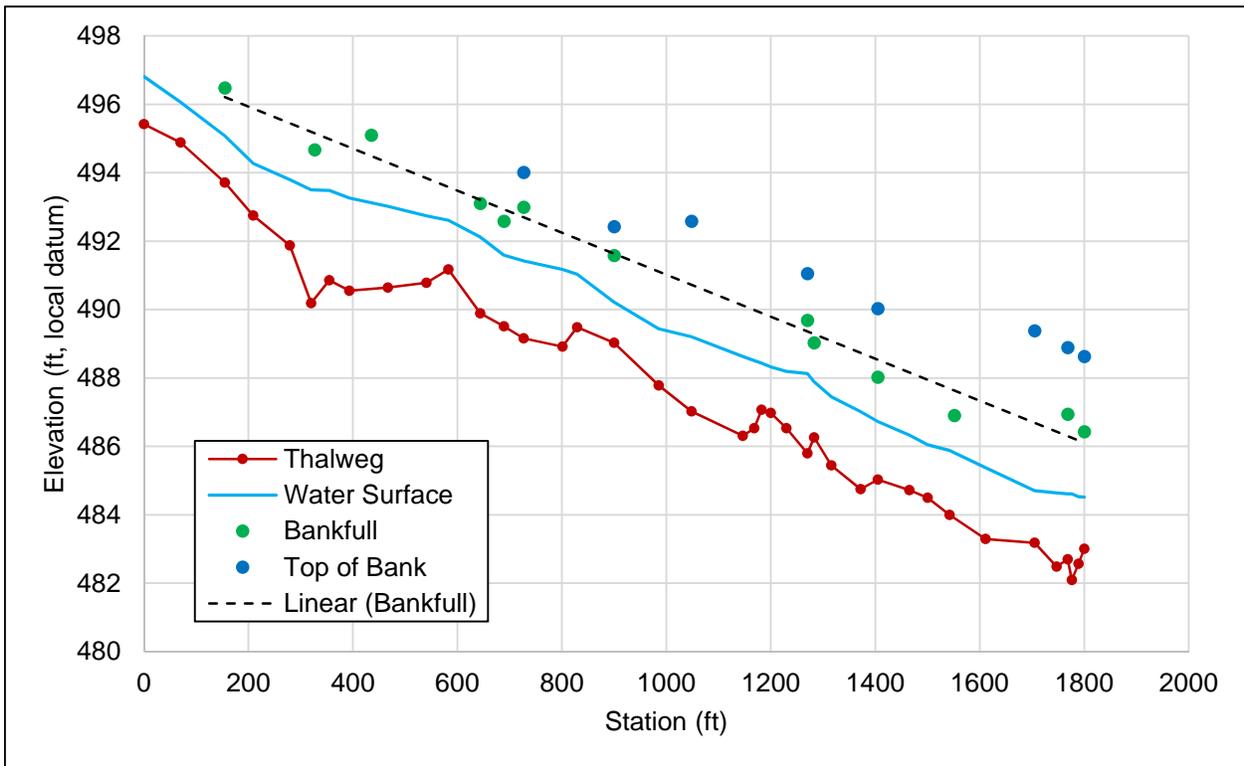
bank elevations are depicted in blue. The reach-wide bankfull channel slope is approximately 0.61%, and a typical riffle cross section depicting moderate width/depth ratio and narrow confined floodplain is presented in Figure 51.

Figure 50. Longitudinal profile through the Ski Hill Reach.

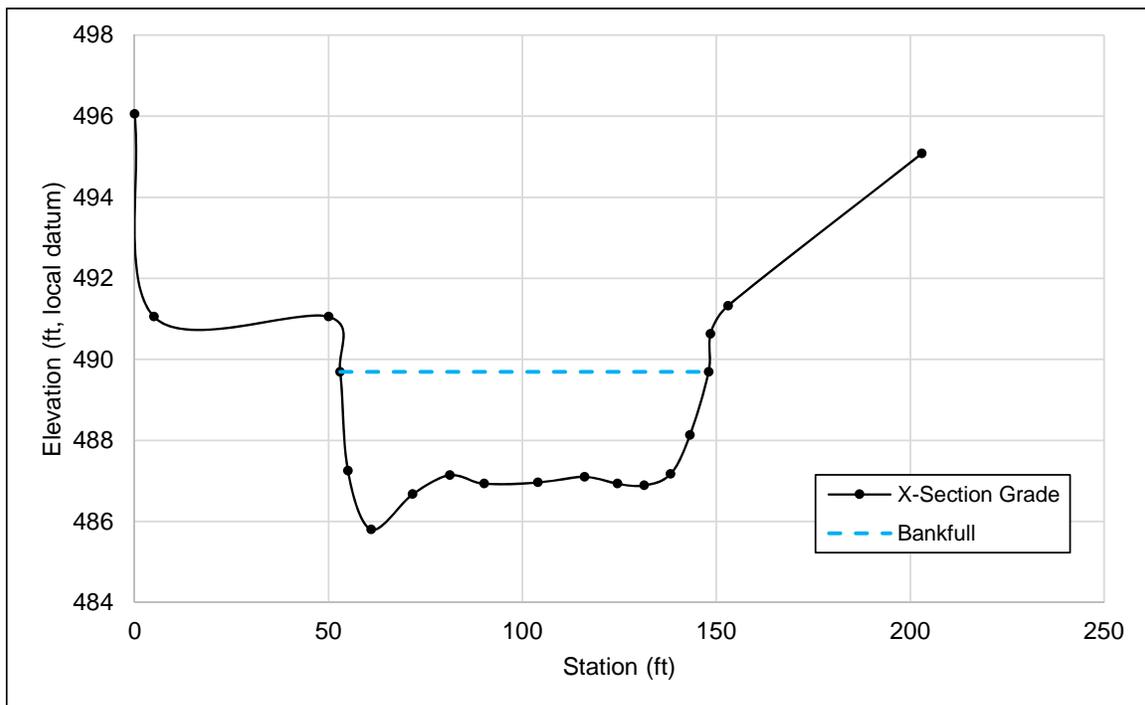
Figure 51. Typical riffle cross section in the Ski Hill Reach.

The dimensionless bankfull shear stress in the Ski Hill Reach is 0.0275 and the dimensional shear stress is 1.013 lbs/ft². Bankfull hydraulic conditions result the mobilization of a 153 mm particle according to a modified Shields curve depicting the incipient motion of sediment particles based on shear stress (Rosgen 2010). Survey data indicate that the reach is capable of transporting the largest particles in the available bedload, and is capable of mobilizing up to the D90 of the surface grains based upon material size class distribution (Figure 52). These analyses indicate that the reach is competent to mobilize the available bedload, but that excess shear stress could achieve mobilization of the largest surface grains and result in channel degradation.

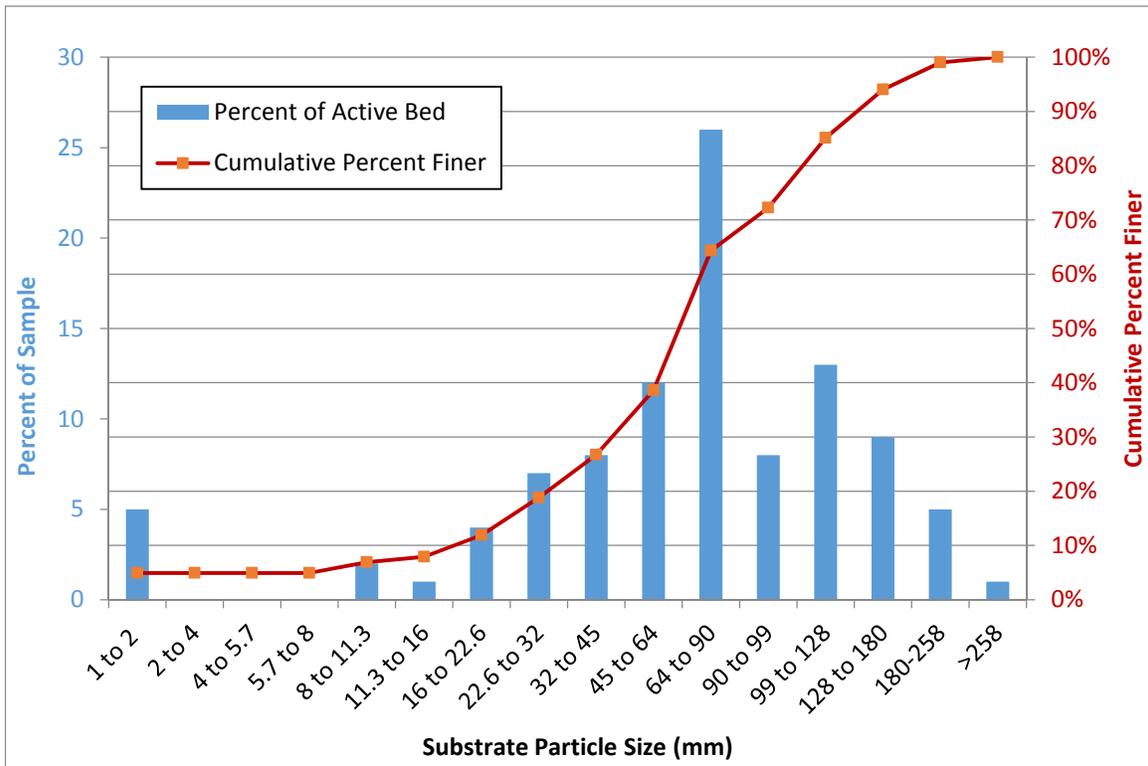
Figure 52. Surface particle size class distribution in the Ski Hill Reach.

Sediment transport analyses completed using the regional curve for bankfull sediment transport rates and the FLOWSED/POWERSED model indicate that the sediment supply at Ski Hill Reach is comprised of 1,962 tons/year of suspended sediment and 1,672 tons/year of bedload. Survey data from Ski Hill Reach indicate that the reach has capacity to transport 2,205 tons/year of suspended sediment and 1,158 tons/year of bedload. The reach therefore has excess capacity to transport the supplied suspended sediment (net capacity of 12%) and the reach has insufficient capacity to transport the supplied bedload (net capacity of -31%). These sediment transport conditions result in widespread sediment deposition and channel aggradation.

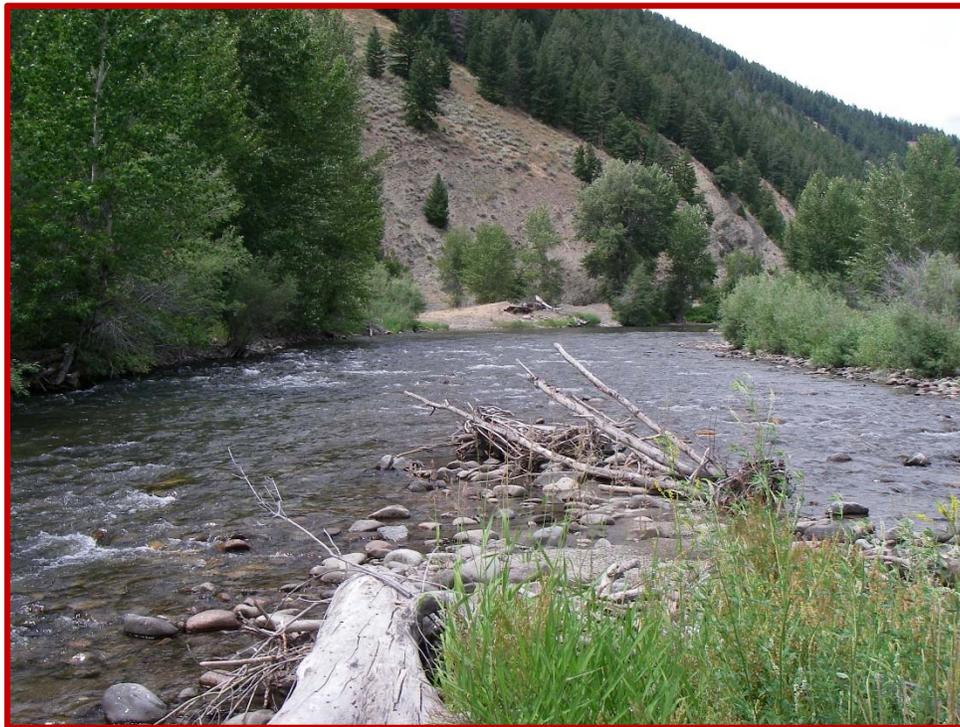
Figure 53. Photograph depicting mid-channel bar and sedimentation in the Highway 75 Reach.

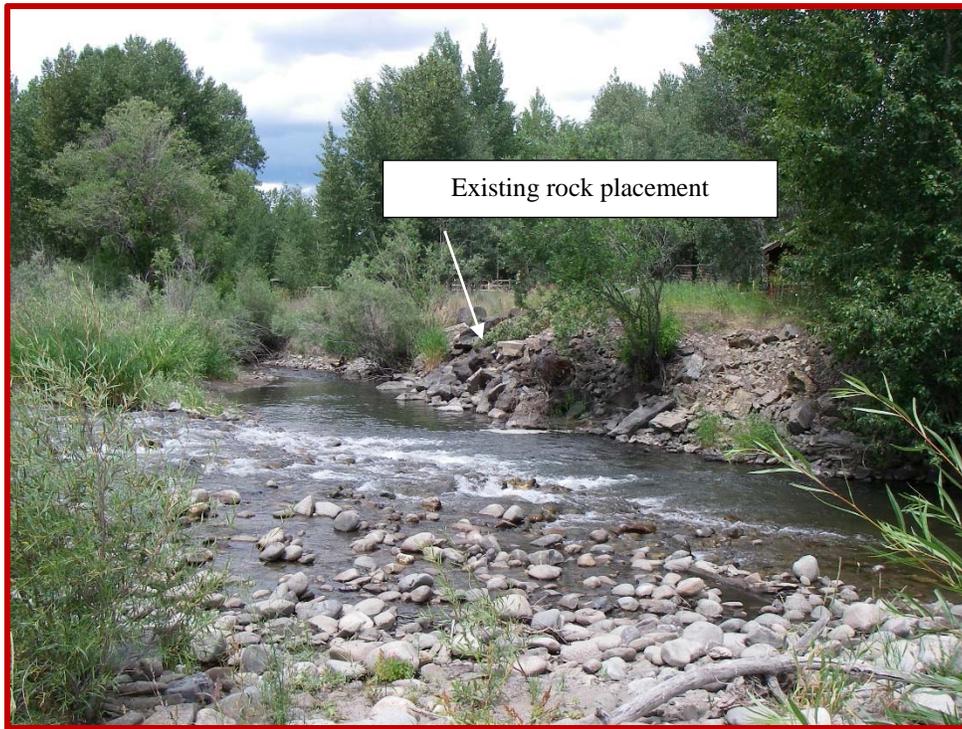
Figure 54. Photograph depicting split channel configuration and sedimentation in the Highway 75 Reach.

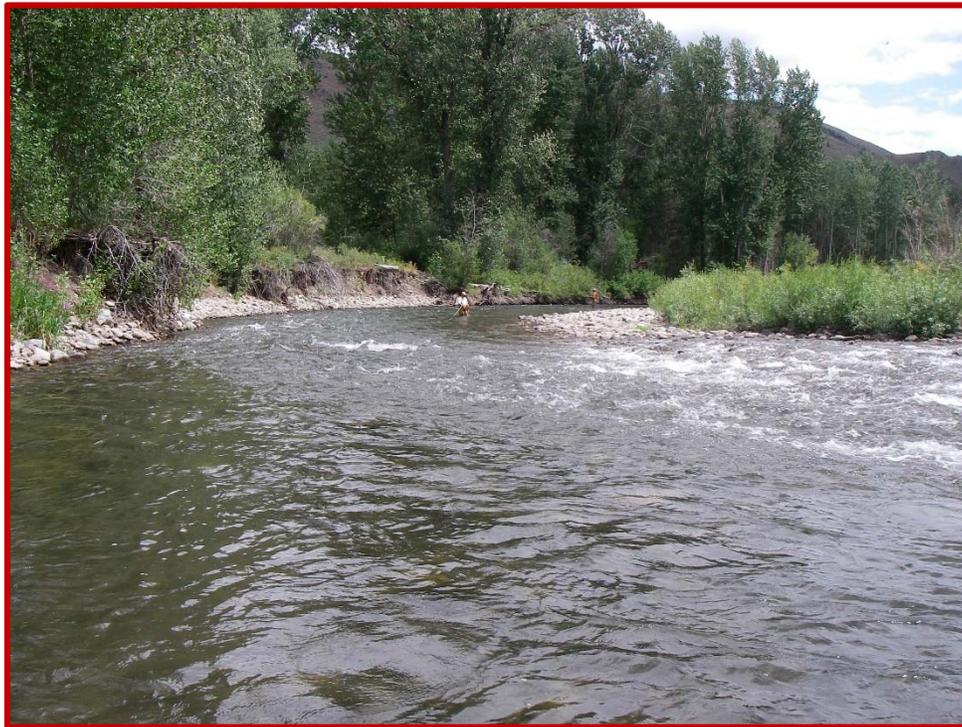
Figure 55. Photograph depicting point bar enlargement (river right) and unstable eroding cut bank (river left) in the Highway 75 Reach.

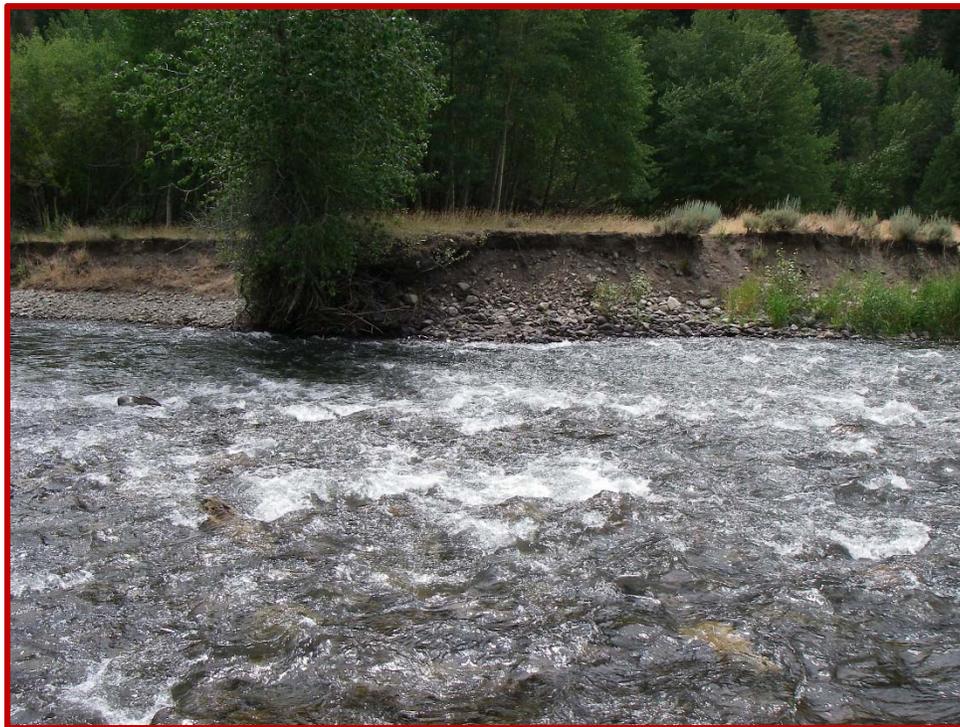
Figure 56. Photograph depicting steep riffle bed feature and tall eroding bank with extreme BEHI in the Highway 75 Reach.

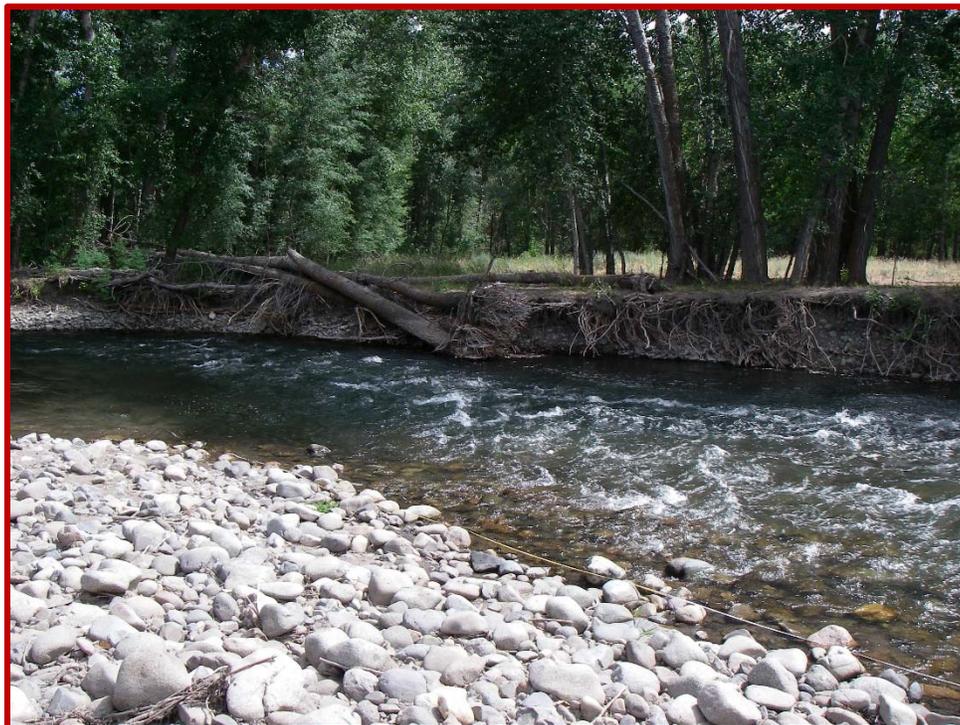
Figure 57. Photograph depicting point bar enlargement and tall eroding bank with extreme BEHI upstream of the highway bridge in the Highway 75 Reach.

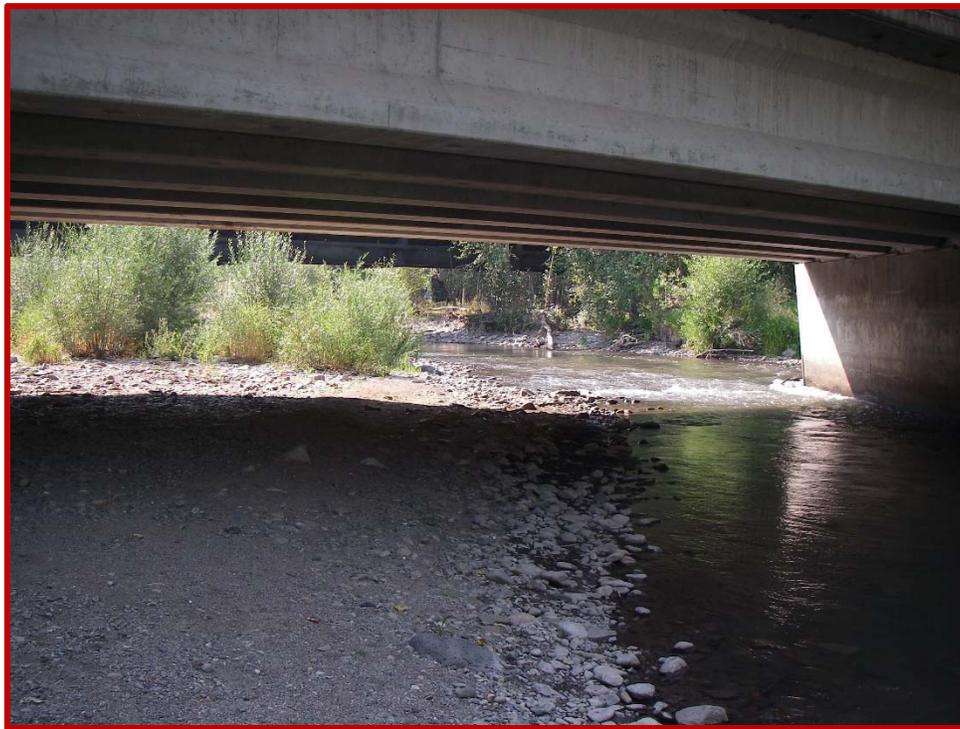
Figure 60. Photograph depicting sedimentation and point bar enlargement under highway bridge in the Highway 75 Reach.

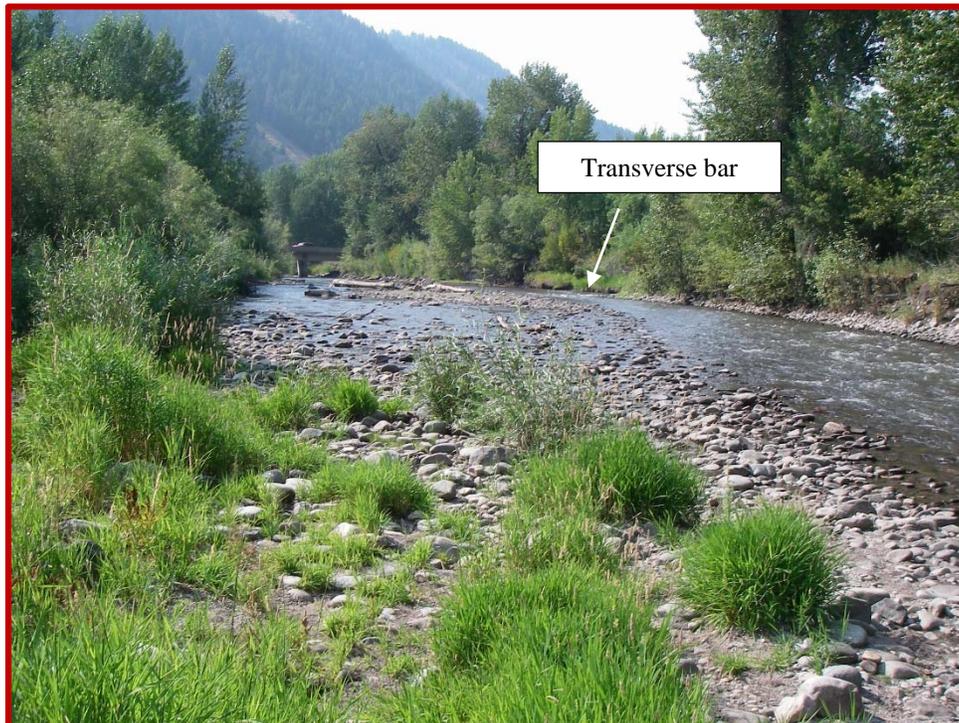
Figure 61. Photograph looking upstream at sedimentation and transverse bar in the Highway 75 Reach.
