**FINAL
GEOMORPHIC ASSESSMENT REPORT
BIG WOOD RIVER
BLAINE COUNTY, IDAHO**

Trout Unlimited

research & consulting inc.

February 1, 2016

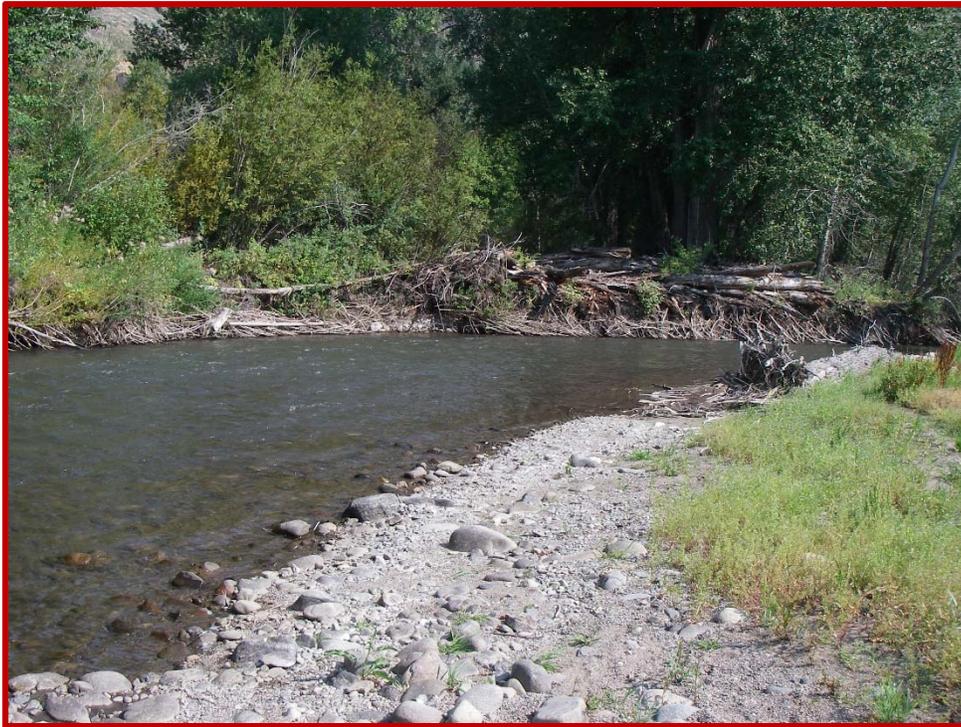
Figure 62. Photograph depicting bar enlargement (river right) and bank erosion (river left) in the Highway 75 Reach.

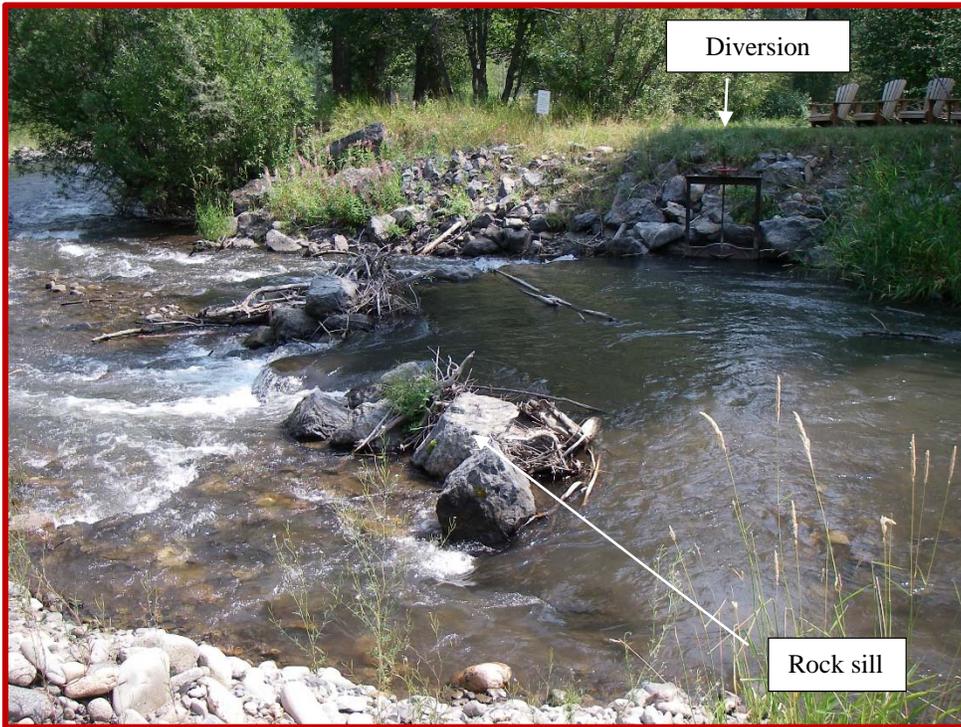
Figure 63. Photograph of river right diversion structure in the Highway 75 Reach.

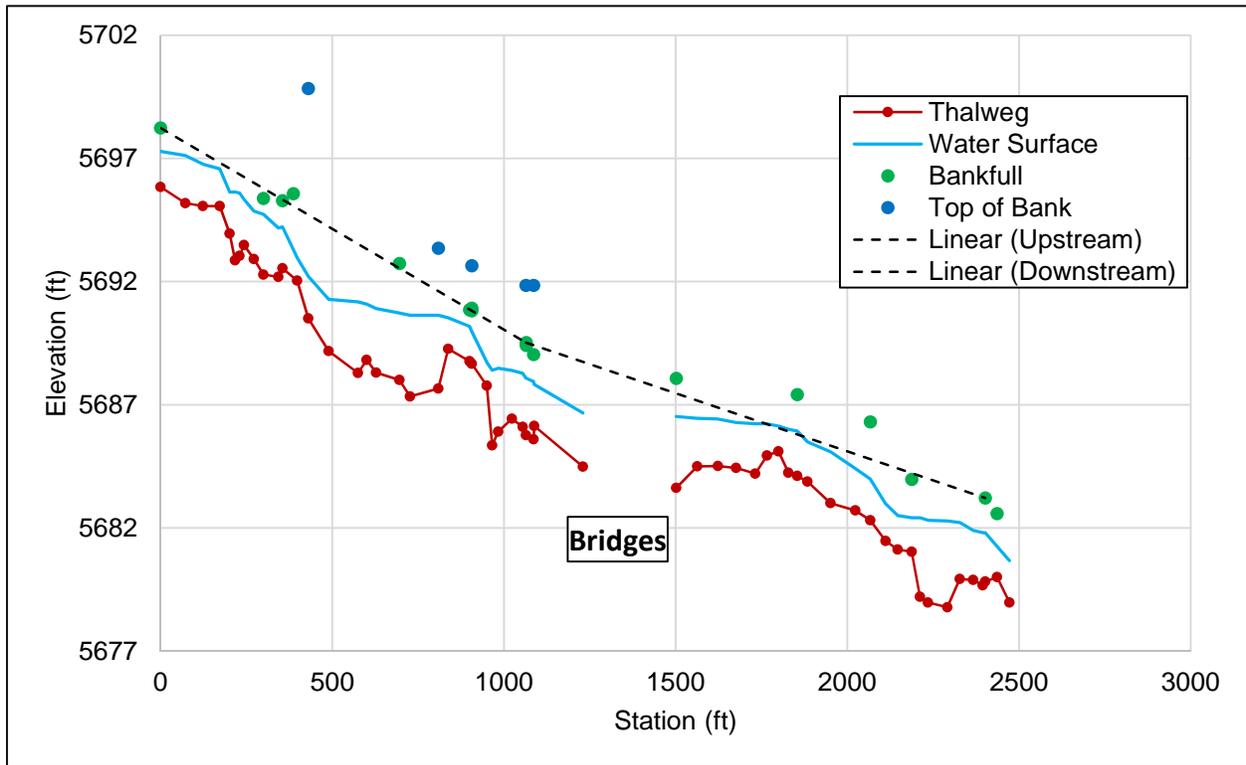
bank elevations are depicted in blue. The reach-wide bankfull channel slope is approximately 0.58%, and a typical riffle cross section depicting high width/depth ratio is presented in Figure 66.

Figure 65. Longitudinal profile through the Highway 75 Reach

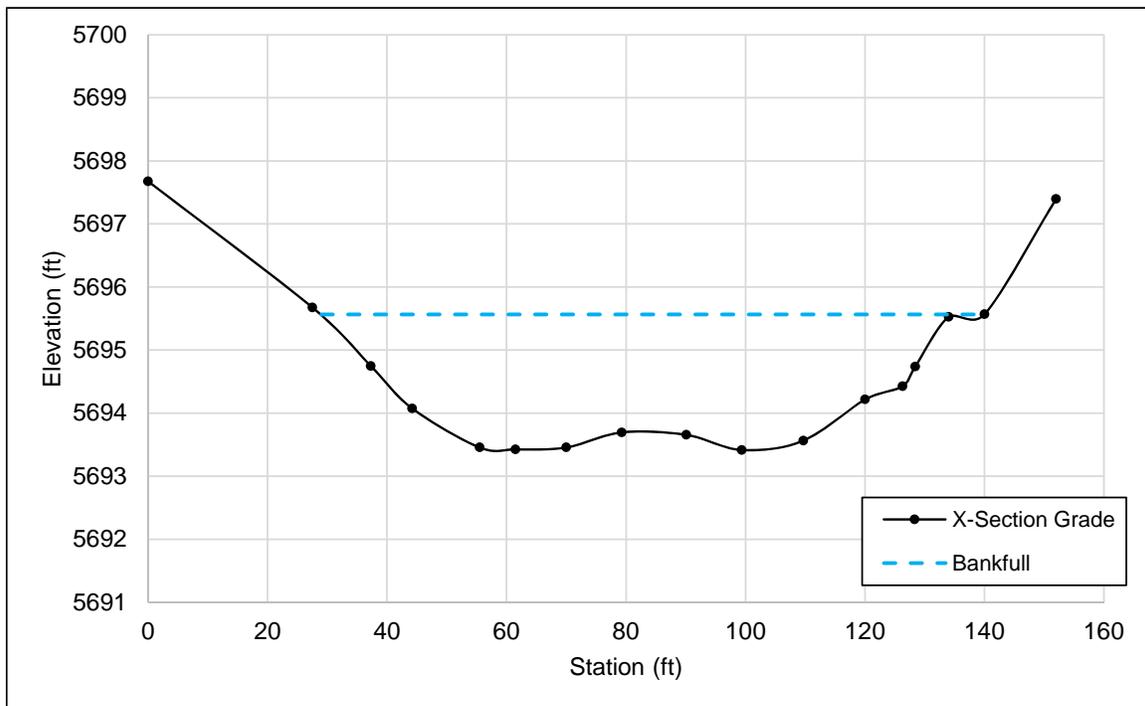
Figure 66. Typical riffle cross section in the Highway 75 Reach.

The dimensionless bankfull shear stress in the Highway 75 Reach is 0.0192 and the dimensional shear stress is 0.691 lbs/ft². Bankfull hydraulic conditions result in the mobilization of a 116 mm particle according to a modified Shields curve depicting the incipient motion of sediment particles based on shear stress (Rosgen 2010). Survey data indicate that the reach is capable of transporting the largest particles in the available bedload, but is capable of mobilizing only up to the D50 of the surface grains based upon material size class distribution (Figure 67). These analyses indicate that the reach is competent to transport the available bedload and that the existing surface grain size class distribution promotes vertical channel stability.

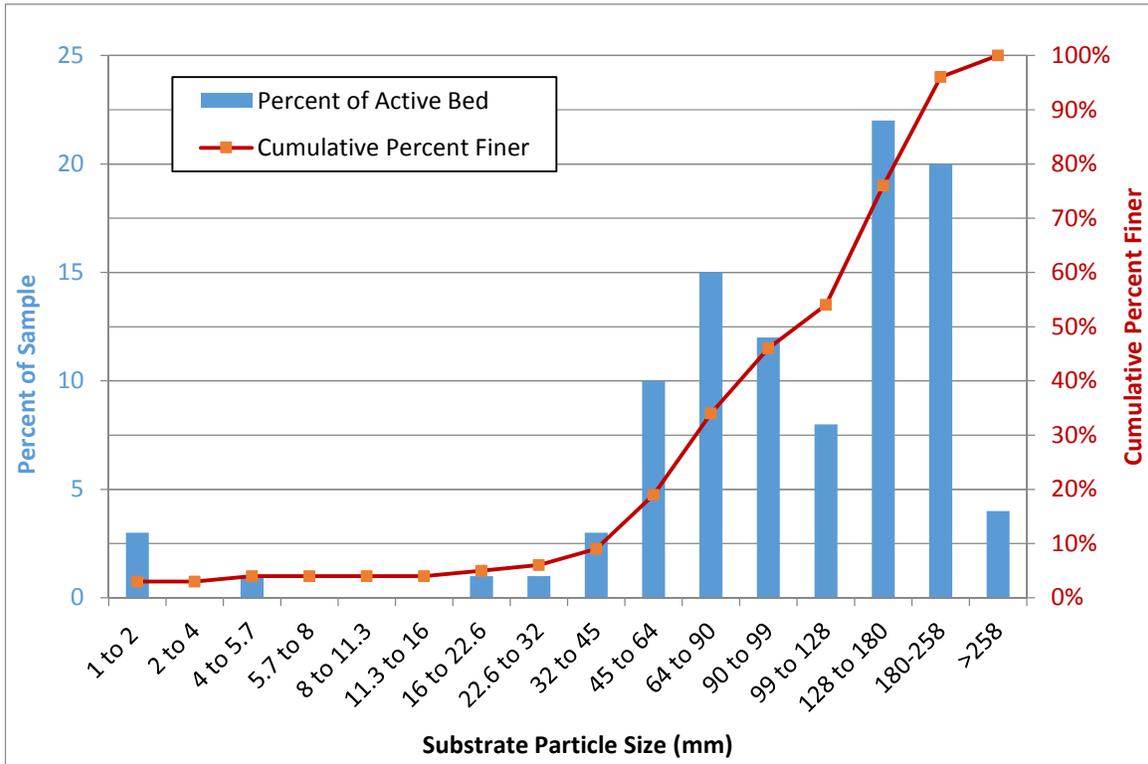
Figure 67. Surface particle size class distribution in the Highway 75 Reach.

Sediment transport analyses completed using the regional curve for bankfull sediment transport rates and the FLOWSED/POWERSED model indicate that the sediment supply at Highway 75 Reach is comprised of 1,334 tons/year of suspended sediment and 1,998 tons/year of bedload. Survey data from Highway 75 Reach indicate that the reach has capacity to transport 1,537 tons/year of suspended sediment and 1,815 tons/year of bedload. The reach therefore has excess capacity to transport the supplied suspended sediment (net capacity of 14%) and the reach has insufficient capacity to transport the supplied bedload (net capacity of -9%). These sediment transport conditions result in excess sediment deposition.

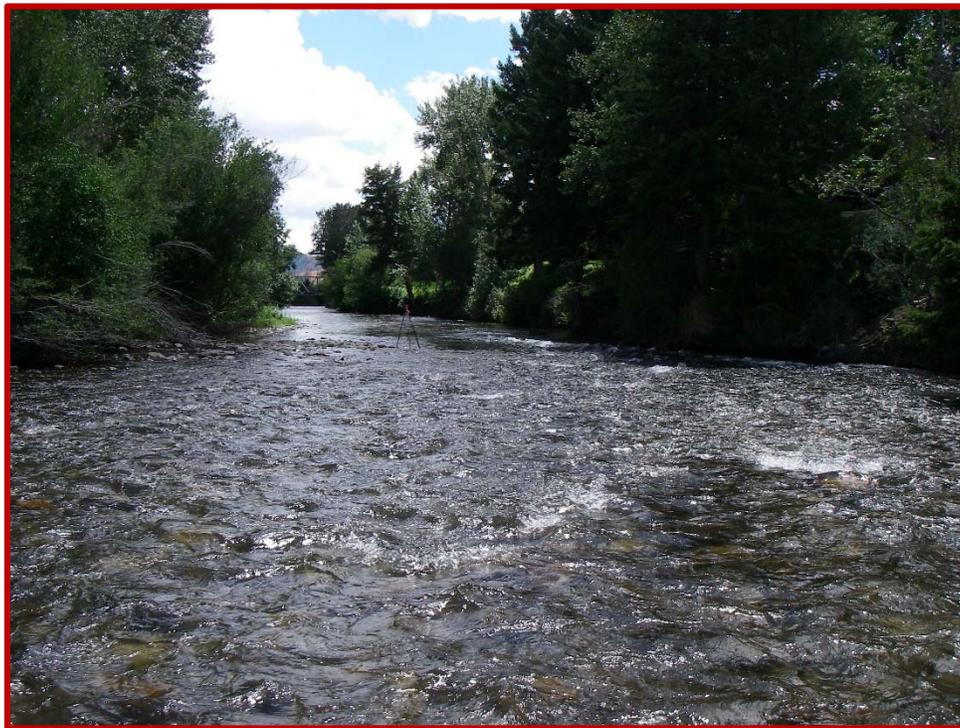
Figure 68. Photograph depicting typical channel entrenchment in Downstream of East Fork Reach.

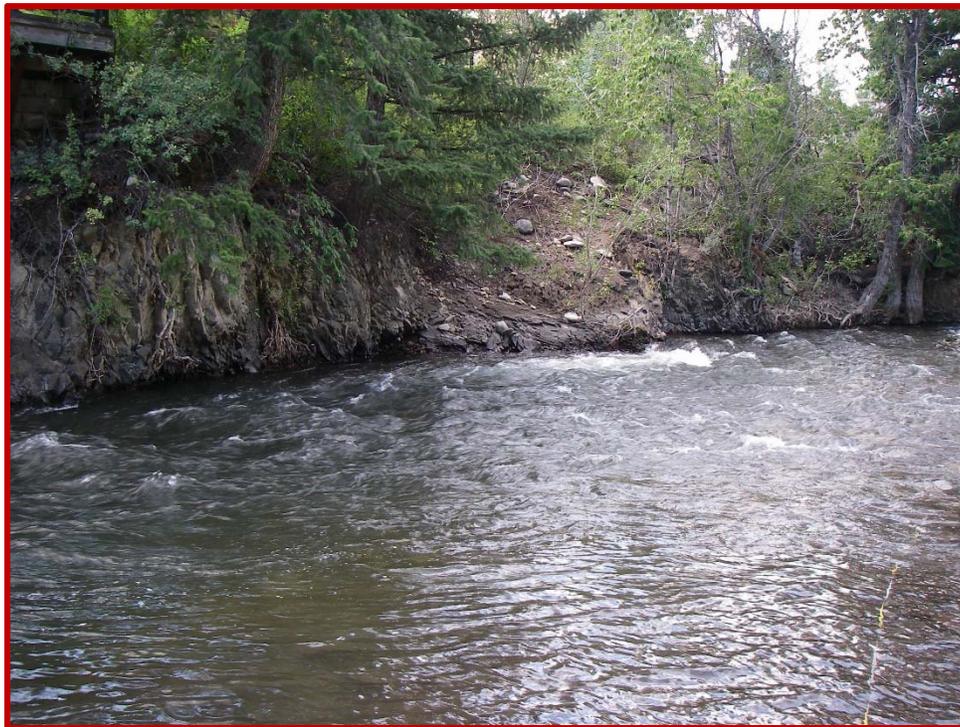
Figure 69. Photograph depicting steep bedrock banks in the Downstream of East Fork Reach.

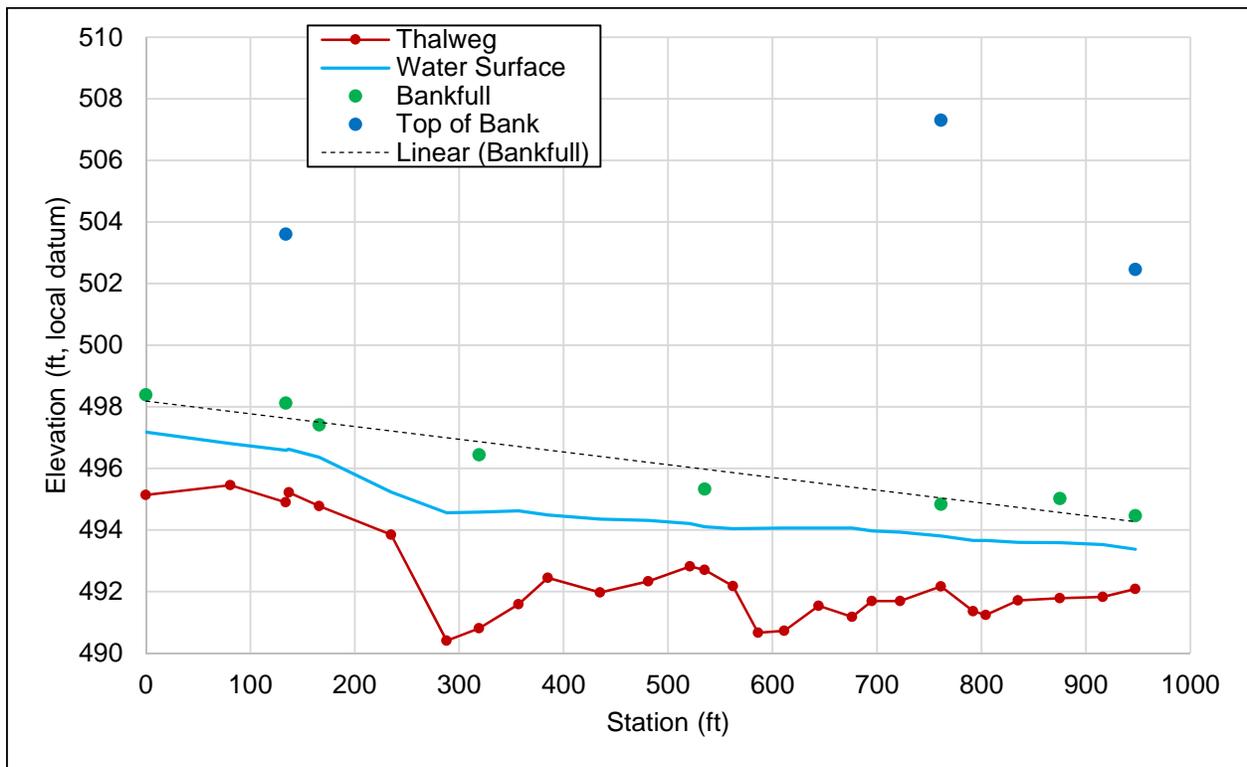
Figure 71. Longitudinal profile through the Downstream of East Fork Reach.

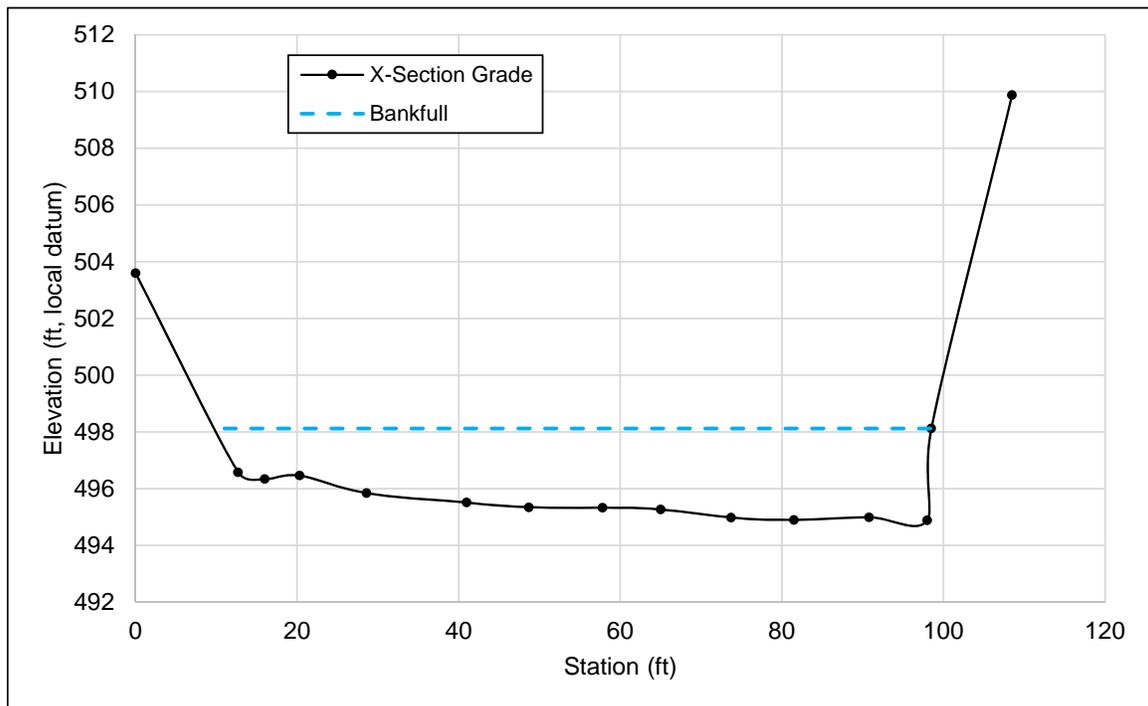
Figure 72. Typical riffle cross section in the Downstream of East Fork Reach.

The dimensionless bankfull shear stress in the Downstream of East Fork Reach is 0.0233 and the dimensional shear stress is 0.67 lbs/ft². Bankfull hydraulic conditions result the mobilization of a 113 mm particle according to a modified Shields curve depicting the incipient motion of sediment particles based on shear stress (Rosgen 2010). Survey data indicate that the reach is capable of transporting the largest

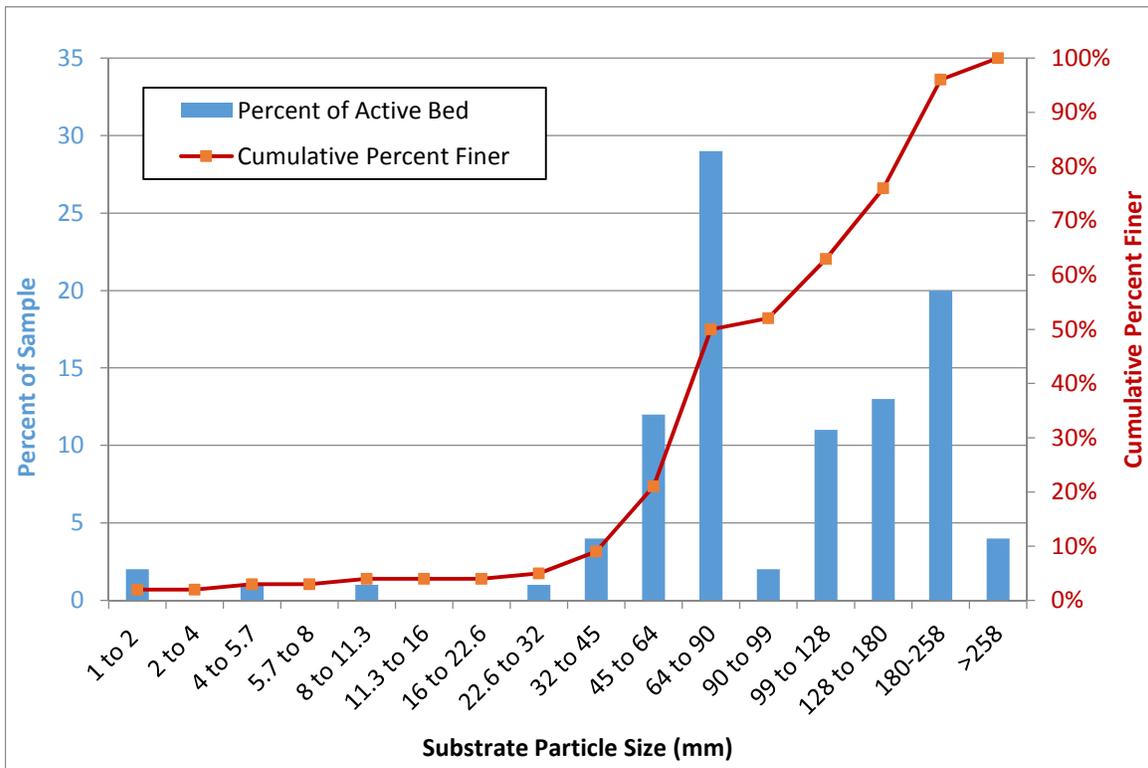
particles in the available bedload, but is capable of mobilizing only up to the D55 of the surface grains based upon material size class distribution (Figure 73). These analyses indicate that the reach is competent to transport the available bedload and that the existing surface grain size class distribution promotes vertical channel stability.

Figure 73. Surface particle size class distribution in the Downstream of East Fork

Sediment transport analyses completed using the regional curve for bankfull sediment transport rates and the FLOWSED/POWERSED model indicate that the sediment supply at Downstream of East Fork Reach is comprised of 1,013 tons/year of suspended sediment and 1,228 tons/year of bedload. Survey data from Downstream of East Fork Reach indicate that the reach has capacity to transport 1,035 tons/year of suspended sediment and 594 tons/year of bedload. The reach therefore has sufficient capacity to transport the supplied suspended sediment (net capacity of 2%) and the reach has insufficient capacity to transport the supplied bedload (net capacity of -52%). These sediment transport conditions result in excess sediment deposition.

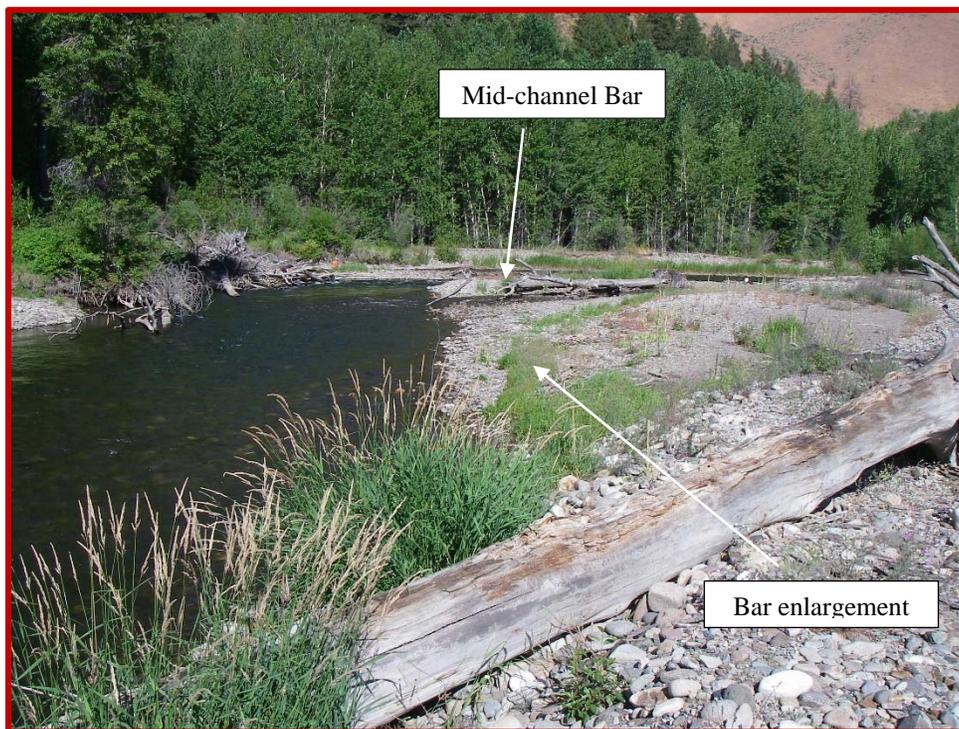
Figure 74. Photograph depicting bar enlargement, mid-channel bar, and split channel configuration of the Downstream of Deer Creek Reach.

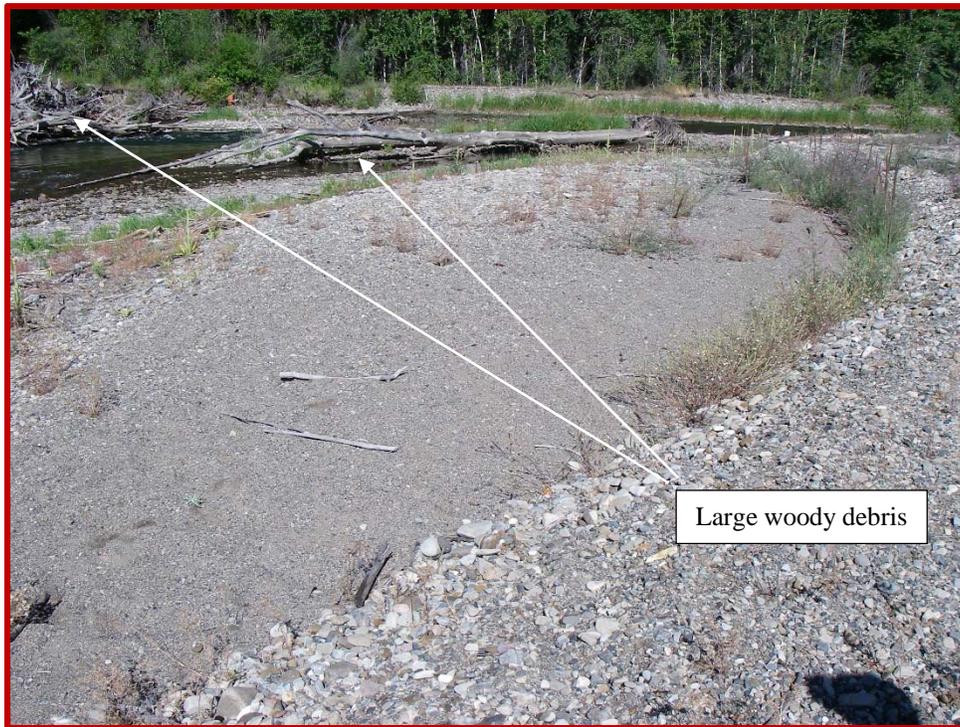
Figure 75. Photograph depicting sedimentation and woody debris accumulations in the Downstream of Deer Creek Reach.

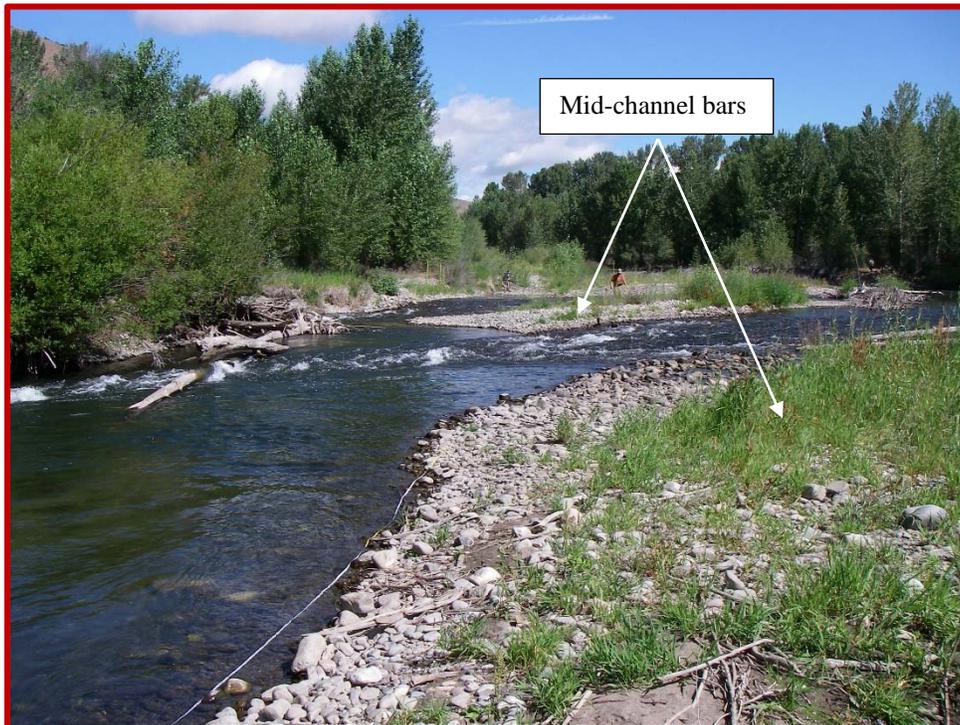
Figure 76. Photograph depicting multiple mid-channel bars and split channel configuration in the Downstream of Deer Creek Reach.

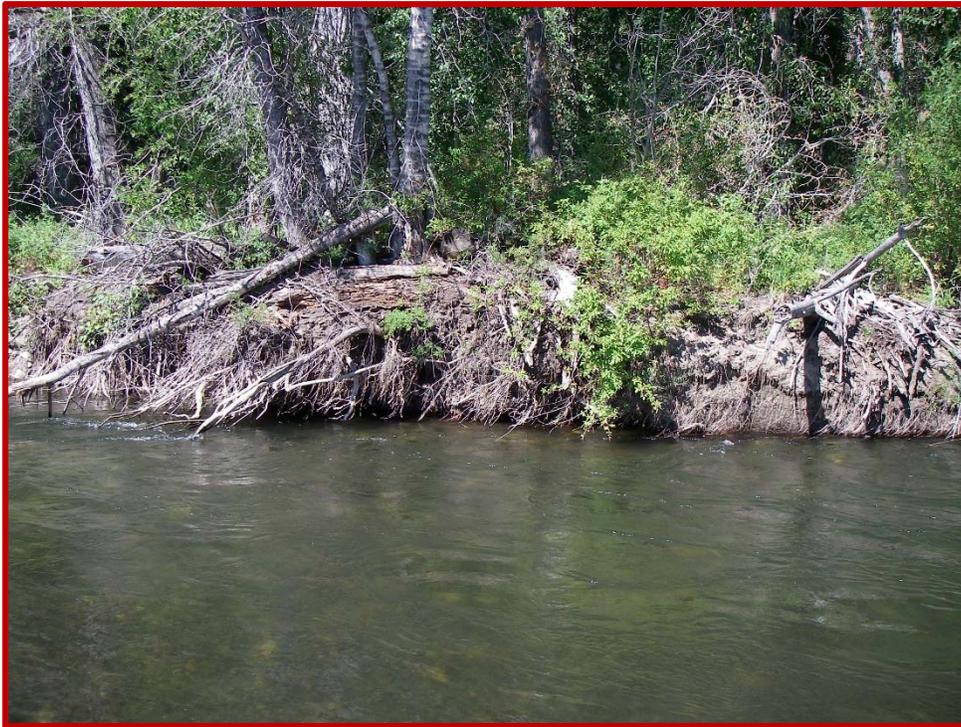
Figure 77. Photograph depicting undercutting vegetated bank with moderate BEHI rating in the Downstream of Deer Creek Reach.

The bank erosion rate at the Downstream of Deer Creek Reach is 0.2742 tons/year/foot, and the 1976-ft long surveyed stream segment contributes an estimated 542 tons of sediment to the watershed in an average year through bank erosion.

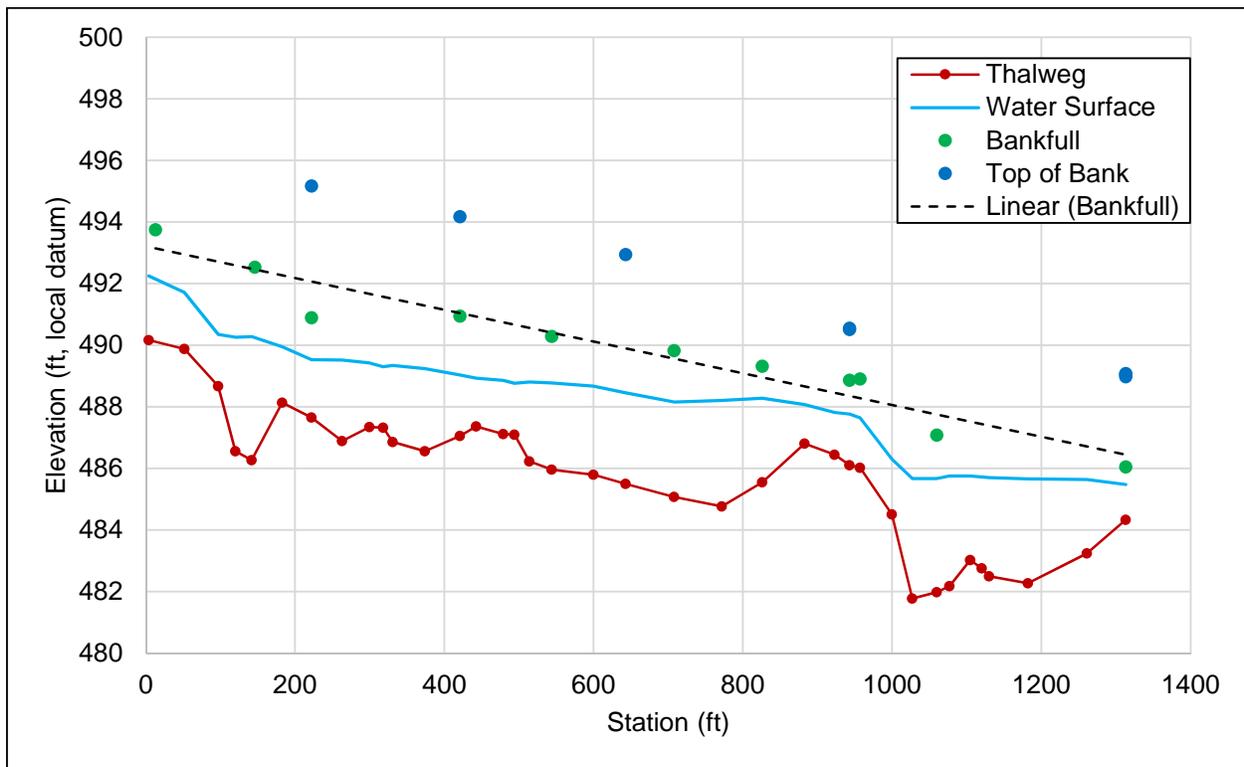
Figure 79. Longitudinal profile through Downstream of Deer Creek Reach.

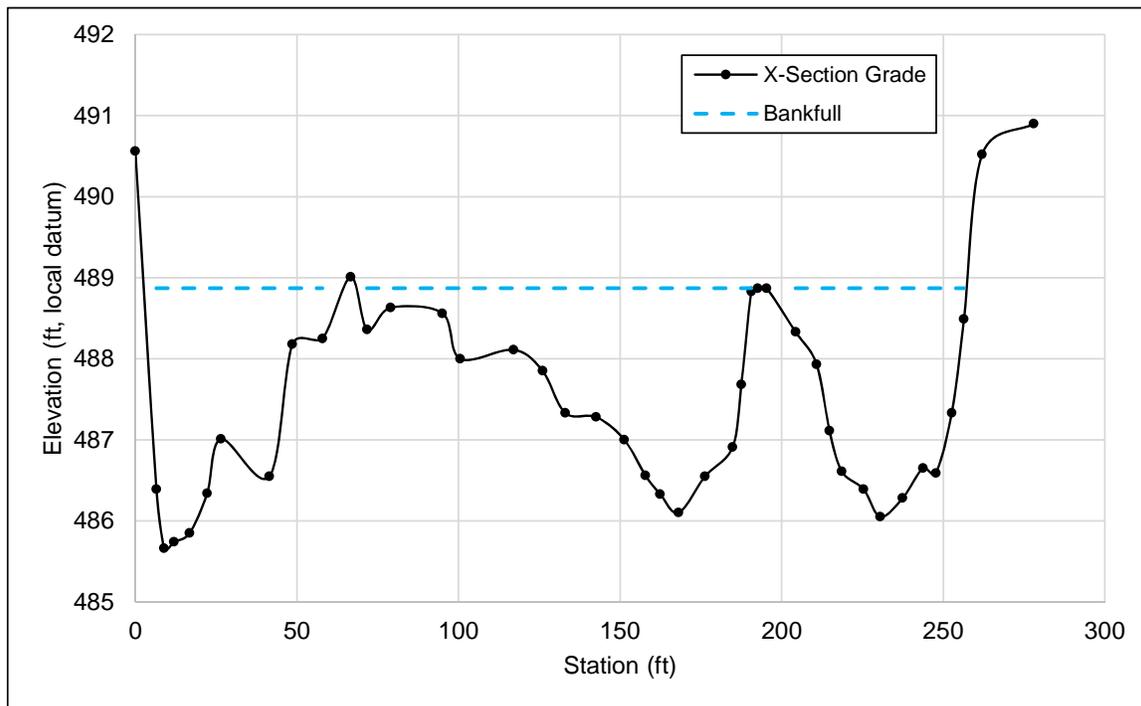
Figure 80. Typical riffle cross section across multiple channels in Downstream of Deer Creek Reach.

The dimensionless bankfull shear stress in the Downstream of Deer Creek Reach is 0.016 and the dimensional shear stress is 0.552 lbs/ft². Bankfull hydraulic conditions result the mobilization of a 98 mm particle according to a modified Shields curve depicting the incipient motion of sediment particles based on shear stress (Rosgen 2010). Survey data indicate that the reach is capable of transporting the largest

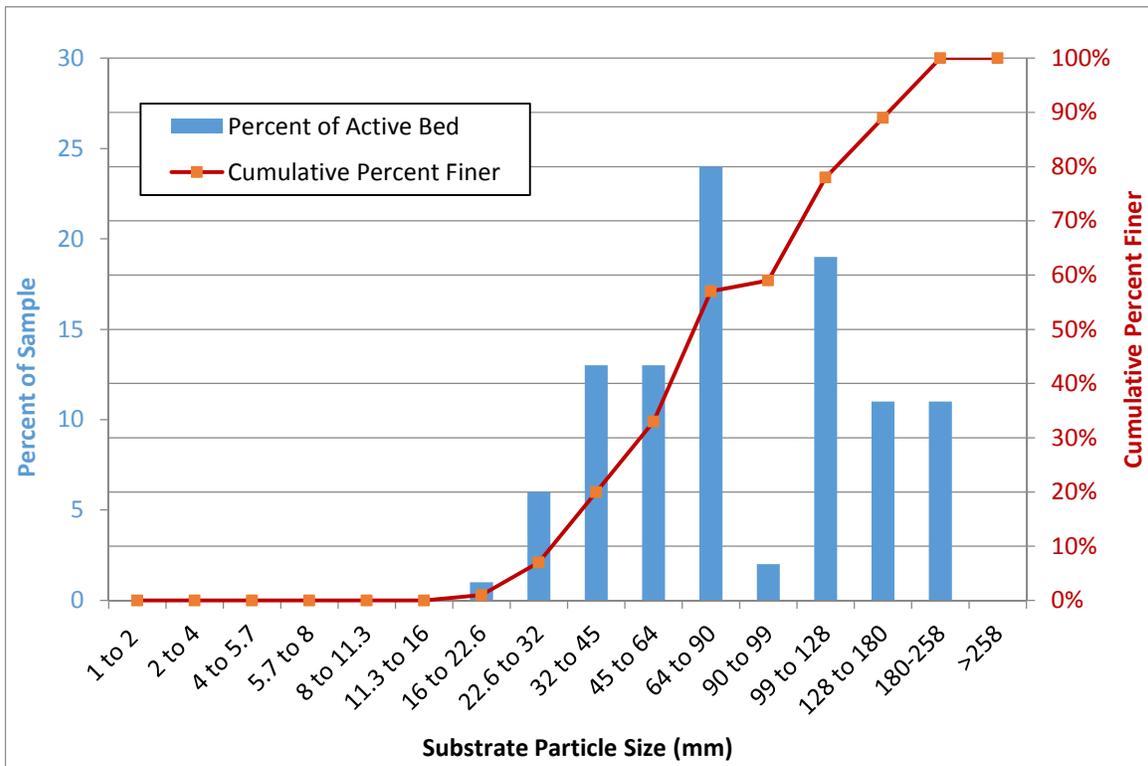
particles in the available bedload, but is capable of mobilizing only up to the D60 of the surface grains based upon material size class distribution (Figure 81). These analyses indicate that the reach is competent to transport the available bedload and that the existing surface grain size class distribution promotes vertical channel stability.

Figure 81. Surface particle size class distribution in the Downstream of Deer Creek Reach.

Sediment transport analyses completed using the regional curve for bankfull sediment transport rates and the FLOWSED/POWERSED model indicate that the sediment supply at Downstream of Deer Creek Reach is comprised of 1,355 tons/year of suspended sediment and 3,033 tons/year of bedload. Survey data from Downstream of Deer Creek Reach indicate that the reach has capacity to transport 1,339 tons/year of suspended sediment and 1,766 tons/year of bedload. The reach therefore has sufficient capacity to transport the supplied suspended sediment (net capacity of approximately zero) and the reach has insufficient capacity to transport the supplied bedload (net capacity of -42%). These sediment transport conditions result in excess sediment deposition and channel aggradation.

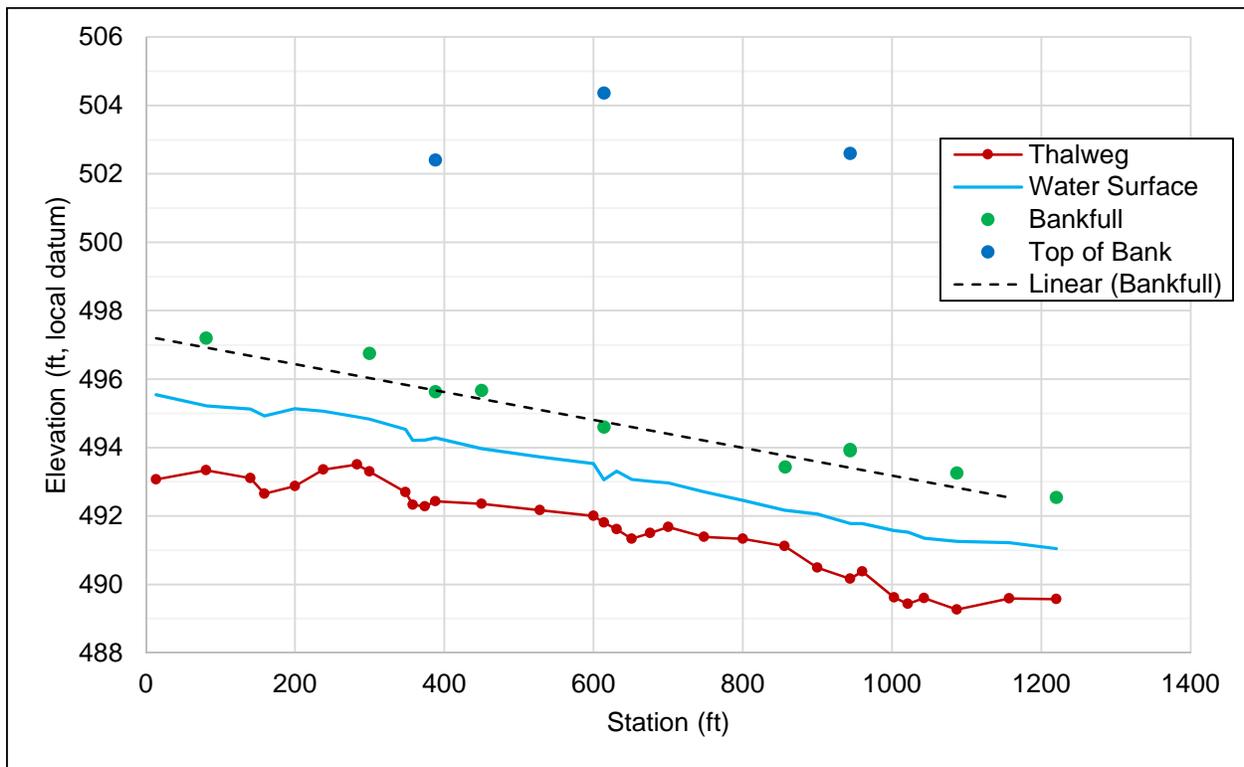
The Bullion Bridge Reach channel profile was analyzed through derivation of a longitudinal profile of the surveyed river reach (Figure 85) in which channel thalweg is depicted in red, water surface is depicted in blue, bankfull indicators are depicted in green, bankfull slope is depicted in dashed black line, and top of bank elevations are depicted in blue. The reach-wide bankfull channel slope is approximately 0.41%. The reach has few scour pools and is dominated by long shallow riffle bed features. A typical riffle cross section depicting high width/depth ratio and channel entrenchment is presented in Figure 86.

Figure 85. Longitudinal profile through the Bullion Bridge Reach.

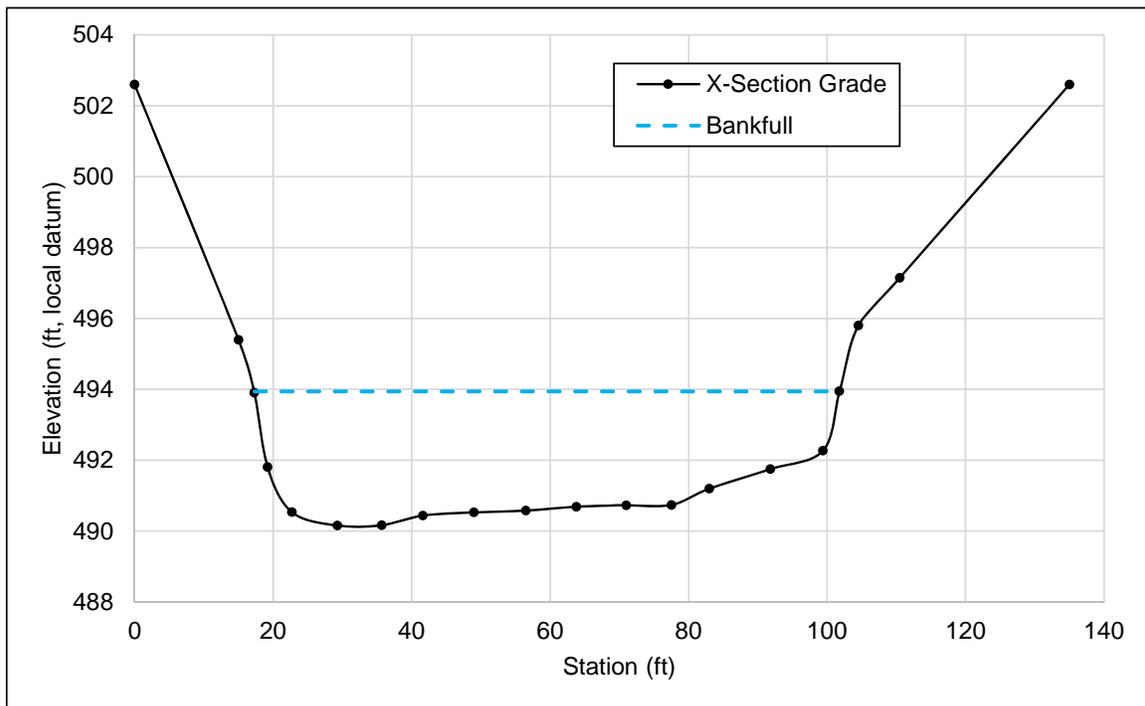
Figure 86. Typical riffle cross section in the Bullion Bridge Reach.

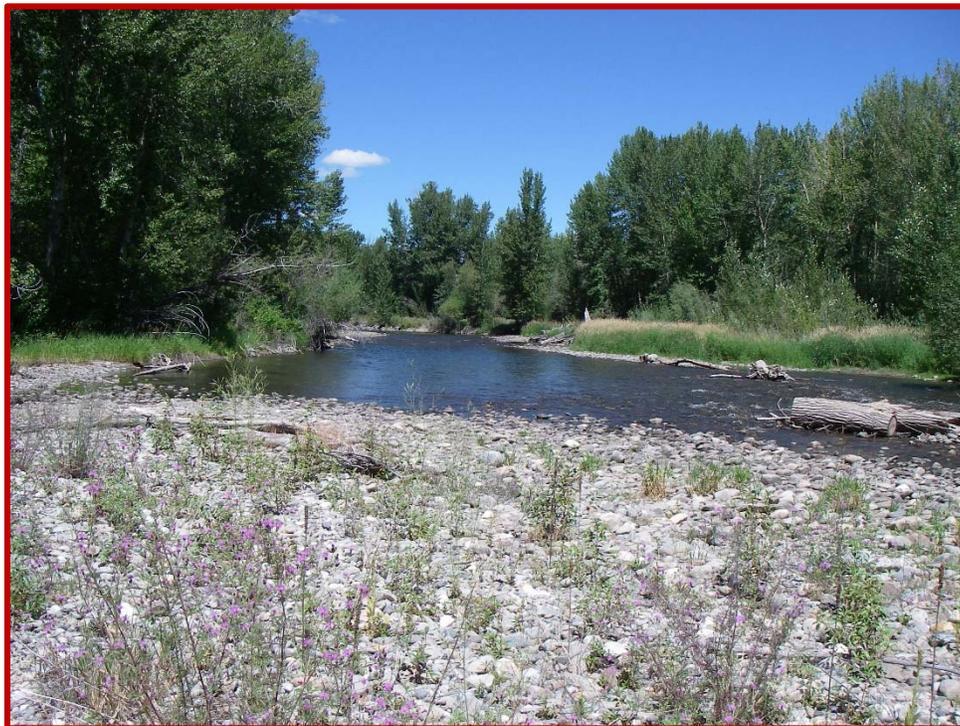
Figure 88. Photograph depicting typical high width/depth ratio and sedimentation in the Colorado Gulch Reach.

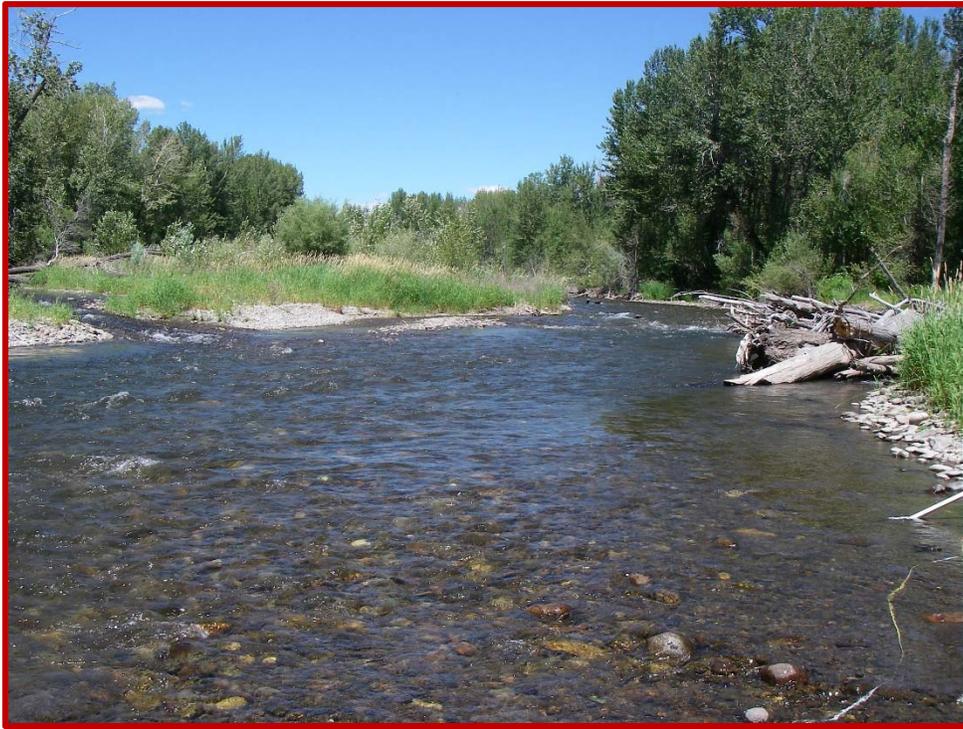
Figure 89. Photograph depicting mid-channel bar, braided channel configuration, and large woody debris accumulations in the Colorado Gulch Reach.

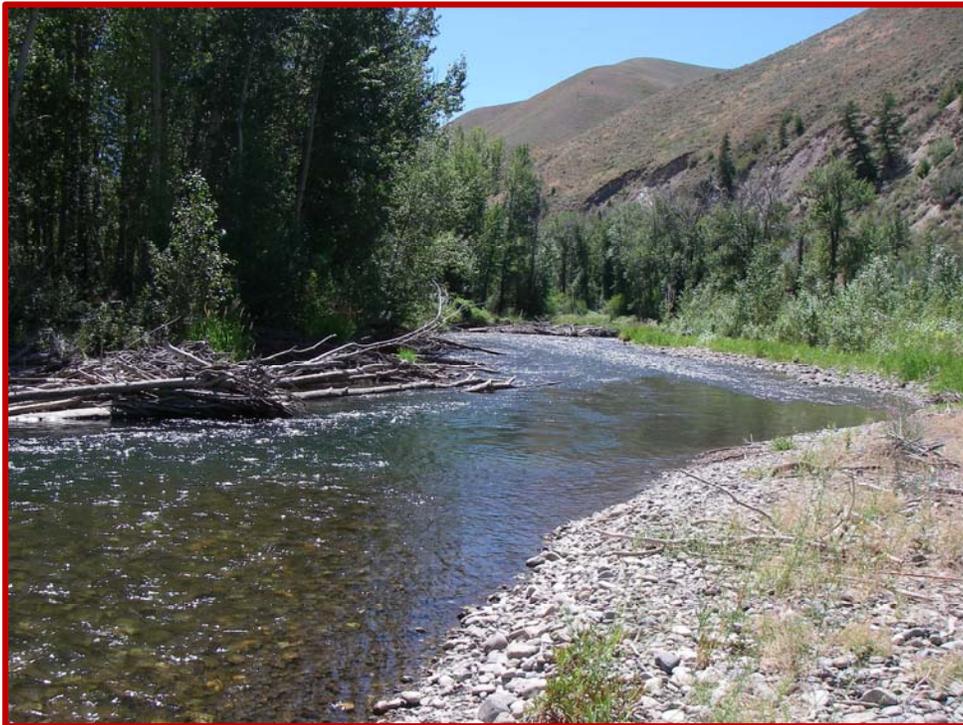
Figure 90. Photograph depicting woody debris jam and scour pool in the Colorado Gulch Reach.

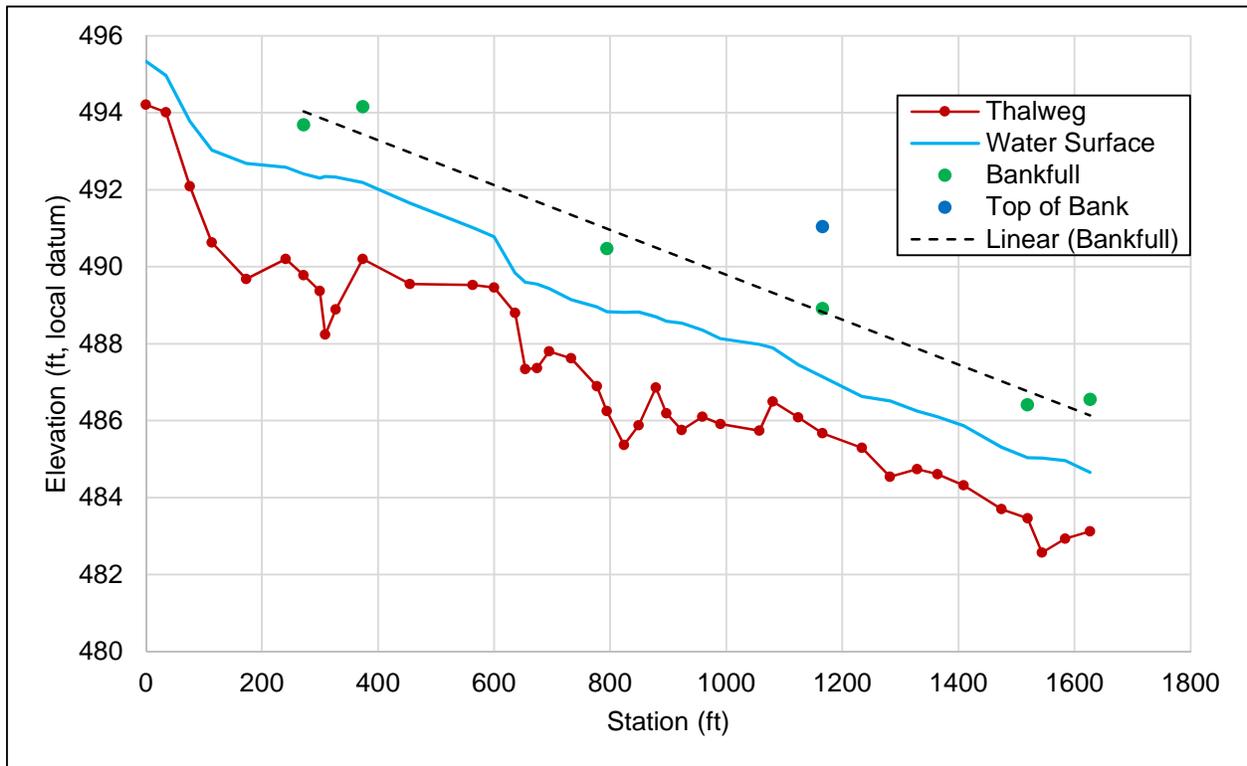
of bank elevations are depicted in blue. The reach-wide bankfull channel slope is approximately 0.58%. The reach is characterized by short steep riffle bed features and deep lateral scour pools associated with large woody debris jams. A typical riffle cross section is presented in Figure 93.

Figure 92. Longitudinal profile through the Colorado Gulch Reach.

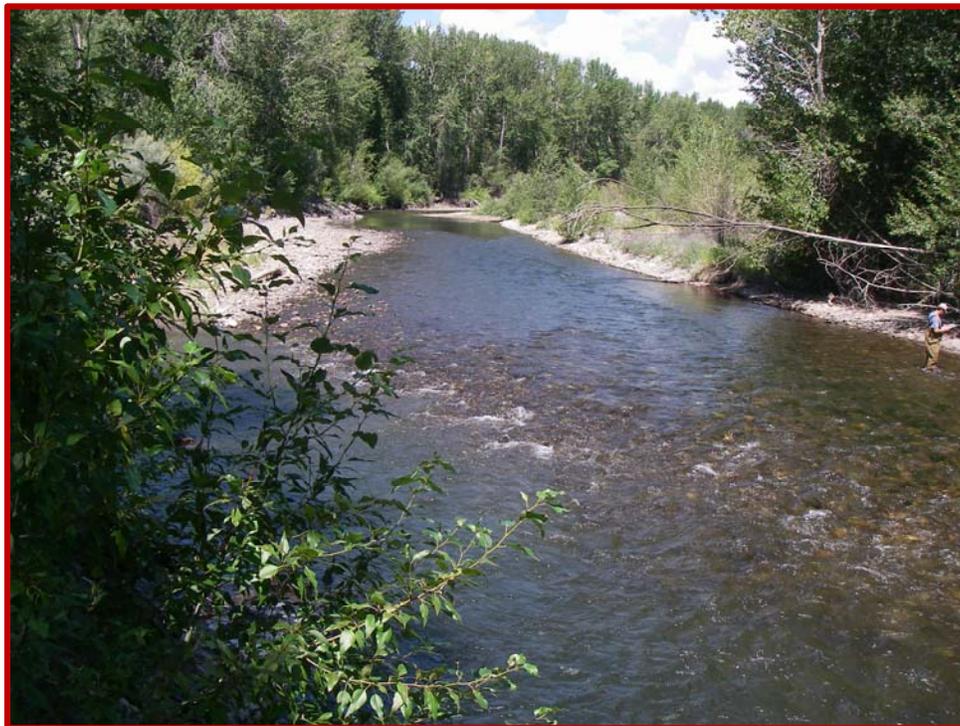
Figure 95. Photograph depicting transverse bar in the Broadford Street Bridge Reach.

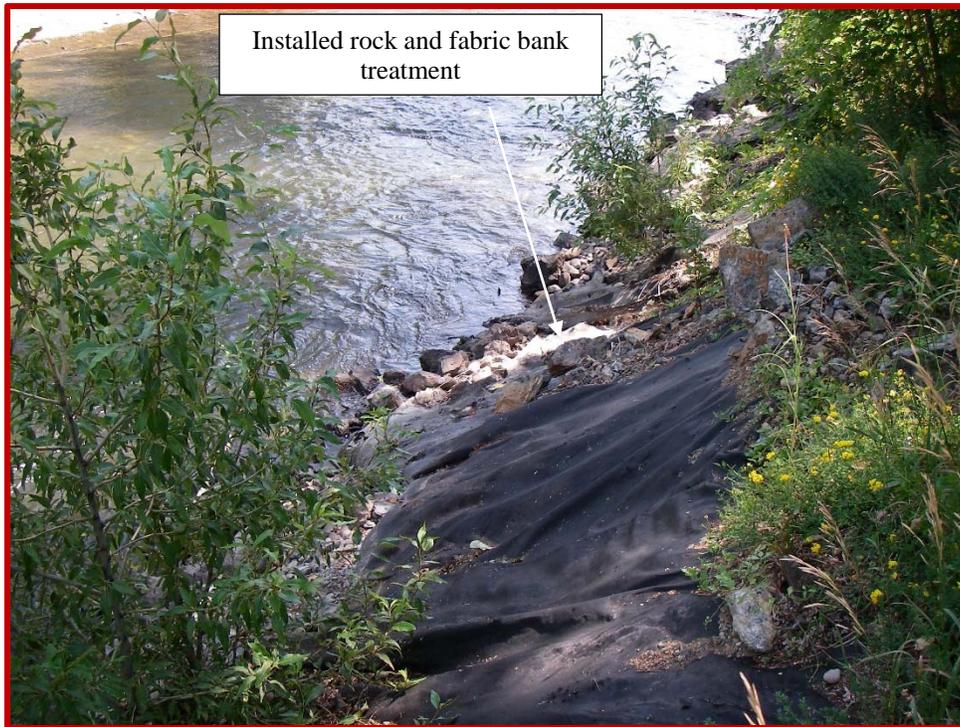
Figure 96. Photograph of installed bank stabilization treatment in the Broadford Street Bridge Reach.

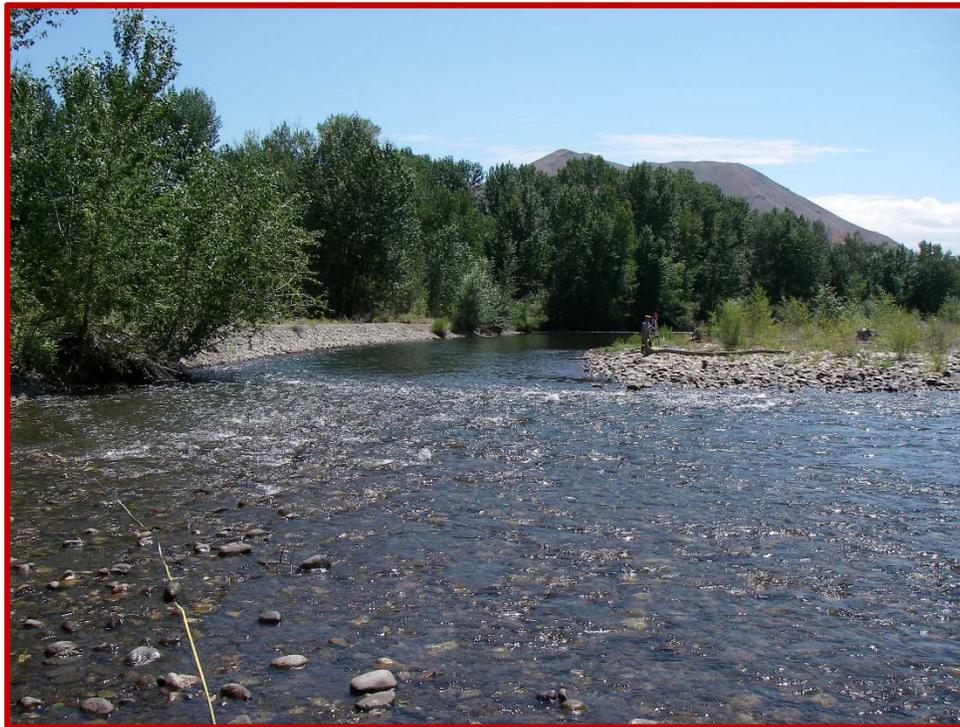
Figure 97. Photograph depicting typical high width/depth ratio, slight entrenchment, and eroding banks in the Broadford Street Bridge Reach.
