**FINAL
GEOMORPHIC ASSESSMENT REPORT
BIG WOOD RIVER
BLAINE COUNTY, IDAHO**

Trout Unlimited

research & consulting inc.

February 1, 2016

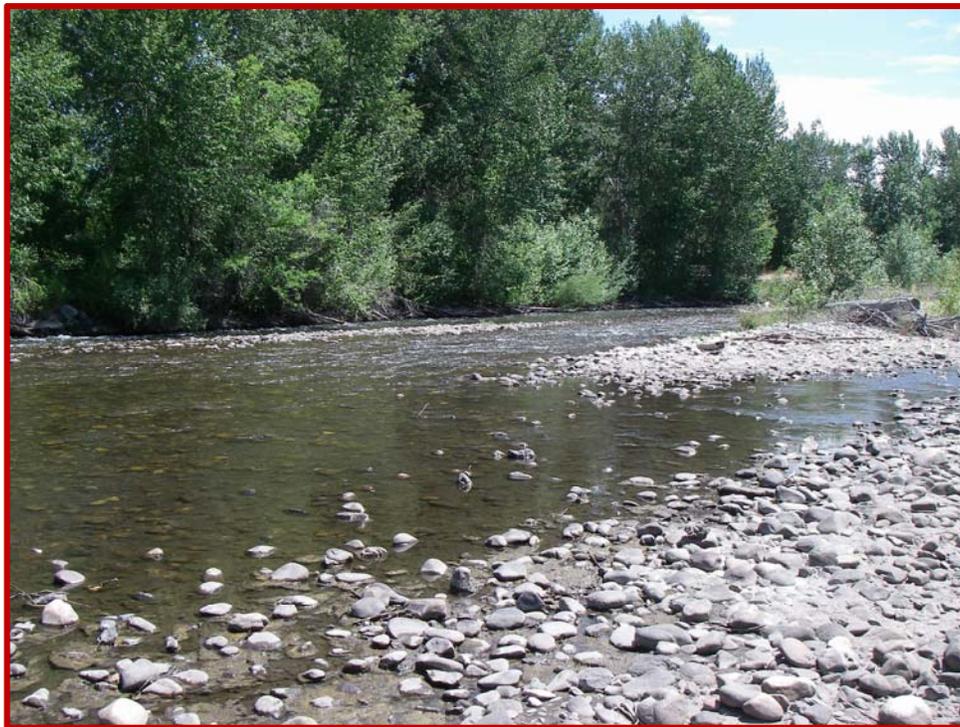
Figure 98. Photograph depicting typical sedimentation (mid-channel bars) in the Broadford Street Bridge Reach.

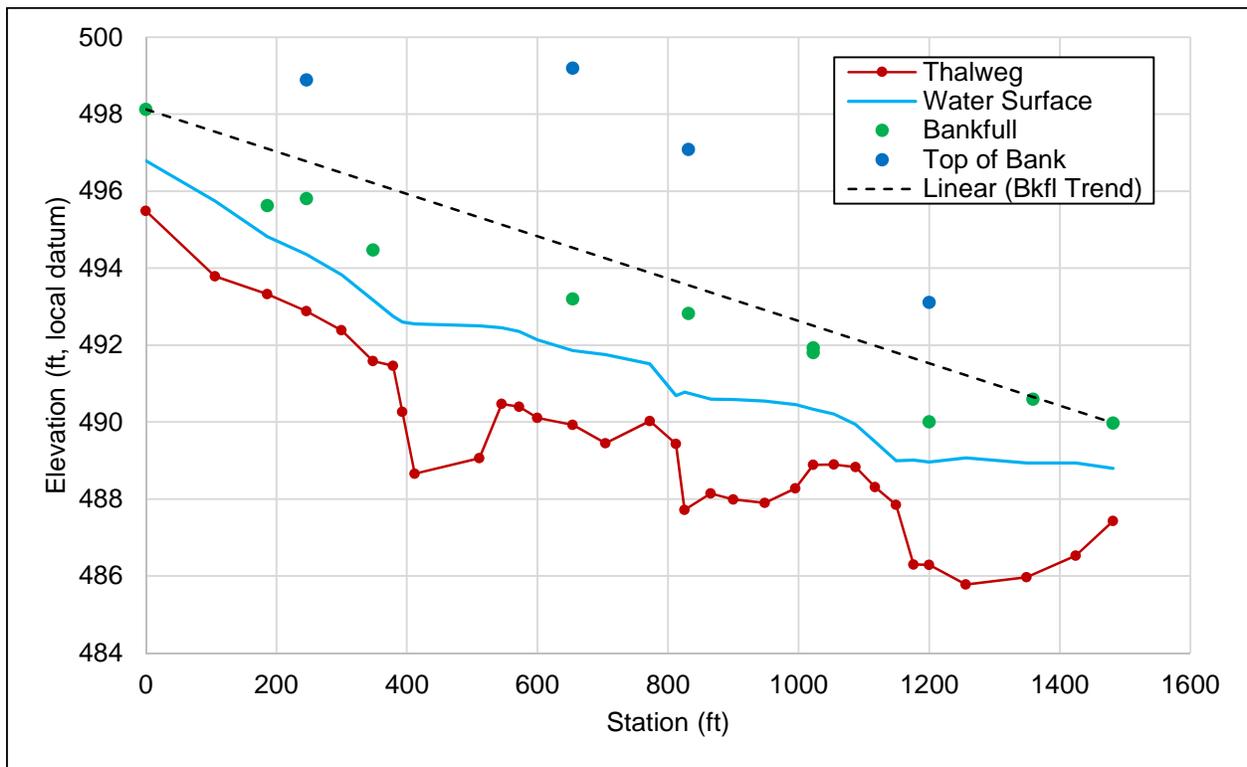
The Broadford Street Bridge Reach channel profile was analyzed through derivation of a longitudinal profile of the surveyed river reach (Figure 100) in which channel thalweg is depicted in red, water surface is depicted in blue, bankfull indicators are depicted in green, bankfull slope is depicted in dashed black line, and top of bank elevations are depicted in blue. The reach-wide bankfull channel slope is approximately 0.55%. High bank heights within the reach result in an F-stream type classification, although the presence of D-type stream conditions in portions of the reach indicates that the reach might be in transition. A typical riffle cross section depicting high width/depth ratio and entrenched channel conditions is presented in Figure 101.

Figure 100. Longitudinal profile through Bradford Reach

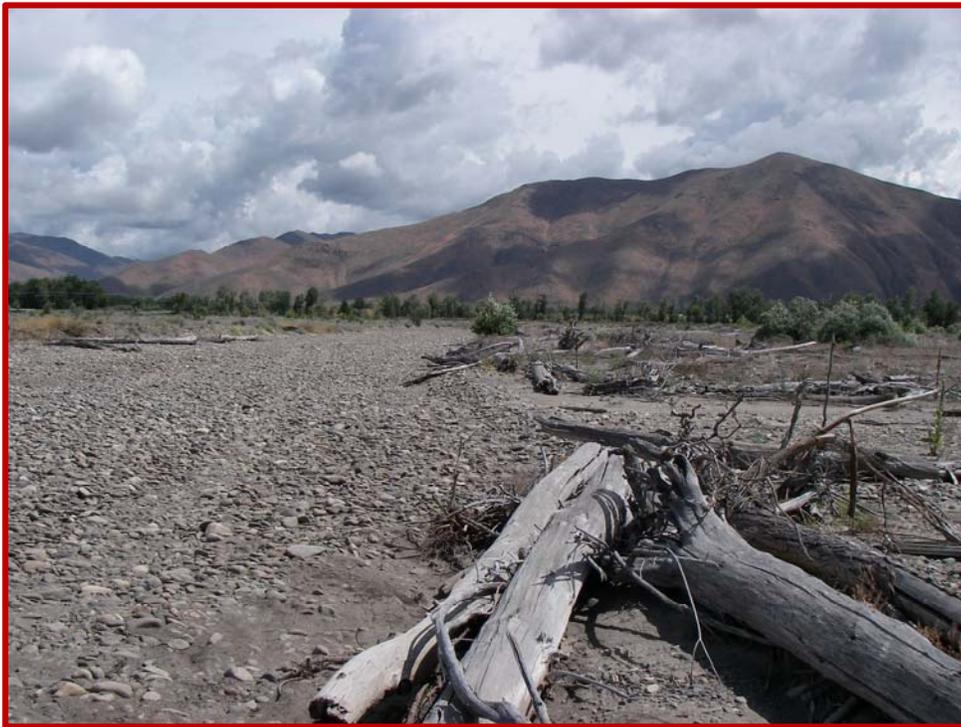
Figure 105. Photograph depicting typical channel conditions in the Glendale Reach.

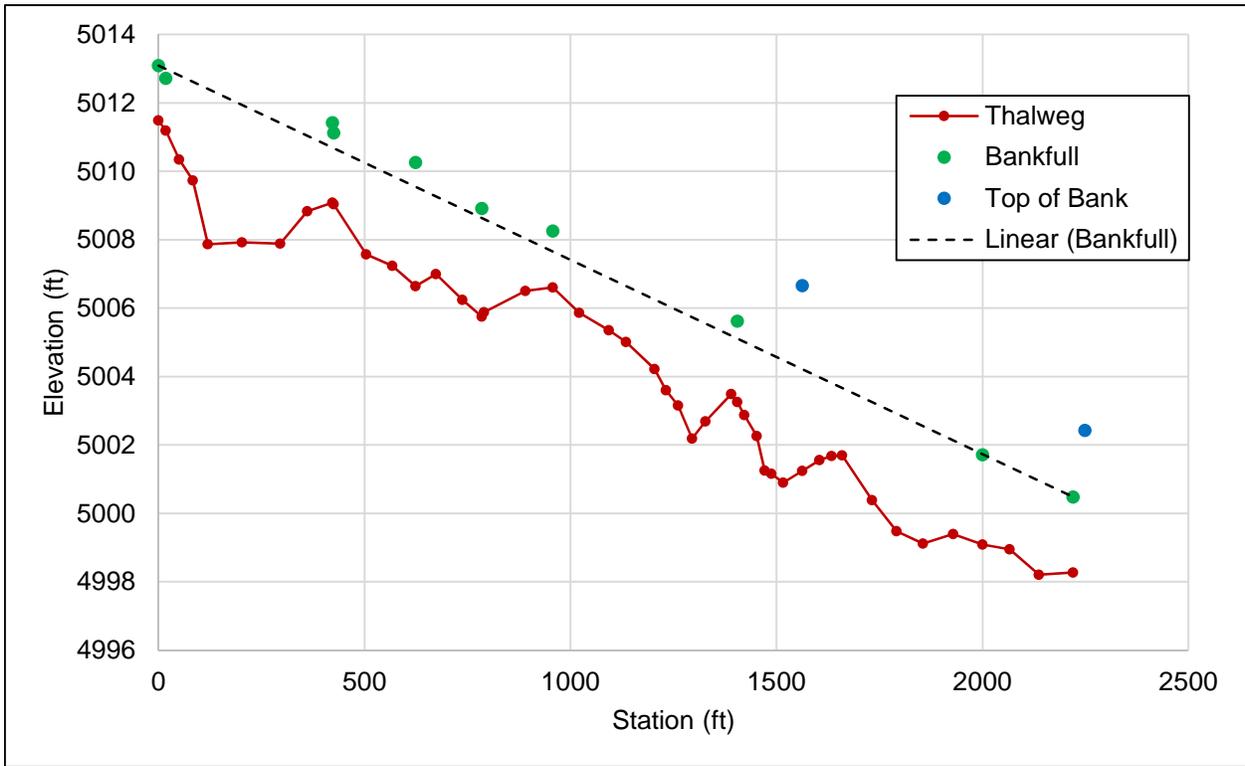
of bank elevations are depicted in blue. The reach-wide bankfull channel slope is approximately 0.57%. The reach is characterized as a braided depositional area with minimal riparian vegetation and irregular bed feature sequences. A typical riffle cross section depicting high width/depth ratio braided channel conditions is presented in Figure 108.

Figure 107. Longitudinal profile through the Glendale Reach.

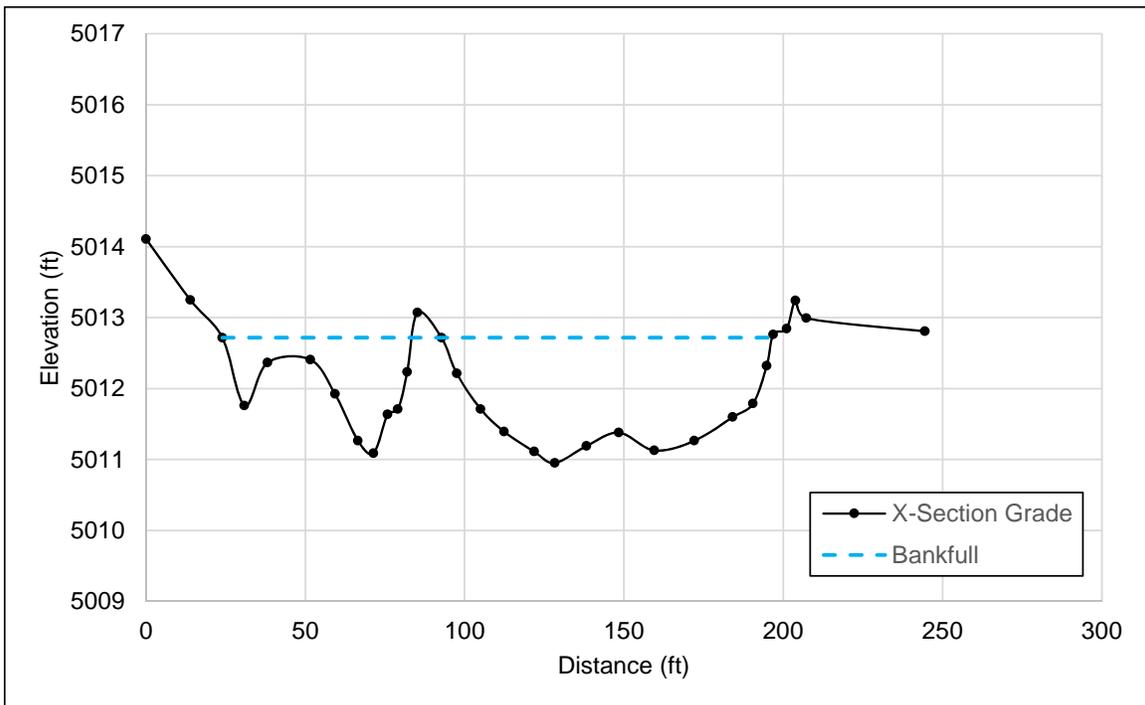
Figure 108. Typical riffle cross section in the Glendale Reach.

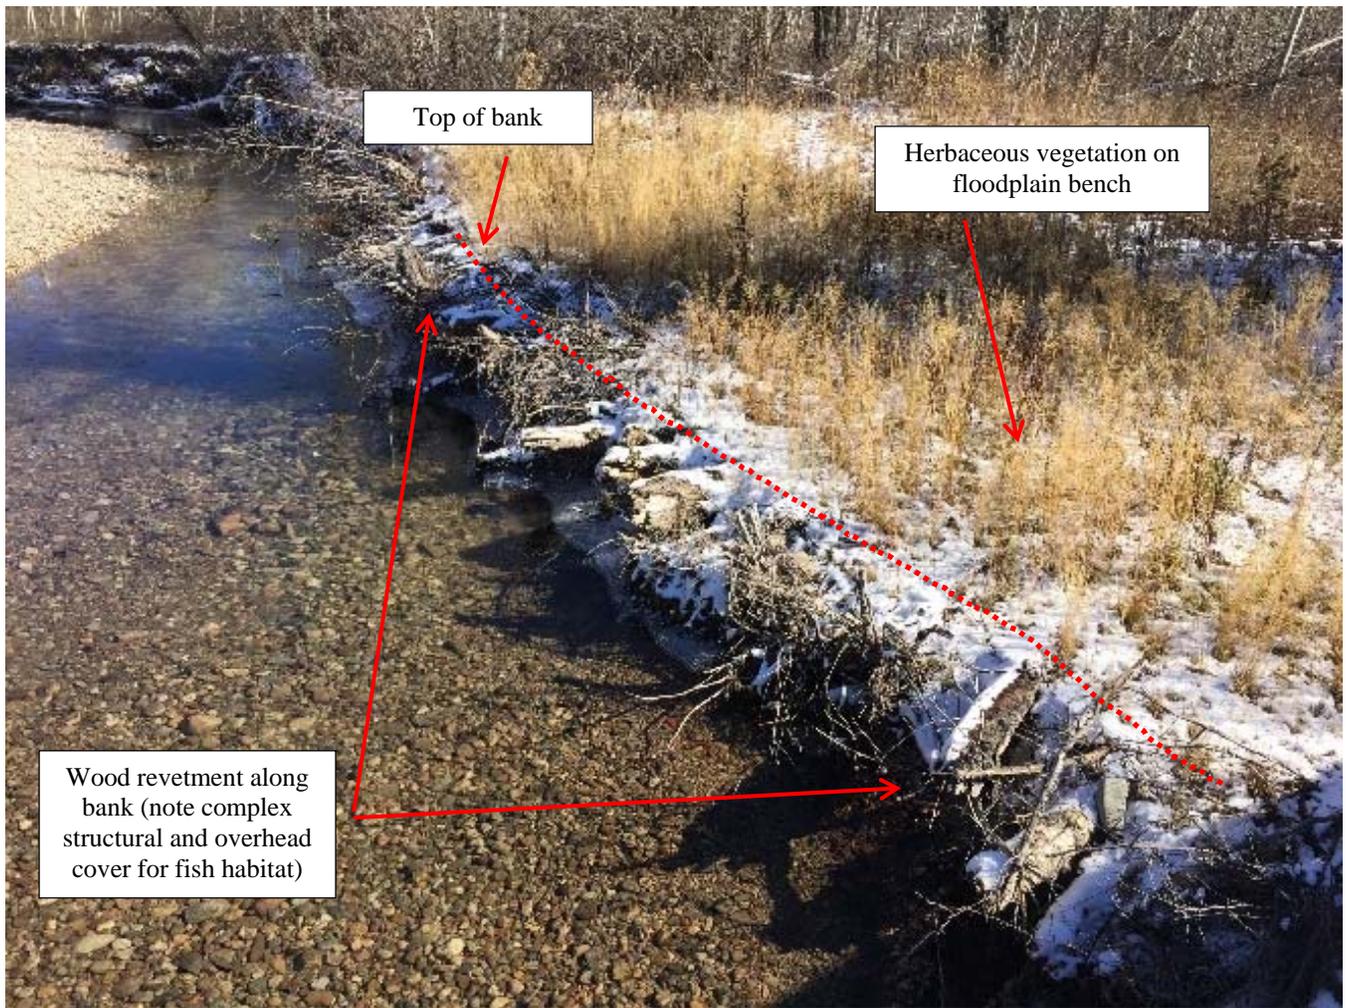
Figure 118. Wood revetment installed along river bank to prevent bank erosion, establish suitable channel width, and improve fish habitat (cover and refuge).

The wood revetment bank treatment is depicted visually in Figures 118 and 119 from projects recently completed in the region. Installed large wood (root wads and logs) harden the lower half of the river bank. Ballast and herbaceous vegetation were installed to establish a floodplain bench at the bankfull elevation. The installed large wood protrudes into the channel several feet (below the water surface), which reduces flow velocities, increases bank stability, and provides complex cover for fisheries benefit.

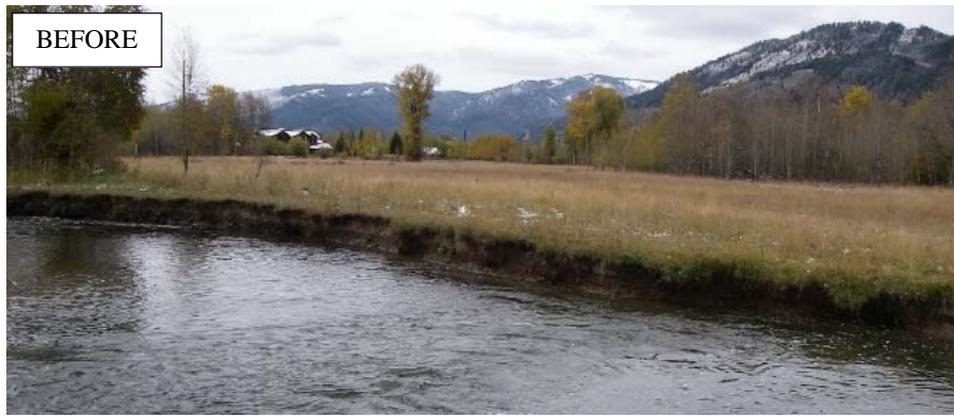
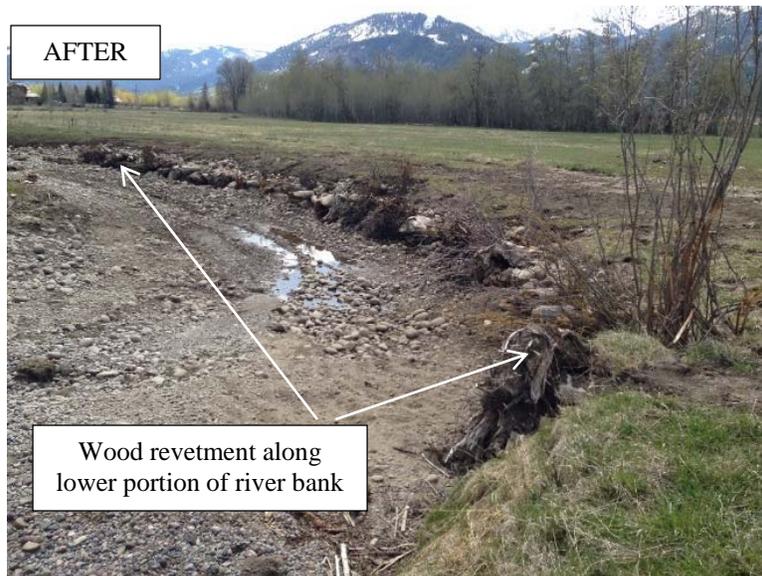
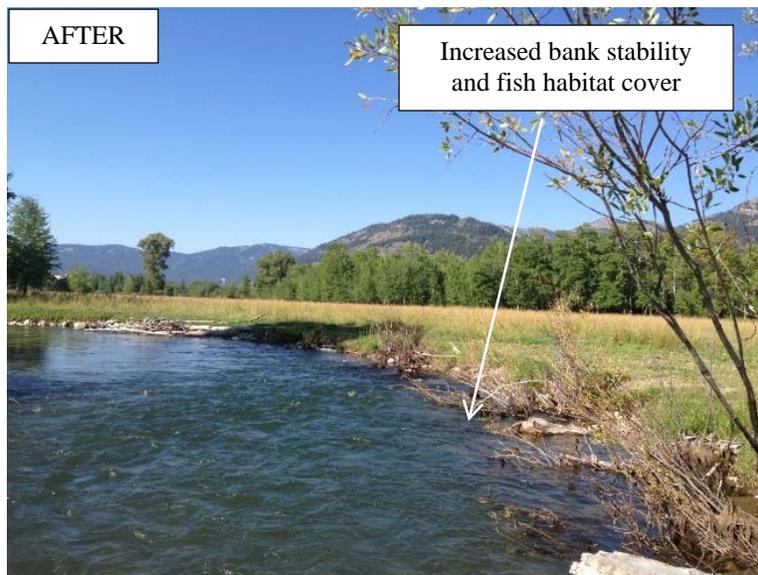
Figure 119. A severely eroding river bank (top) was stabilized with the wood revetment treatment (middle). The treatment effectively reduces potential for bank erosion, reduces near-bank flow velocities and erosive energy, and dramatically increases fish habitat through establishment of cover (structural, wood, and overhead).
